R E P O R T

ORE DRESSING AND METALLURGICAL LABORATORIES.

Investigation No. 1620.

Metallurgical Examination of Two Recoil Cylinders.

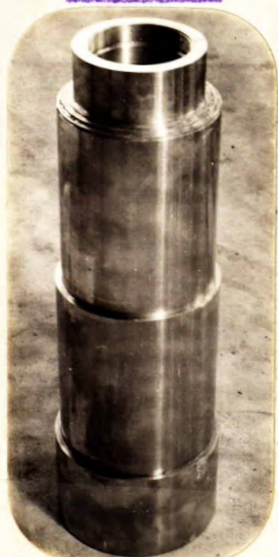
Figure 1.

rejected because of sand splits which were visible on the outside diameters and in the bores, also that the sand splits were more numerous in the bore of Forging No. 266 than in the bore of No. 271.

RECOIL CYLINDER "AS RECEIVED".
(Approximately 1/10 size).

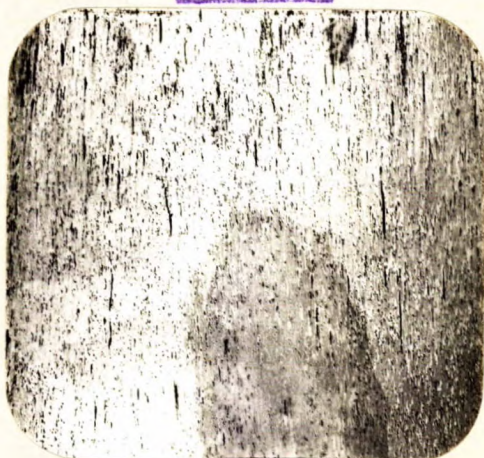
Figure 2.

The bore of Forging No. 271 had been machined to a smooth surface near the large end, and therefore this forging was taken for the metallurgical examination. The "sand splits" or inclusions were visible to the naked eye on both forgings but were especially noticeable on the machined surface of the bore of Forging No. 271. Figure 1 is a photograph of one of the cylinders in the "as received" condition. No inclusions are visible in the photograph. Figure 2 is a photograph of a deep-etched section of the cylinder. The inclusions are plainly visible in this section.

PHOTOGRAPH OF
DEEP-ETCHED SECTION.
(Approximately $\frac{1}{2}$ size).
Note "sand splits"
or inclusions.

Inclusions occurred throughout the cylinder; they are not merely surface defects.

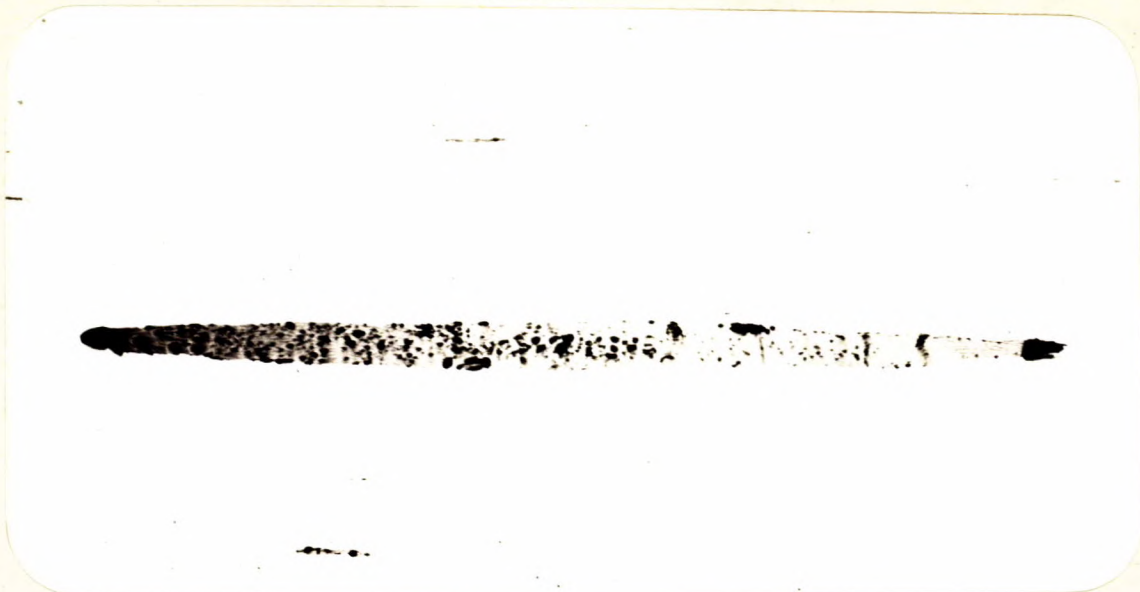
The inclusion was examined under various lighting arrangements and appeared to be mostly iron sulphide. Figure 3, at a magnification of 20 diameters, shows this inclusion. A sulphur print (using 4 per cent H₂SO₄) from the mounted sample proved that the inclusion was a complex sulphide of iron with some manganese. Figure 4, at a magnification of 20 diameters, shows the inclusion after a sulphur print was taken. A comparison of this figure with Figure 3 shows that the acid

The sulphide inclusions found in both forgings are

objectionable. However, they are not considered to be sufficient cause to reject these cylinders.

X20.

SULPHIDE INCLUSION BEFORE TAKING SULPHUR PRINT.

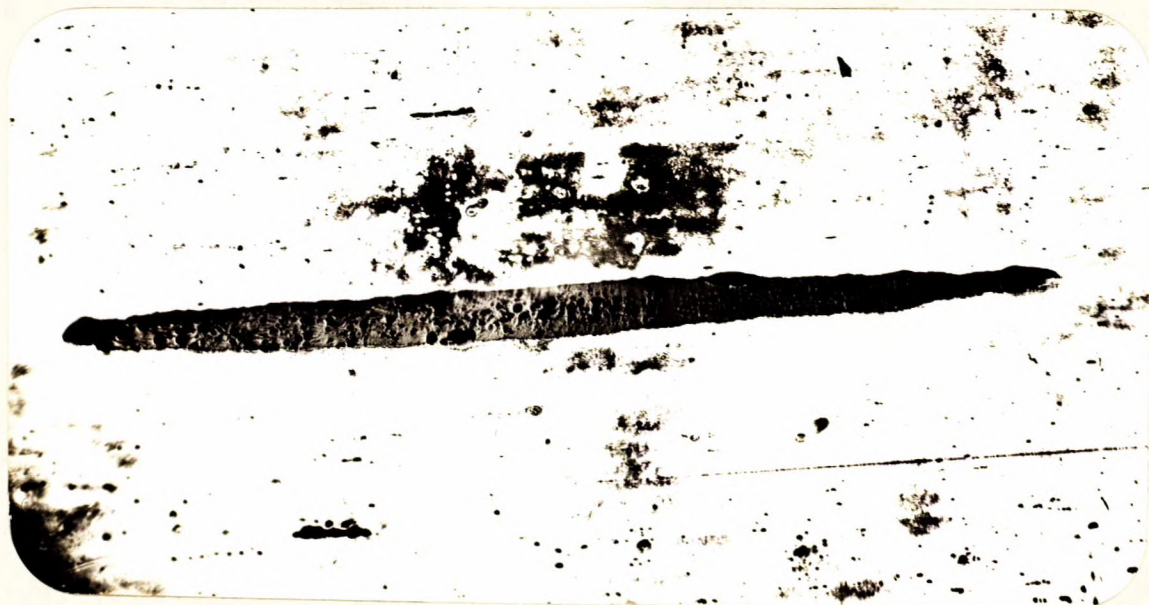
Figure 4.

strongly attacked the inclusion.

X20.

SULPHIDE INCLUSION AFTER TAKING SULPHUR PRINT.

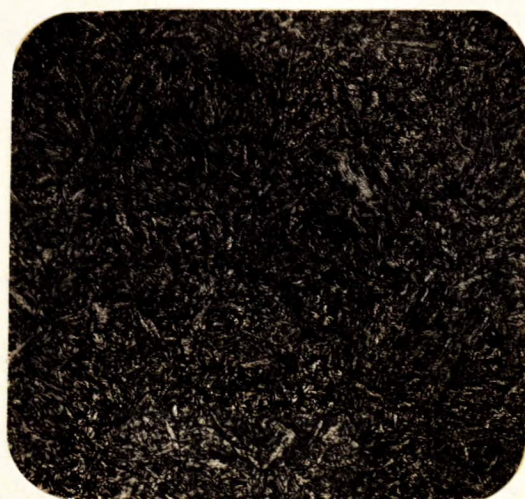
Figure 5.

Microscopic examination of the etched surfaces showed that the heat treatment was satisfactory (see Figure 5).

The heat treatment given the forgings was satisfactory, resulting in a normal structure.

X100, nival etch.

SHOWS NORMAL STRUCTURE AFTER HEAT TREATING.
