April 8th, 1944.

R E P O R T
of the
ORE DRESSING AND METALLURGICAL LABORATORIES.

Investigation No. 1623.

Examination of Steel Bolts Used in Snowmobile Track.

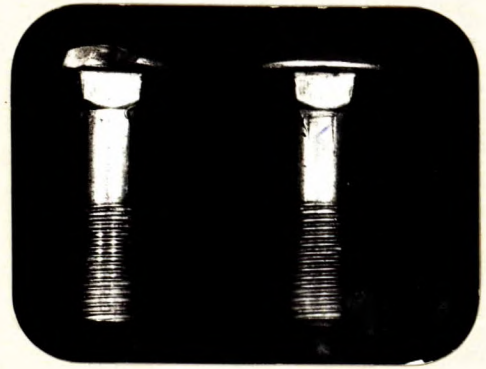
Specimens of broken and unused bolts are shown in Figure 1. Magnafluxing revealed large cracks in the remaining part of the head of the broken bolt, but there was no evidence of cracks in the neck or shaft.

BOLTS AS RECEIVED.
(Actual size).

The presence of cracks in the broken heads and the nature of the fracture indicate that the metal failed by cracking rather than by shearing.

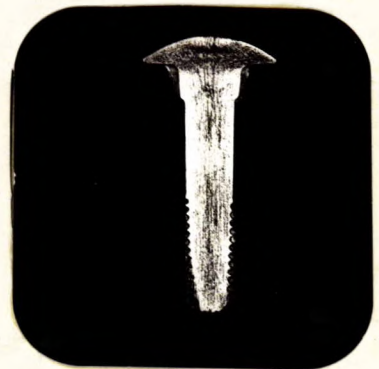
One bolt was sectioned longitudinally and macro-etched with 50 per cent HCl for 20 minutes, to determine the character of grain flow and the internal condition of the metal. The etched surface is shown in Figure 2.

MACRO-ETCHED SURFACE.

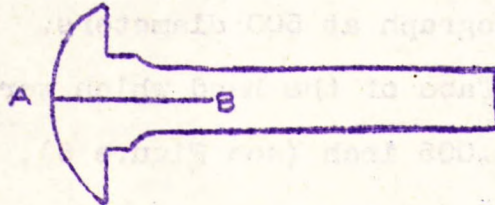
Two bolts (one broken and one unused) were sectioned longitudinally and Vickers hardness readings were taken along the line A-B as shown in Figure 3.

Hardness surveys clearly show that the hardness is above that specified (200-260 Brinell). Readings taken at close proximity to cracks varied from 490 to 502 Vickers (460 Brinell). The decrease in hardness toward the thicker section is normal for shallow hardening steels such as SAE 1035.

The high hardness values show that the bolts after quenching have not been properly drawn to obtain the specified hardness. Indeed, with this hardness it is quite likely that they have not been drawn at all. Without this necessary toughening and stress-relieving treatment, the failure of the bolt heads is explainable.

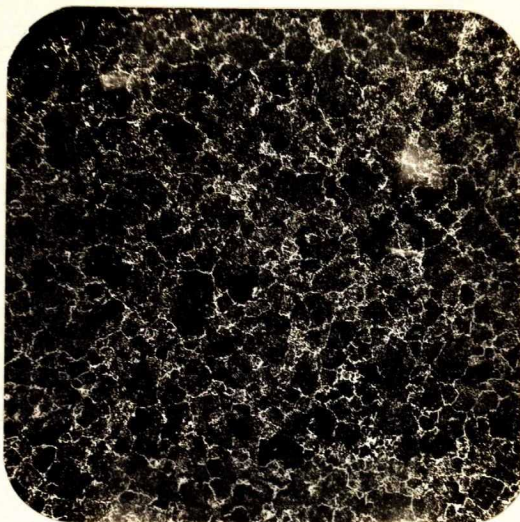
The grain size, as determined by McQuaid-Ehn test, is 5 (A.S.T.M.). See Figure 4.

X100, etched in 2 per cent nital.
GRAIN SIZE, 5 (A.S.T.M.).

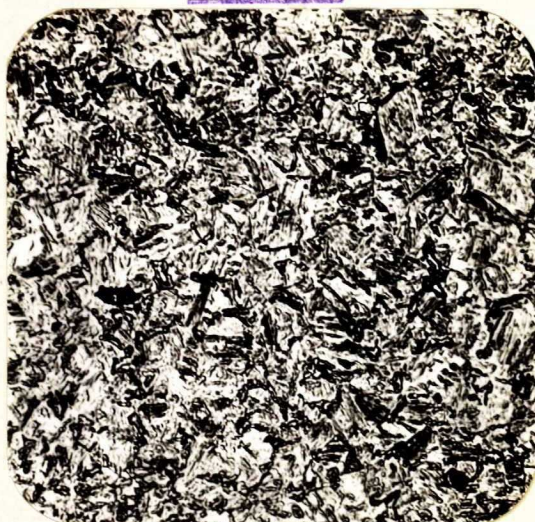
Figure 5.

surface. In the head, and particularly in the zone where cracking occurred, the microstructure was composed of martensite with troostite at the grain boundaries, as shown in Figure 5, a photomicrograph at 500 diameters. There were some areas at the surface of the head which were decarburized to a depth of 0.004-0.005 inch (see Figure 6).

The microstructure was heterogeneous (martensite and troostite), which further substantiates this evidence. Had the bolts been drawn at a suitable temperature (about 800° F.), the troostite structure would have transformed and a uniform tempered structure would have resulted.

X500, etched in 2 per cent nital.
MARTENSITE AND TROOSTITE.

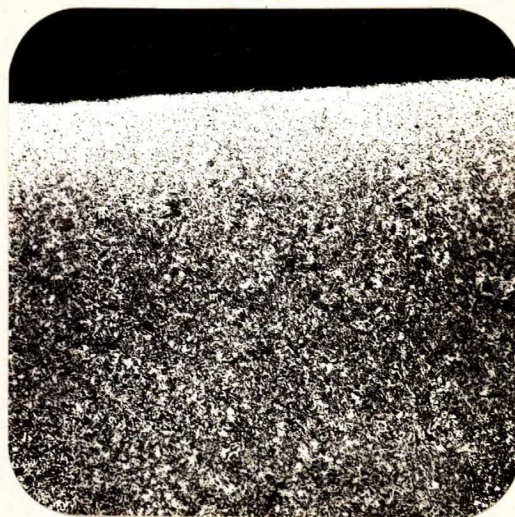
Figure 6.

The amount of decarburization is small and is not

likely to have influence on the behaviour of the bolt in service (unless it is considered that failure was occurring due to fatigue).

X100, etched in 2 per cent nital.
DECARBURIZATION.
