April 11th, 1944.

Investigation No. 1624.

Examination of Welded Bogie Suspension
Bracket from Snowmobile.

Bureau of Mines
Division of Metallic
Minerals.

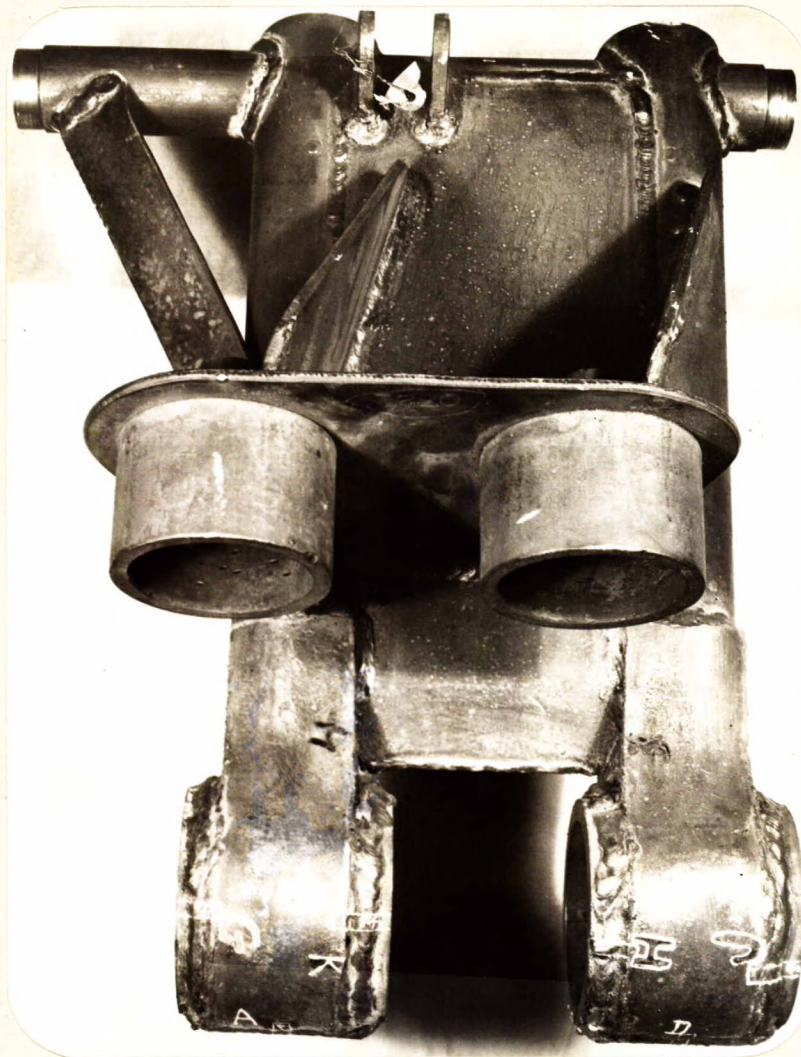
Figure 1.

A visual examination of the bracket reveals considerable undercutting, irregular welds, and improperly located weld metal. The x-ray examination reveals porosity, undercutting, slag inclusions, and lack of fusion. All of the above are confirmed by macro examination and, in addition, there is some evidence of poor fit-up.

BRACKET IN 'AS RECEIVED' CONDITION.

White rectangles indicate areas from
which macro samples were received.

1. Every effort should be made to improve fit-up of parts to be welded.

2. Surfaces to be welded should be cleaned of all scale and dirt.

3. Welding supervision should instruct welders on the effects of too high welding currents, improper electrode inclination, etc., and attempt to ensure that instructions are carried out.

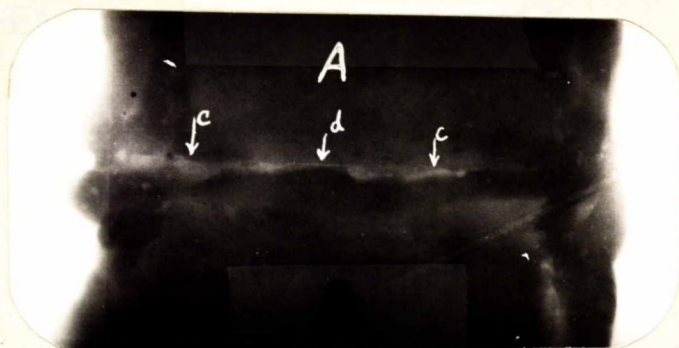
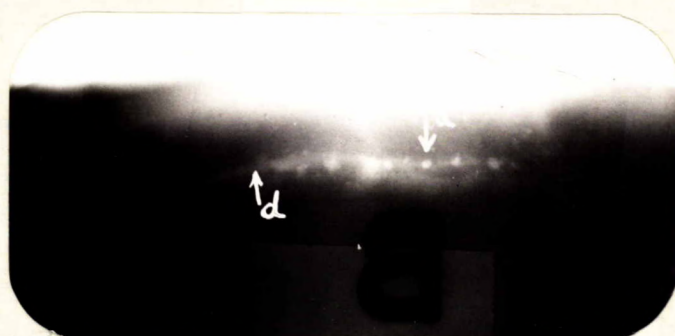
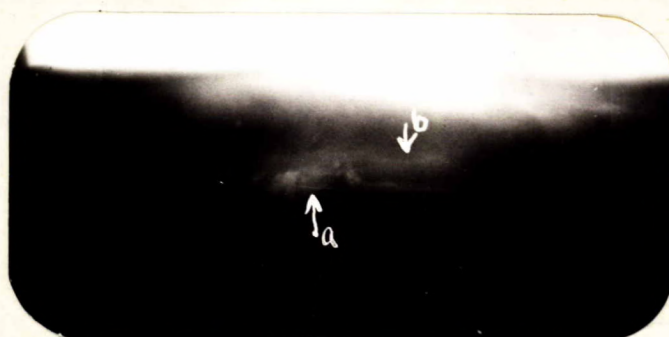
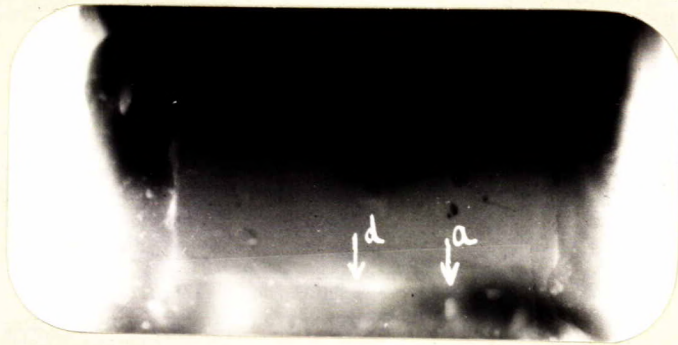
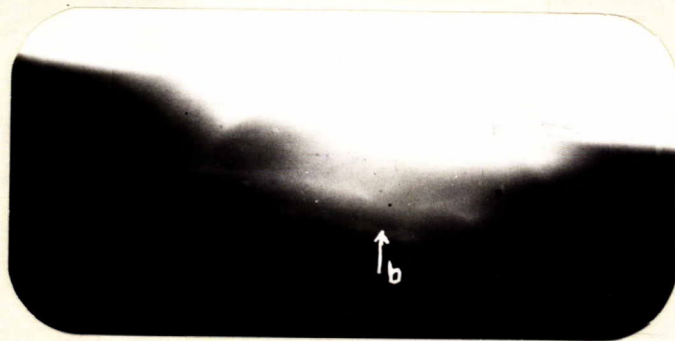
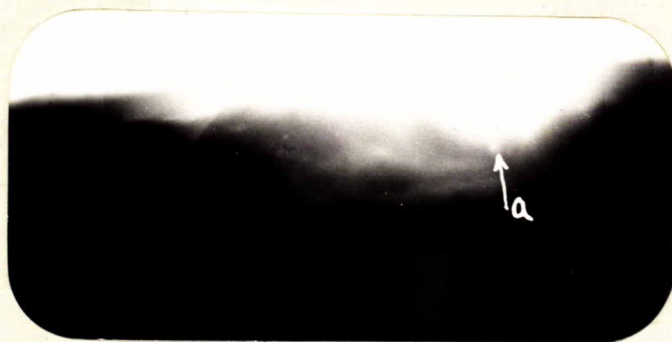
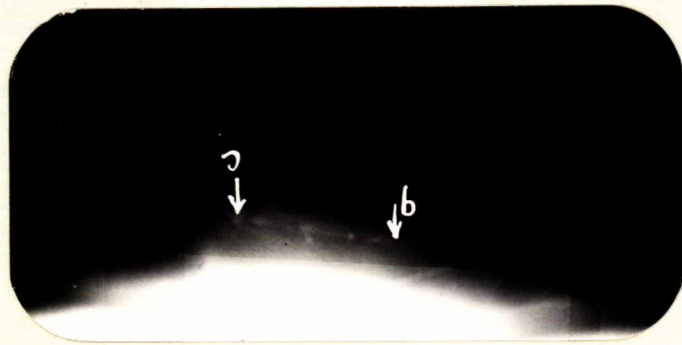
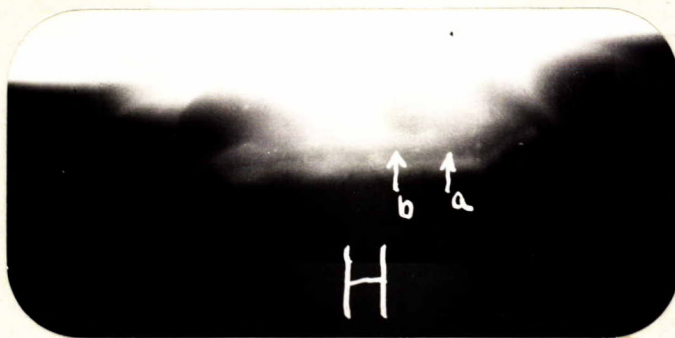
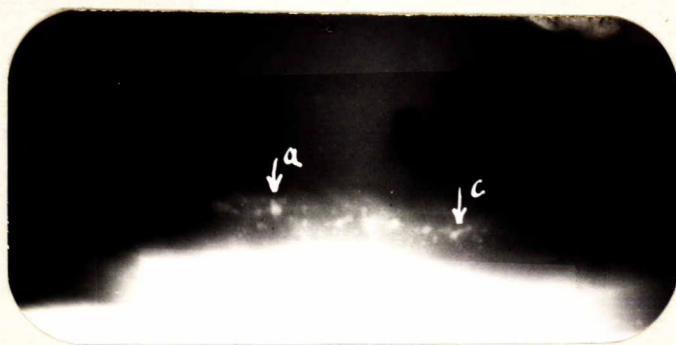
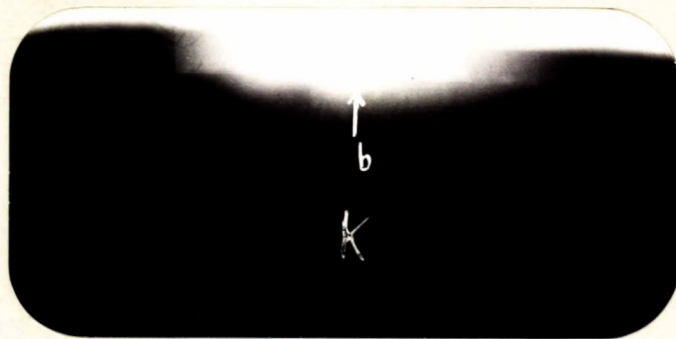
1. The suspension bracket was subjected to a thorough visual examination. Figure 1 shows the bracket "as received".
2. The shaft rings were subjected to an x-ray examination by the National Research Council, Ottawa. Figures 2 to 11 are reproductions of the exographs of the welds of the shaft rings. In examining these reproductions it should be borne in mind that there is an inevitable loss of sensitivity in the reproduction process and that the colours of the reproduction are the reverse of the exograph itself.
3. Macro sections were machined from the welds of the shaft rings in those areas in which the exographs indicated the presence of welding defects. Figures 1, 12, 13 and 14 show the

Porosity, undercutting and slag inclusions are probably the result of using too high a welding current. This leads to a pronounced boiling action of the molten metal which is then difficult to control and direct. In the fillet welds around the strap joining the shaft ring to the main body, lack of fusion at the root of the weld is probably the result of improperly cleaned surfaces. All scale, dirt and grease should be removed before welding.

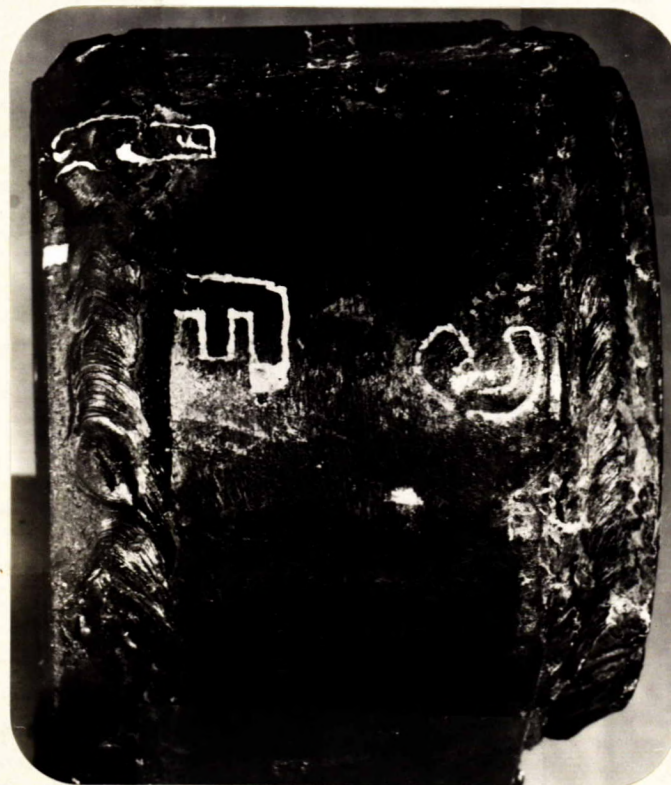
Figure 12.

CLOSE-UP OF ONE SHAFT RING.

White rectangles indicate areas from
which macro samples were machined.
Note irregularity of welds.

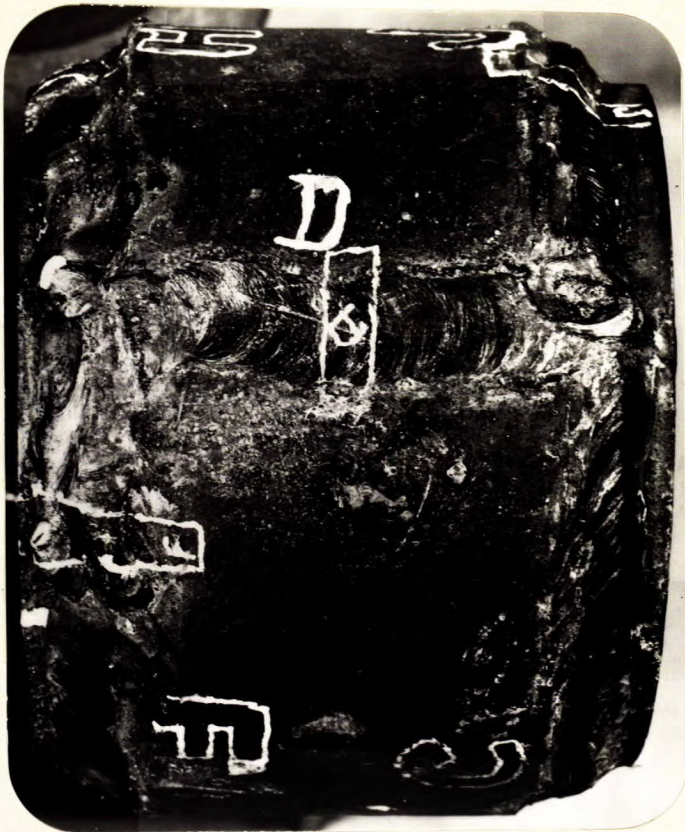
CLOSE-UP OF WELD JOINING ENDS OF STRAP.

Note irregular width of weld.
White rectangles indicate areas from
which macro samples were machined.

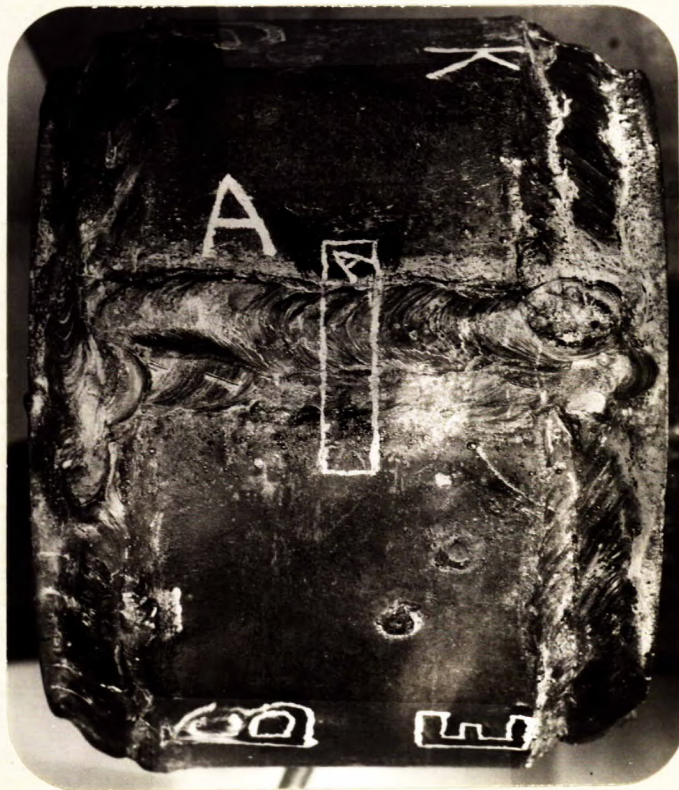
Figure 14.

CLOSE-UP OF WELD JOINING ENDS OF STRAP.

Note irregularity of welds. White
rectangles indicate areas from which macro
samples were machined.

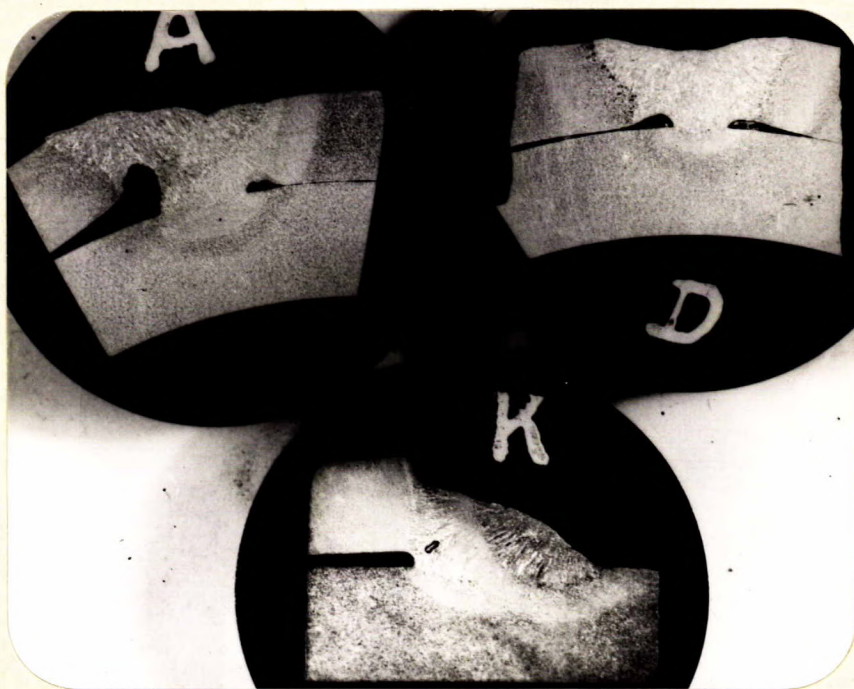
Figure 15.

MACRO SAMPLES OF WELDS OF SHAFT RINGS.

<u>Sample</u>	<u>Comment</u>
A	- Gas inclusion at root of weld. Low penetration. Poor fit-up on right side.
D	- Penetration low.
K	- Good weld with small gas inclusion.

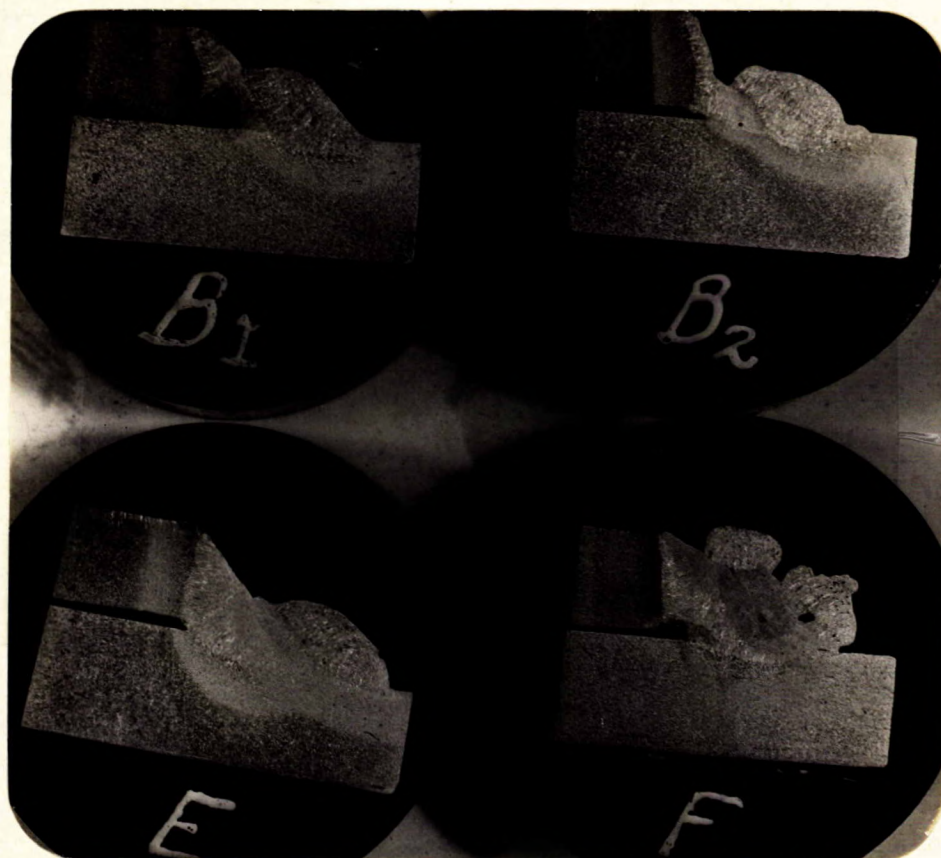
Figure 16.

MACRO SAMPLES OF WELDS OF SHAFT RINGS.

<u>Sample</u>		<u>Comment</u>
B ₁	-	Large gas inclusion at root of weld. Good penetration.
B ₂	-	Undercutting on vertical edge. Poor location of weld metal. Poor fit-up.
E	-	Good penetration; slight undercutting. Poor fit-up.
F	-	Poor penetration at root of weld. Very irregular and gassy weld.

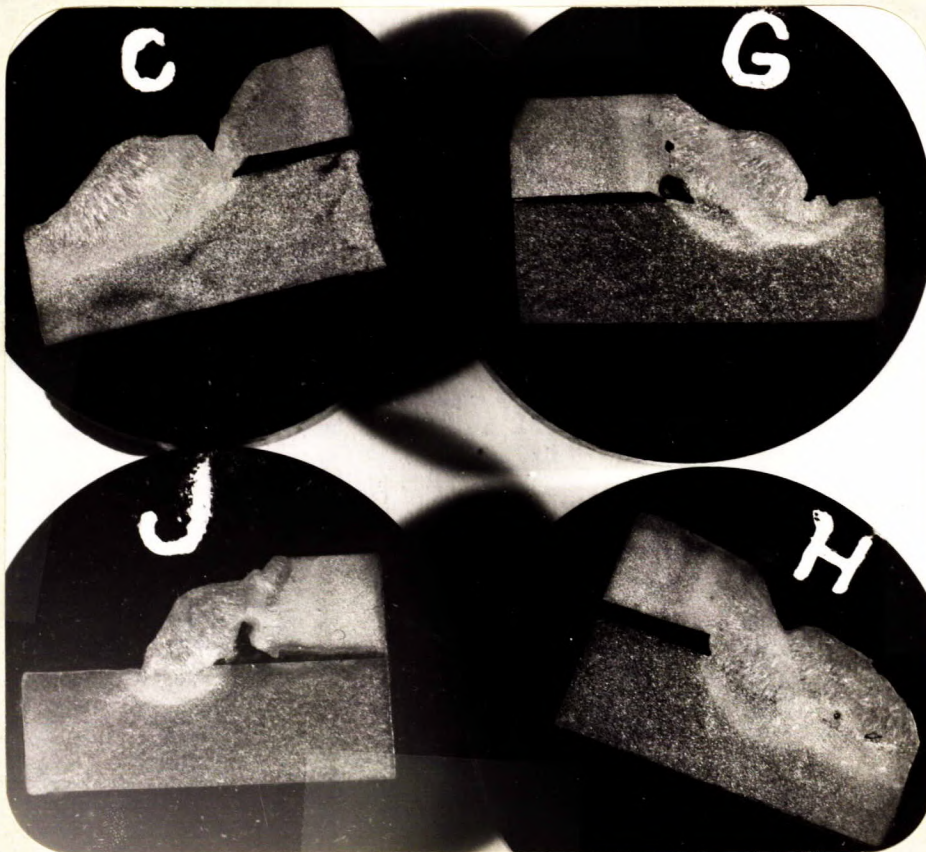
Figure 17.

MACRO SAMPLES OF WELDS OF SHAFT RINGS.

<u>Sample</u>	<u>Comment</u>
C	- Poor fit-up; severe undercutting. Penetration good.
G	- Gas inclusions at root of weld. Penetration good.
J	- Lack of fusion at root of weld.
H	- Poor fit-up; some undercutting and gas inclusions.
