April 11th, 1944.

Investigation No. 1625.

Examination of Connecting Rod Bearings  
from Ford Vehicle C-118.

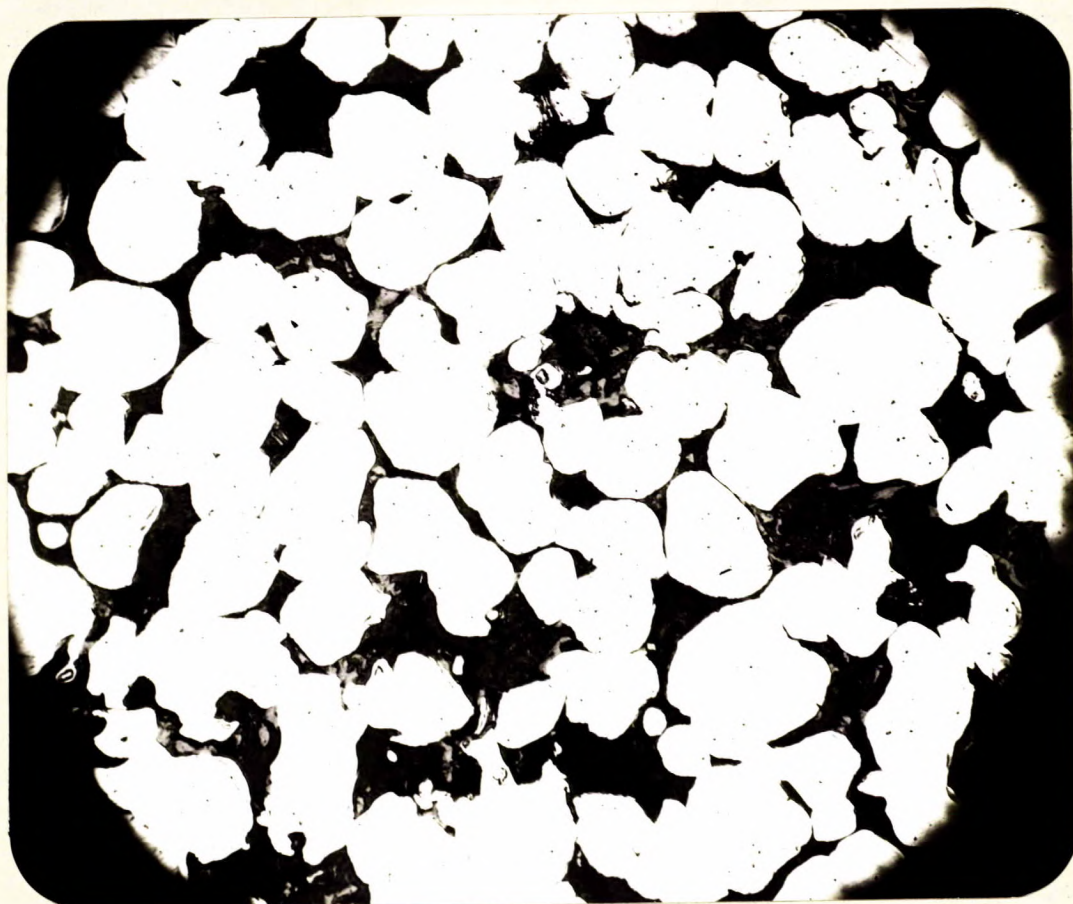
Figure 1.

X250, unetched.

TANGENTIAL SECTION.

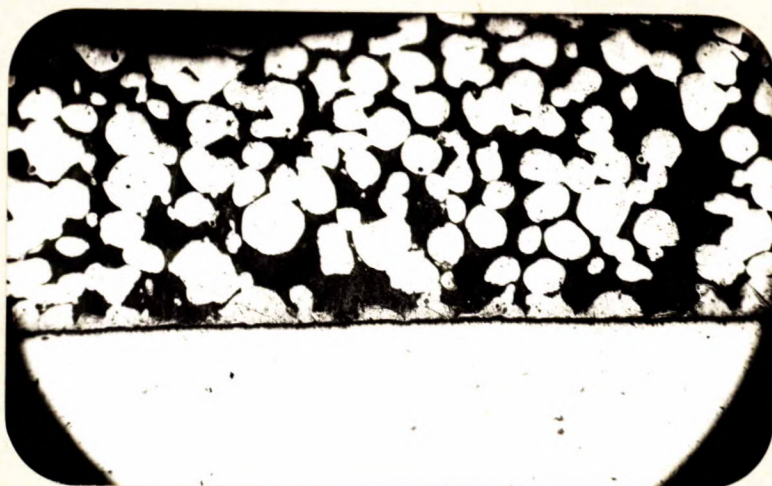
Figure 2.

X100, unetched.

RADIAL SECTION.
