ORE DRESSING AND METALLURGICAL LABORATORIES.

Investigation No. 1628.

Examination of a Section of Admiralty Cable
(Pattern A.P. 7048) which Failed in Service.

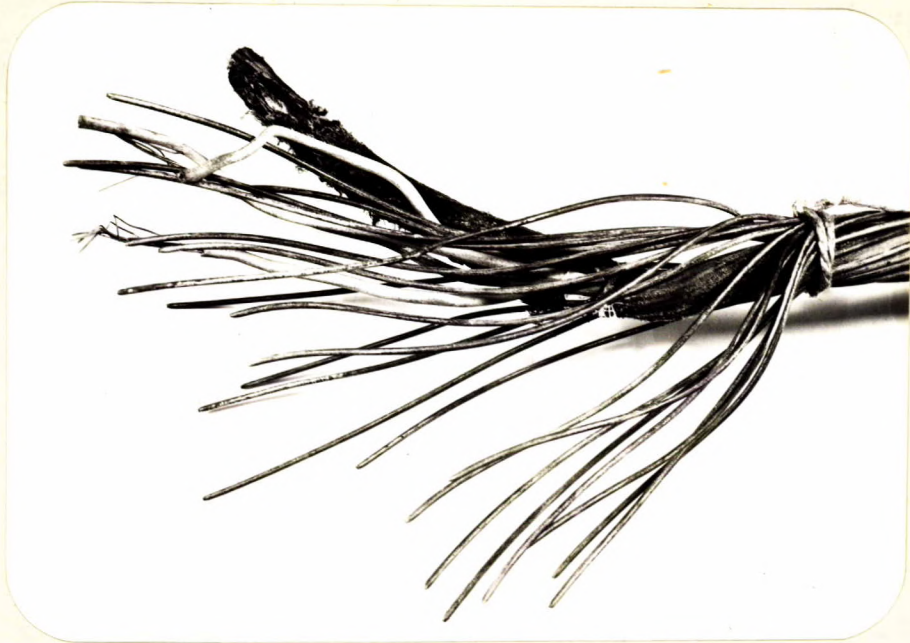
Figure 1.

The section of cable submitted was approximately 3½ feet long by 7/8 inch outside diameter. Figure 1 is a photograph of the broken end of the cable as received. Figure 2 is a photograph of the broken ends of all strands comprising the armoured cable. This photograph shows that all 22 strands in the cable broke in tension. There was no sign of wear or abrasion on the section of cable submitted for examination.

BROKEN SECTION OF CABLE, AS RECEIVED.

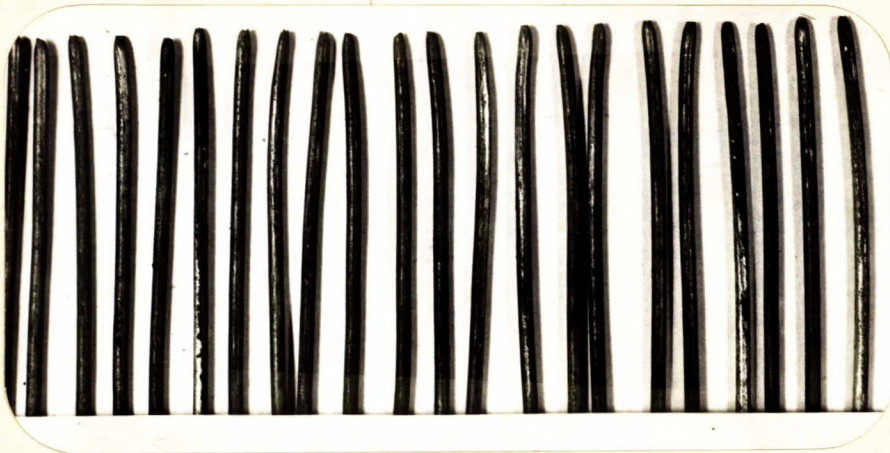
Figure 2.

Figure 3 shows the necked ends of the strands pulled in tension. A comparison of this illustration with Figure 2 shows definitely that all the strands in the cable "as received" broke in tension, as they are necked down in an exactly similar manner to the strands pulled in the tension machine.

The section of Admiralty cable (Pattern 7048) submitted had broken under tension.

BROKEN ENDS FROM CABLE, SHOWING
STRANDS WERE BROKEN IN TENSION.

Note necking on all strands.

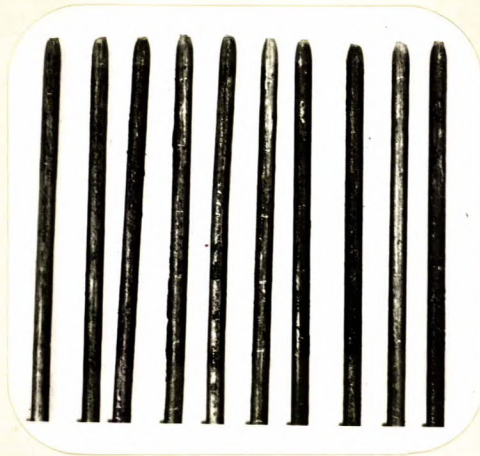
Figure 3.

STRANDS BROKEN IN TENSILE
TESTING MACHINE.

Note necking on all strands.

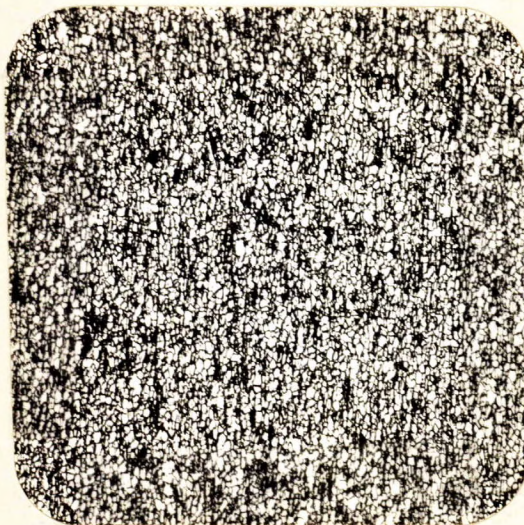
Figure 4.

A longitudinal section from one of the armour wires was mounted, hand polished, etched in 2 per cent nital, and microscopically examined. The structure revealed was normal for wire of this composition after cold working and subsequent annealing (see Figure 4).

Chemical analysis and microscopic examination showed that the steel used was satisfactory.

NORMAL STRUCTURE OF 0.11
PER CENT CARBON WIRE
AFTER COLD WORKING
AND ANNEALING.
