ORE DRESSING AND METALLURGICAL LABORATORIES.

Investigation No. 1635.

Metallurgical Examination of Three SAE 3115 Universal  
Carrier Track Pins to Determine Whether Recent Failures  
are Due to Substandard Pins or Warped Track.

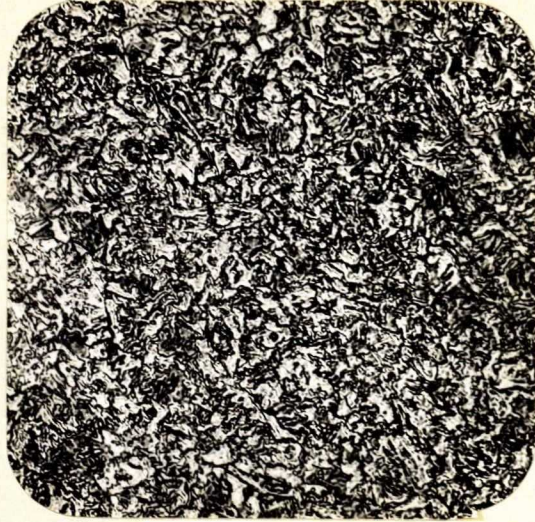
Figure 1.

Microscopic examination of transverse specimens showed a core structure of low-carbon martensite (see Figure 1, a photomicrograph at X500 magnification).

The martensitic microstructure of both case and core indicates suitable heat treatment.

X500, etched in 2 per cent nital.

CORE STRUCTURE.

Low-carbon martensite.

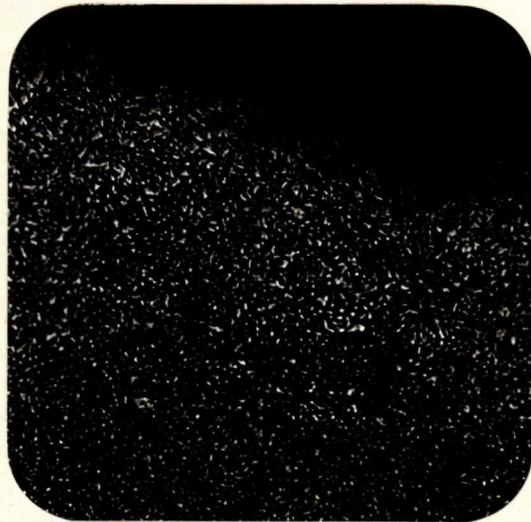
Figure 2.

A typical example of the microstructure of the case is shown in Figure 2 (a photomicrograph at X500). It is composed of fine martensite.

X500, etched in 2 per cent nital.

CASE STRUCTURE.

Nodular tempered martensite.
