May 8th, 1944.

ORE DRESSING AND METALLURGICAL LABORATORIES.

Investigation No. 1636.

Metallurgical Examination of C.D.P. Track Pins  
Which Failed O.A. 227 Impact Test.

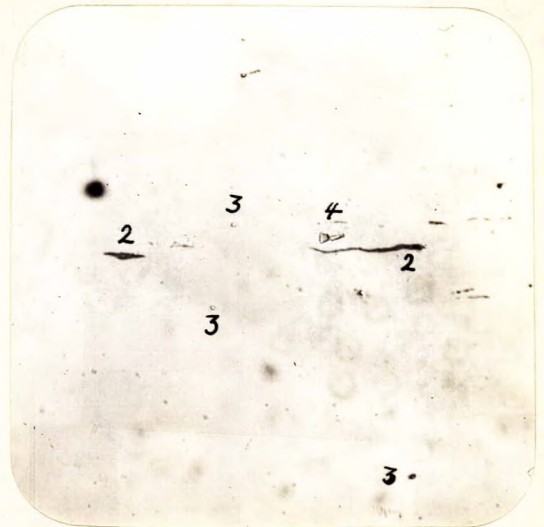
- (1) Inclusions of the oxide type (alumina, iron and manganese) which were grouped together in stringers in the direction of rolling. See Figure 1, a photomicrograph at X500 magnification.
- (2) Elongated inclusions of the sulphide-basic silicate type. See Figure 2, photomicrograph at X500.
- (3) Acid silicate inclusions which are not elongated in the direction of rolling. See Figure 2.
- (4) Titanium cyano nitride inclusions (pink in colour and strongly angular. See Figure 2.

INCLUSIONS.  
2. Sulphide silicate.  
3. Acid silicate.  
4. Titanium nitride.

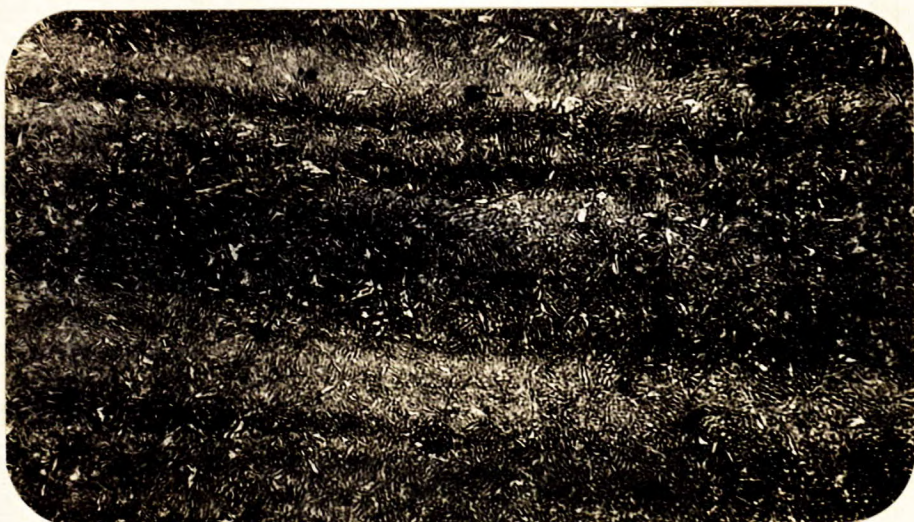
Figure 3.

revealed a tempered martensitic microstructure banded with light etching areas. This banding was more noticeable and extensive than usually found in SAE 9255 pin steel. A typical example of this microstructure is shown in Figure 3, a photomicrograph at X250 magnification. For comparative purposes, the microstructure of a longitudinal section of a C.D.P. track pin in which this banding is not visible is shown in Figure 4, also a photomicrograph at X250.

It should be pointed out that the possibility exists whereby micro cracks (hair line) are produced in the quenching operation of the heat treatment process. No evidence, however, was found during this operation to definitely substantiate this condition. It is felt that banding is the most likely cause of failure.

TEMPERED MARTENSITE BANDED WITH  
LIGHT ETCHING AREAS.

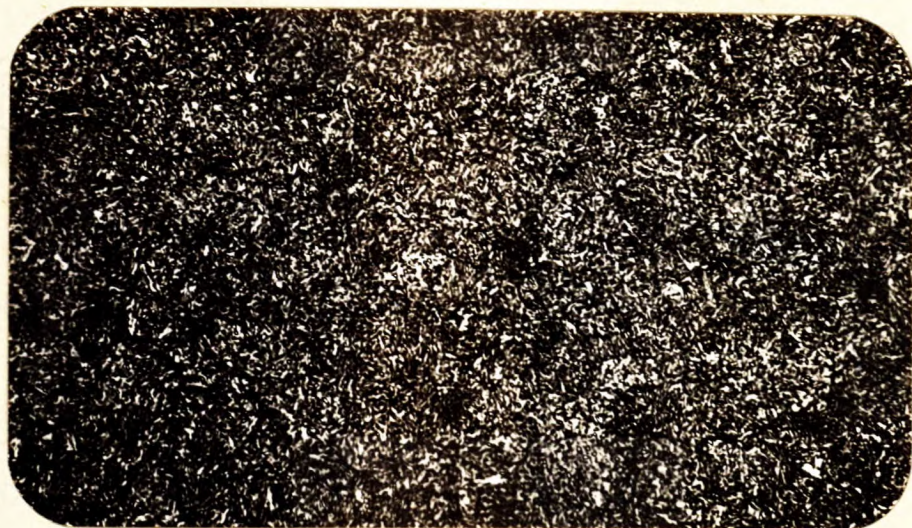
Figure 4.

X250, etched in 2 per cent nital  
MICROSTRUCTURE OF A C.D.P. PIN IN  
WHICH BANDING IS NOT NOTICEABLE.

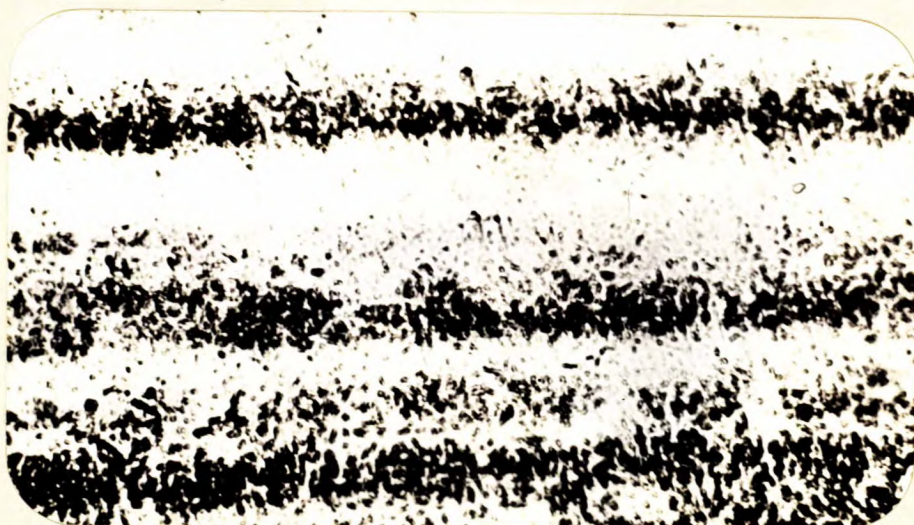
Figure 5.

Longitudinal specimens representative of the three pins, etched with Stead's copper reagent, showed a heavily banded structure, indicating segregation in these banded areas. A typical example of a longitudinal section so etched is shown in Figure 5, a photomicrograph at X250.

The specimens etched with Stead's copper reagent (see Figure 5) indicate considerable segregation. Although generally considered to show phosphorus segregation, this etch is stated by Hatfield to show heterogeneous distribution of manganese and silicon equally well. The phosphorus content

of these pins (0.007 per cent) is low; so that it is quite likely the light etching areas are the result of silicon segregation. In either case, the result would be loss of ductility and strength.

X250, etched with Stead's reagent.  
SEGREGATION IN BANDED STRUCTURE.
