ORE DRESSING AND METALLURGICAL LABORATORIES.

Investigation No. 1637.

Examination of Broken Rear Axle Pinion and Damaged
Rear Axle Shaft from Four Wheel Drive Truck.

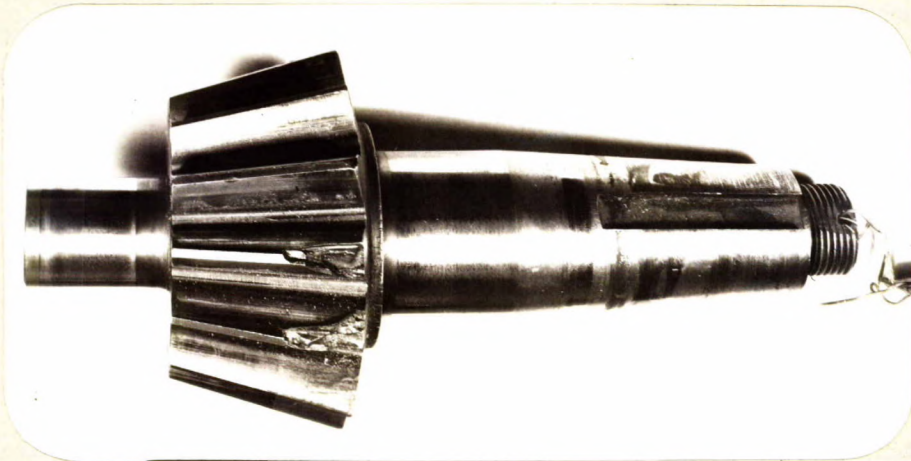
Longitudinal cracks were observed on each gear
tooth of the pinion "as received". These cracks appeared to
have started on one end of the pinion about the middle of
the tooth. As the crack progressed, some bits chipped off

from the gear teeth. This condition is illustrated in Figure 1. It was observed that there were fairly heavy machine tool marks on the end of the pinion where the crack originated.

BROKEN PINION.
(Approximately $\frac{1}{2}$ actual size).

The progressive nature of the cracks observed in the pinion gear teeth is characteristic of a fatigue failure. The composition of the steels is within the range specified except the low manganese content of the pinion and the molybdenum in axle shaft steel which is just under the minimum specified. No significance, however, is attached to the low content of these elements. The presence of grain boundary carbides in the cased surface of the pinion would have an embrittling effect and definitely would lower the endurance limit of the part. These free carbides can be eliminated by a diffusion heat treatment or possibly by carburizing under less active conditions. Both pinion and shafting steels had the specified grain size and were heat treated to the specified

1. The pinion submitted for examination has failed by fatigue.
 2. The presence of free carbides in the grain boundaries is due to faulty heat treatment, and this condition is considered definitely as having contributed to the premature failure of the pinion.
 3. No metallurgical reason was observed which would account for the distortion of the axle shaft. Failure apparently was brought about by stresses greater than those which the part was designed to withstand.
 4. The distortion of the shafting indicates that test conditions were unusually severe, and it is possible that the metallurgically defective pinion might have withstood less severe service. There is also a possibility that gear alignment and faulty gear contour may have been contributing causes.
-

1. Machine tool marks should be reduced to a minimum in order to avoid stress raisers, which definitely accelerate fatigue failure.
2. Shotblasting of the parts will increase the fatigue strength of moving parts subjected to alternating stresses, and it is recommended.
3. A check on the case-hardening heat-treatment cycle used should be made, in order to determine the time-temperature cycle required to eliminate free carbides in the case.
4. The steel specified for the rear axle shaft is considered to be of a suitable composition and should prove satisfactory under normal operating conditions.
5. Pin alignment and dimensions also should be checked.

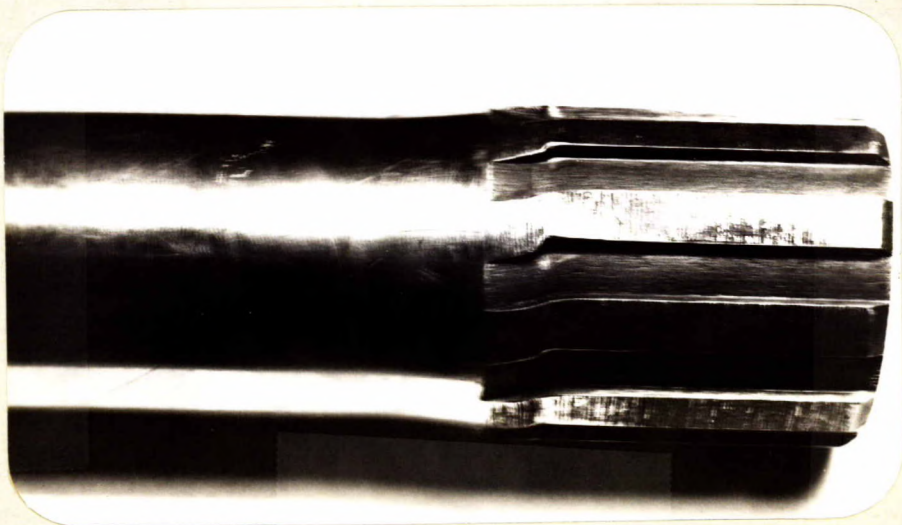
Figure 2.

The rear axle shaft was found to have been twisted about 15 degrees on each end at the base of the splined section. (See Figure 2).

SHOWING TWIST AT END OF SHAFT.
(Approximately to size).

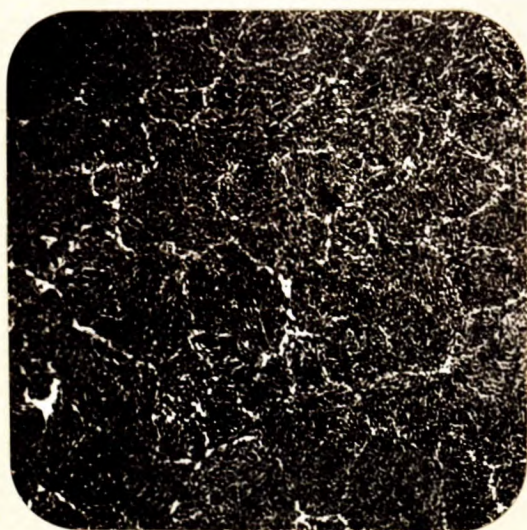
Figure 3.

are photomicrographs, at X500 magnification, showing the nital-etched structures of the case and core of the pinion. The microstructure of the case consists of drawn martensite with free carbides enveloping the grains. The structure of the core consists of low-carbon drawn martensite. Figure 5 is a photomicrograph, at X1000 magnification, showing the nital-etched structure of the shaft steel. The structure consists of tempered martensite. The McQuaid-Ehn grain sizes of the pinion and shaft steels were also determined. The grain size of the pinion is 5 and that of the shaft is 7. The case depth was determined with a Brinell microscope and was found to be 0.040 inch.

GRAIN BOUNDARY CARBIDES
IN CASE OF PINION.

hardness. The absence of ferrite shows that both parts were finally quenched above the upper critical of the interior material. The hardness of the pinion indicates that the quenching most probably was in oil. While the presence of grain boundary carbides is a definite defect, it is possible that other dimensional and mechanical conditions may have contributed to failure. The coarse machining marks would cause severe stress concentration, but poor alignment of parts or a lack of proper contour would cause even more severe concentration of stress.

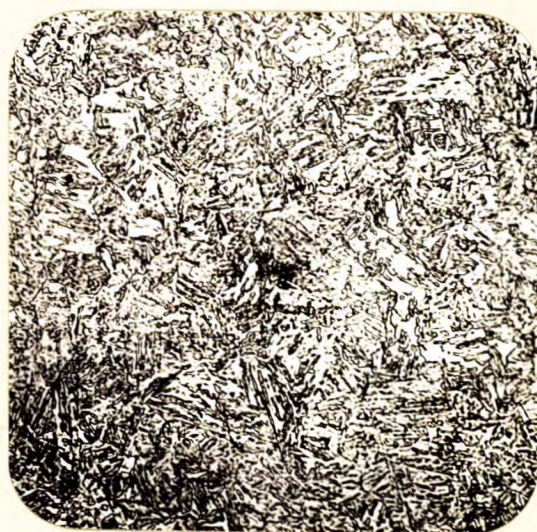
Figure 4.

MICROSTRUCTURE OF THE
CORE OF PINION.

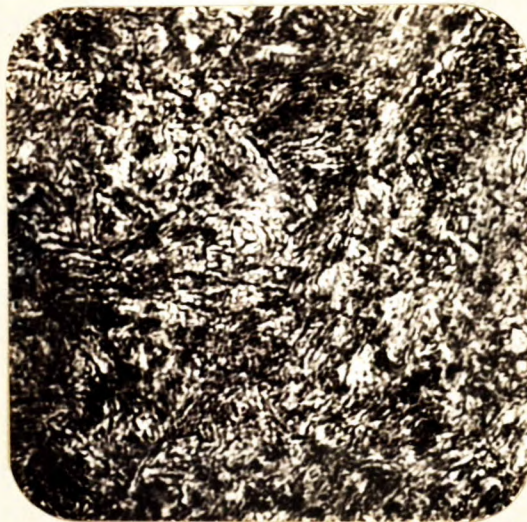
Figure 5.

MICROSTRUCTURE OF SHAFT STEEL.
