Investigation No. 1638.

Investigation of the Surface Condition of High  
Manganese Steel Produced by Electric Steels  
Limited, Cap de la Madeleine, Quebec.

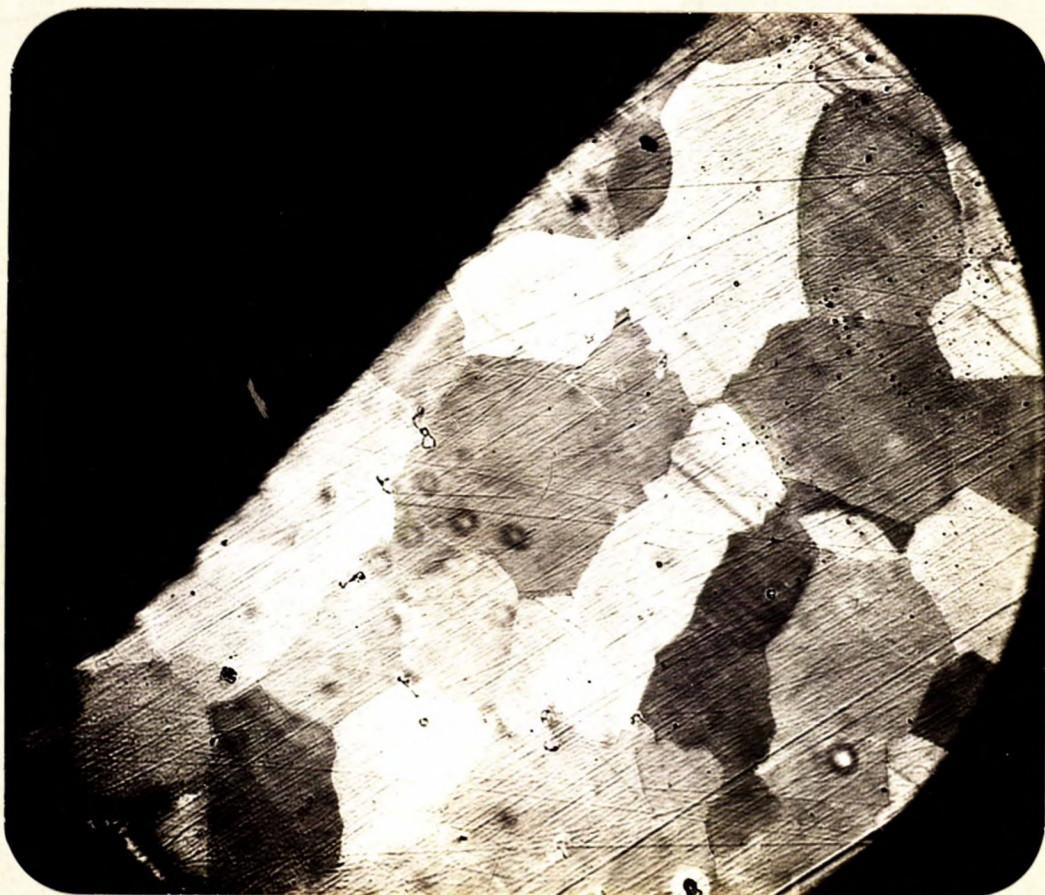
Figure 1.

COVERED BAR A.

(Note: Surface has not been decarburized - no martensitic layer.)

It can be seen readily, from the photomicrographs, that no noticeable decarburization occurs when the test specimen is covered, e.g. Bar A. When it is placed in the annealing furnace uncovered, a heavy decarburization takes place which, on the subsequent quench, gives a martensitic layer. This was approximately 0.012 inch thick, as shown by Bar B.

Bar A does not represent the surface of the shoe. A covered specimen of this type, if from the same heat, does represent, however, the metal in the shoe. The bend test will consequently give an indication as to the relative ductility of the heat of steel produced, not taking into account the actual surface condition of the shoes.

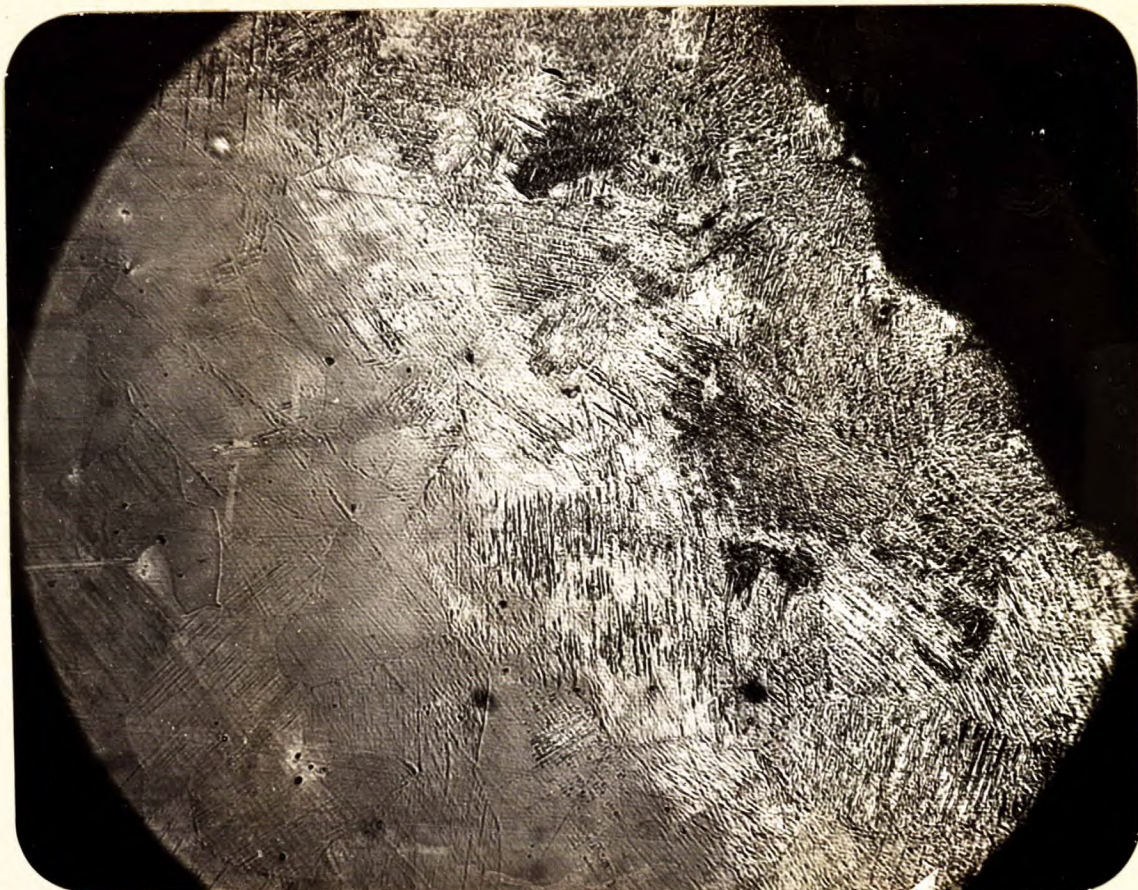
UNCOVERED BAR B.

(Note: Heavy layer of martensite (0.012 in.) at the surface.)

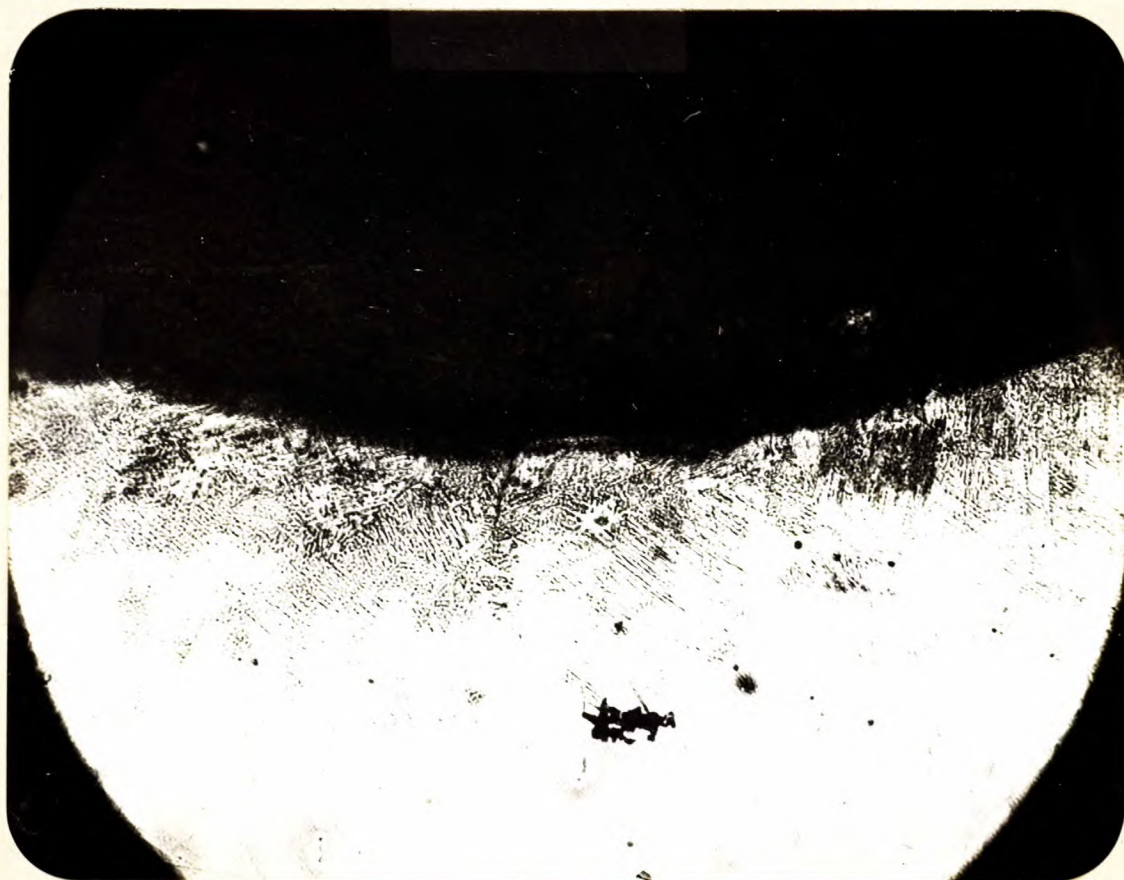
Figure 3.

SURFACE OF A PRODUCTION LINK.

(Note: Martensite layer at the surface (0.003 in.) -  
some decarburization has taken place.)

The shoe, which represents a production lot, has a layer of martensite about 0.003 inch. It is probably difficult to avoid some decarburization, especially if a long soaking period is used.

During the period when the headless pin was being tried, some difficulty was experienced when an attempt was made topeen the collars of the Electric Steels Limited track shoes. Figure 3 indicates that this difficulty may possibly have been caused by the cracking, on rivetting, of the brittle martensitic skin. This may not only have caused the peening difficulty but also may have been responsible for the failure to keep the pin locked in during service.
