ORE DRESSING AND METALLURGICAL LABORATORIES.

Investigation No. 1639.

Examination of Broken Snowmobile Bogie
Suspension Brackets.

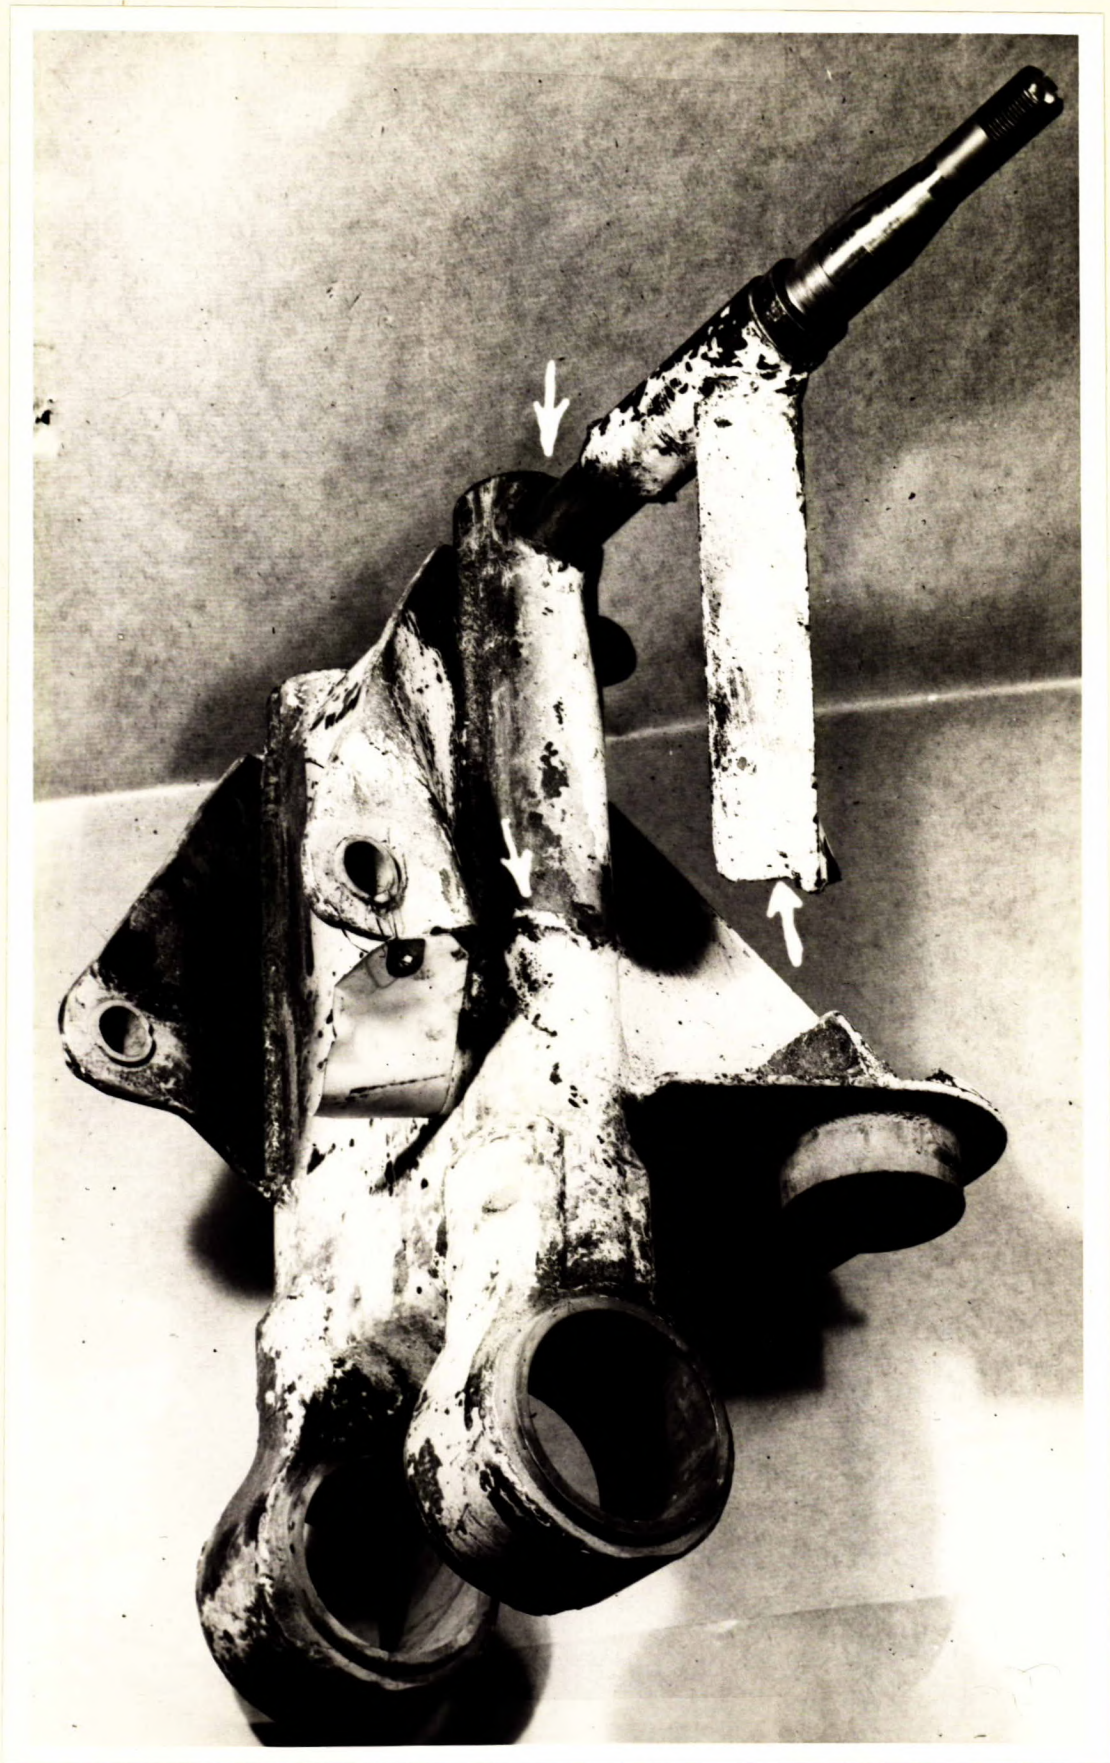
Figure 1.

A visual examination of Sample A reveals that both the angle iron brace and the pinion support tube fractured in the heat-affected zones of the welds. It would appear that the angle iron brace broke first and the additional load applied to the pinion support tube was too great for the latter. The chemical analysis and the micro-examination of both of these failed parts reveal that the angle iron brace is of a composition which must be welded with care if trouble is to be avoided. In this particular case a thin layer of weld metal has produced the conditions for high heat-affected-zone hardness. The micro-structure in this area is coarse-grained, with ferrite grain boundaries. This condition, plus considerably higher hardness, results in both low impact resistance and low fatigue strength. The analysis and the micro-examination of the pinion support tube reveal no evidence of substandard material or of welding defects. This supports the belief that the failure in this

SAMPLE A, AS RECEIVED.

Arrows point to fractured areas.

2. All angle braces should be joined to the bogies

by means of a double-pass weld. This will refine the grain and reduce the hardness of the heat-affected zone of this high-carbon material. Stress relief alone would reduce the hardness but would have no grain-refining effect.

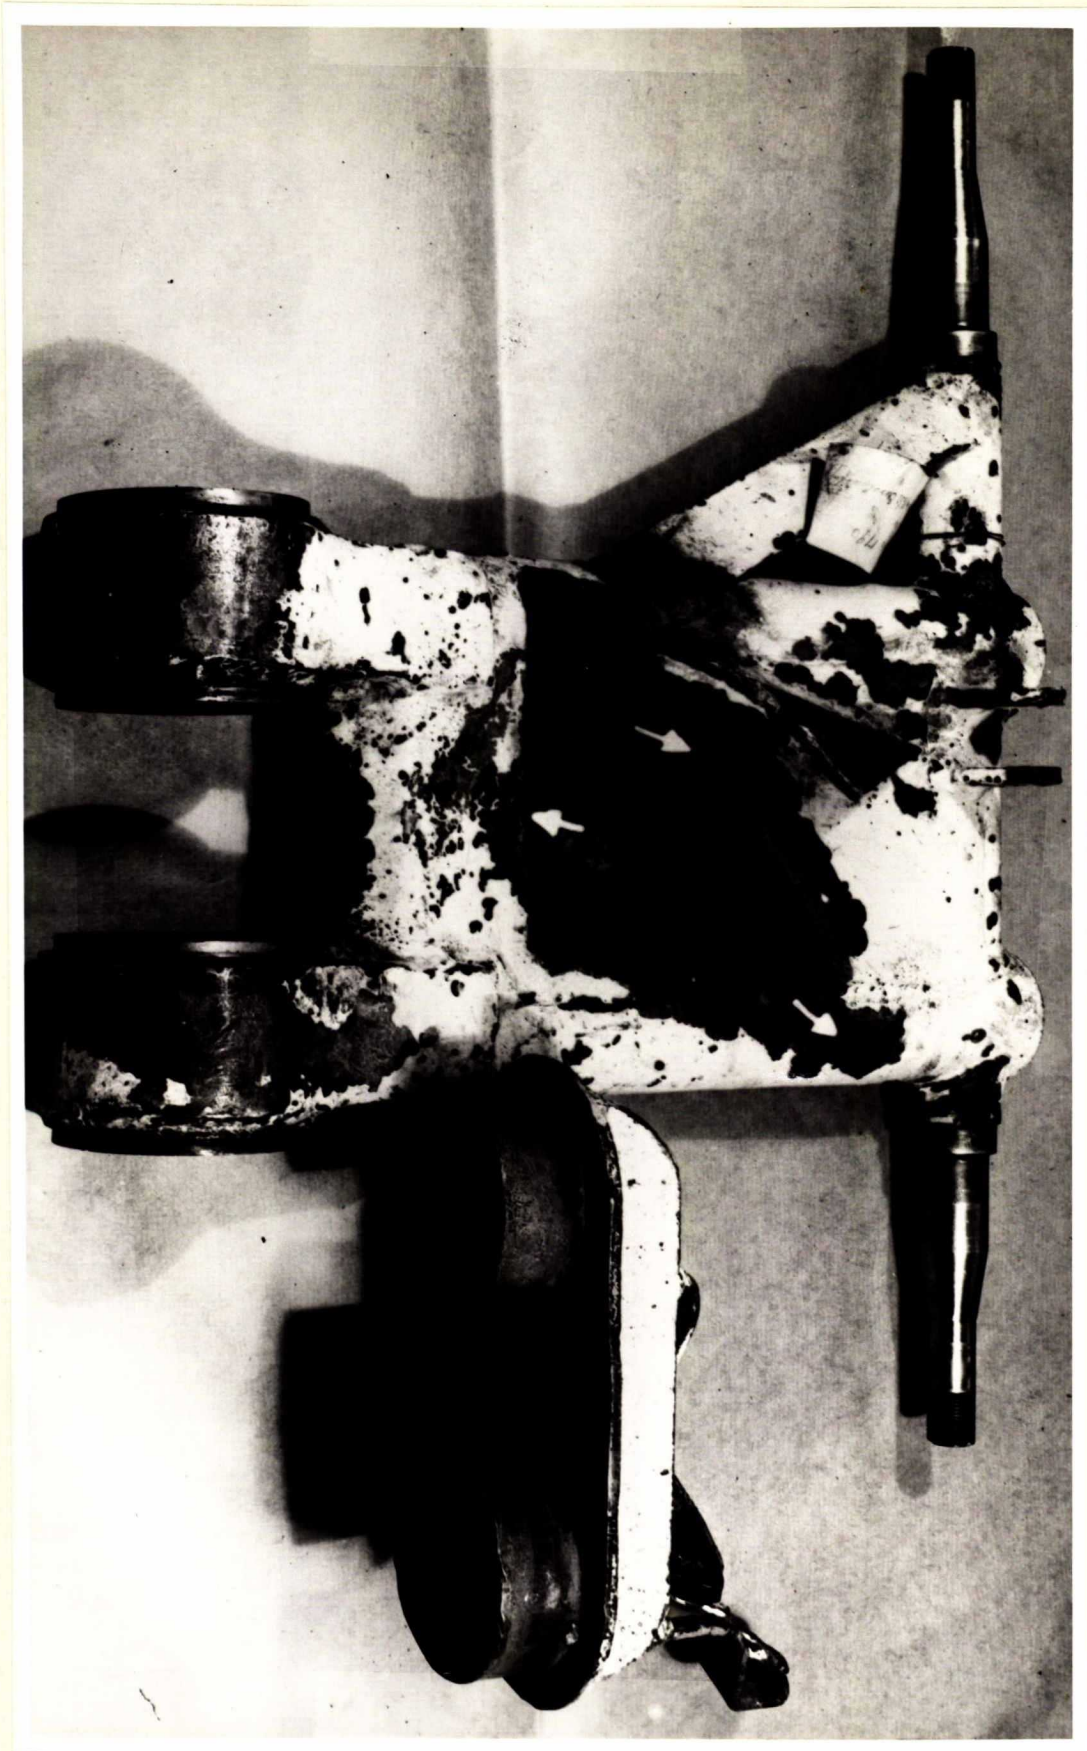
A visual examination of Sample B reveals that the welding is, from the standpoint of welding defects, not responsible for this failure. Micro-examination revealed no evidence of faulty welding. It is most important, however, to note that the photomicrographs of specimens from both samples show little or no deformation at fractured edges. This is characteristic of materials which fail when under severe stress in three directions at right angles to one another. When these conditions prevail, local yielding to imposed additional stresses is impossible since the additional stresses are opposed by other high stresses. The result is a brittle type of failure. It would seem that at least one possible cause of failure of this particular bogie is either that it has not been stress-relieved after welding or that the stress relief has been at such a low temperature as to be ineffective. The ultimate result of this has been severe locked-up welding stresses in the bogie when it was subjected to field testing.

SAMPLE B, AS RECEIVED.

Arrows point to fractured area. Note severe tearing of base plate and pipe frame members.

4. All bogies before being released to production should be subjected to a stress-relieving treatment at 1150-1200° F. for at least one hour, followed by a slow cool. Every effort should be made to segregate those bogies which have received this treatment from those receiving lower temperature treatment. The latter bogies should then be given the proper treatment.

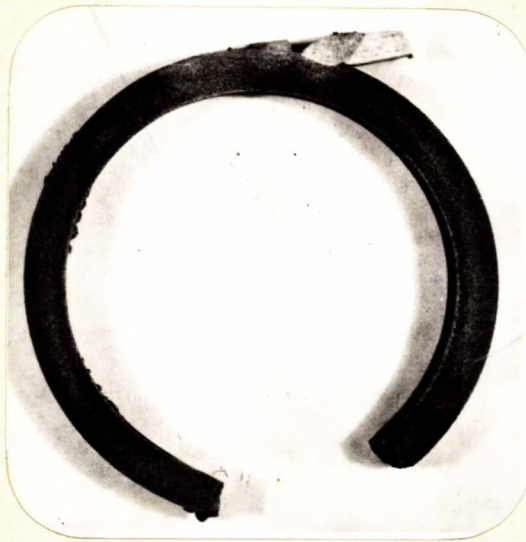
Figure 3.

SAMPLE B. - SECTION OF ONE PIPE FRAME MEMBER
AFTER DEEP ETCH IN 50 PER CENT HCl AT
180° F. FOR 10 MINUTES.

A fully killed steel.

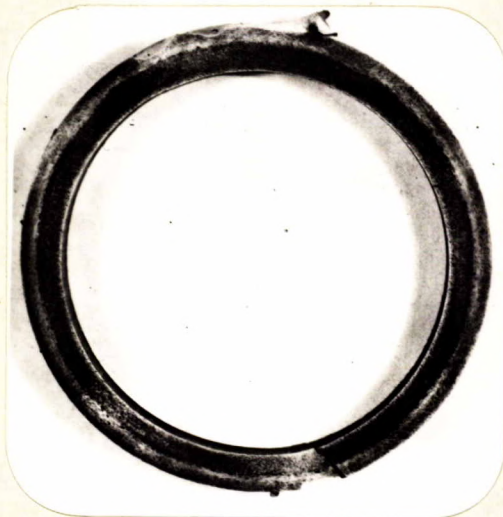
Figure 4.

SAMPLE B. - SECTION OF SECOND PIPE FRAME
MEMBER AFTER DEEP ETCH.

A rimmed steel.

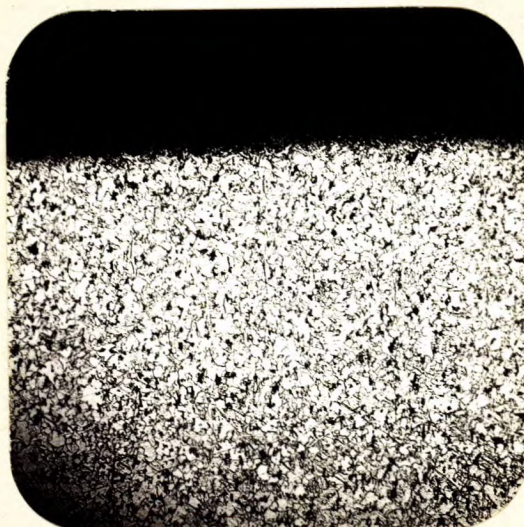
Figure 5.

EDGE OF FRACTURE OF PINION SUPPORT
TUBE OF SAMPLE A.

Pearlite in a matrix of ferrite.
Note absence of distortion of
structure at fractured edge.

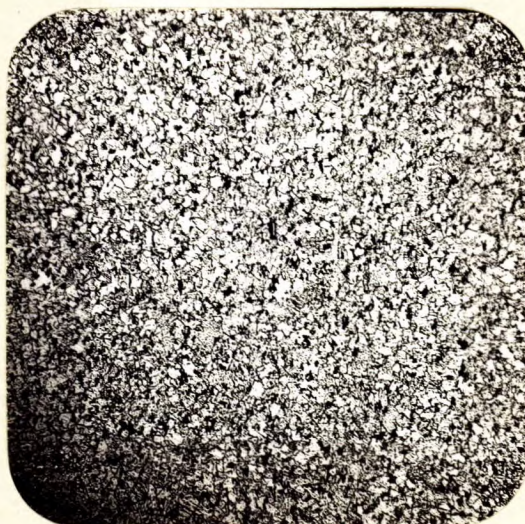
Figure 6.

STRUCTURE OF FRACTURED PINION SUPPORT TUBE
OF SAMPLE A, REMOTE FROM FRACTURED AREA.

Pearlite in a matrix of ferrite. No
perceptible difference from Figure 5.

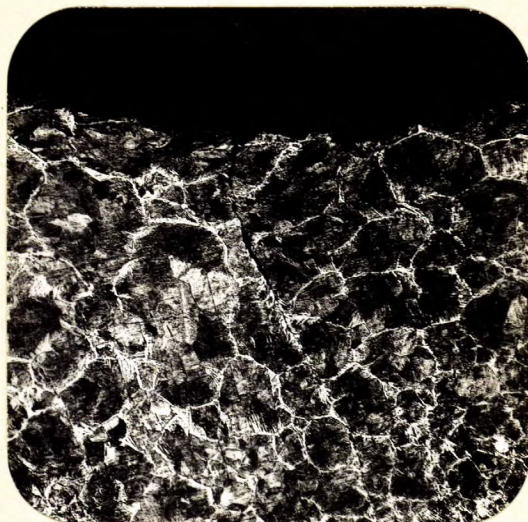
Figure 7.

EDGE OF FRACTURE OF ANGLE IRON
BRACE OF SAMPLE A.

Coarse-grained sorbite with ferrite at
grain boundaries. Note crack following
grain boundaries.

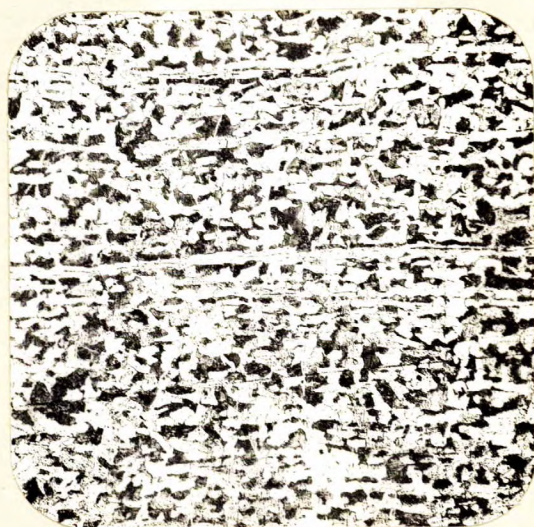
Figure 8.

NORMAL STRUCTURE OF ANGLE IRON
BRACE OF SAMPLE A.

Pearlite in a matrix of ferrite. Typical
banded structure of hot rolled steel.

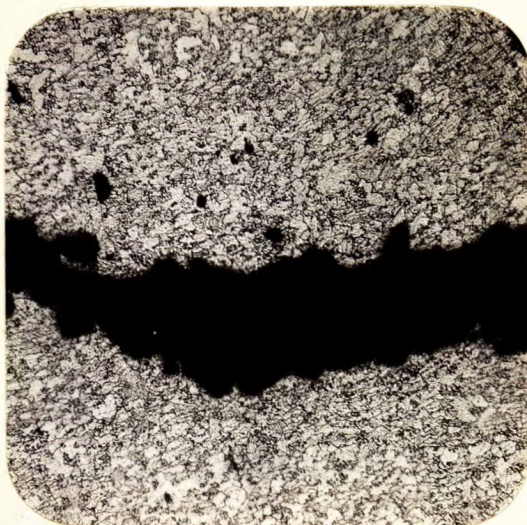
Figure 9.

SAME MATERIAL AS FIGURE 4. FRACTURE IN
PIPE FRAME MEMBER OF SAMPLE B.

Mostly ferrite with some pearlite. Note
absence of distortion along fractured edge.

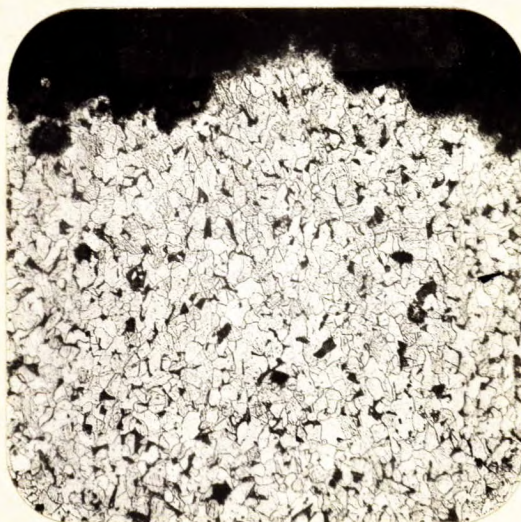
Figure 10.

SAME MATERIAL AS IN FIGURE 3. FRACTURE IN
PIPE FRAME MEMBER OF SAMPLE B.

Pearlite in a matrix of ferrite. Note
absence of distortion along fractured edge.

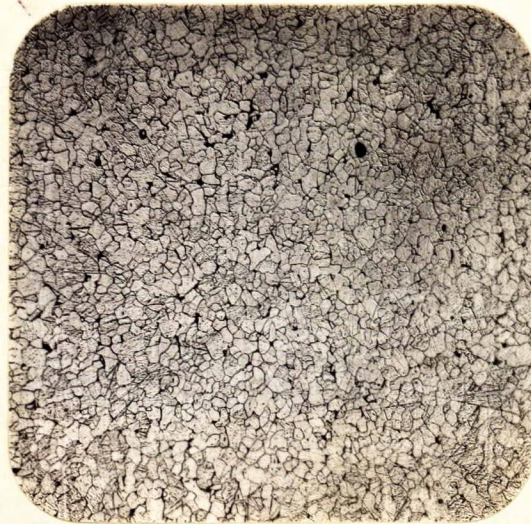
Figure 11.

STRUCTURE OF FRACTURED BASE
PLATE MATERIAL OF SAMPLE B.

Typical low-carbon steel structure -
nearly pure ferrite.
