O T T A W A May 10th, 1944.

Investigation No. 1640.

Examination of Broken Austenitic Manganese
Steel Cone Crusher Mantle.

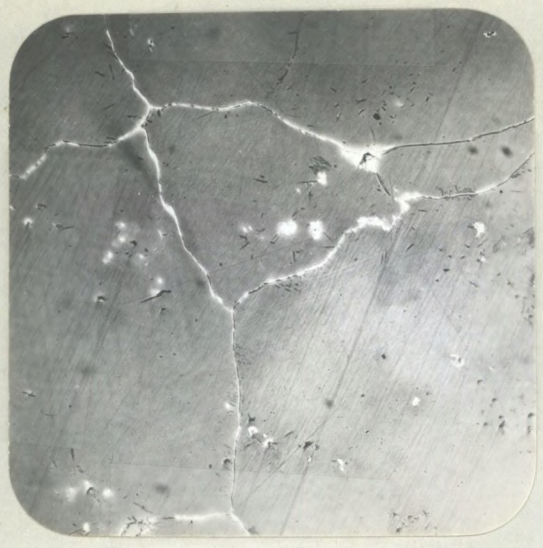
Figure 1.

A specimen cut from the sample submitted was prepared for the microscope. A 4 per cent picral etch was used to show the structure. Figures 1 and 2 show the steel structure at X100 and X500 magnifications respectively. Note that there is a continuous carbide film around the grains.

The structure shown in Figures 1 and 2 indicates that the quenching during heat treatment has not been severe enough to prevent carbides from forming.

1. The cone crusher mantle failed because of the presence of carbides on the grain boundaries.
2. The carbides are present on the grain boundaries because the carbon content is too high.

X100, picral etch.
PHOTOMICROGRAPH SHOWING GRAIN
BOUNDARY CARBIDES AND ALSO A
FEW CARBIDES THROUGHOUT THE
GRAINS.

1. It is recommended that the carbon content of these castings be reduced to 1.0 to 1.3 per cent and that the manganese be kept within the range of 11 per cent to 14 per cent.
2. It is not recommended that the heat-treatment practice be changed at this time.

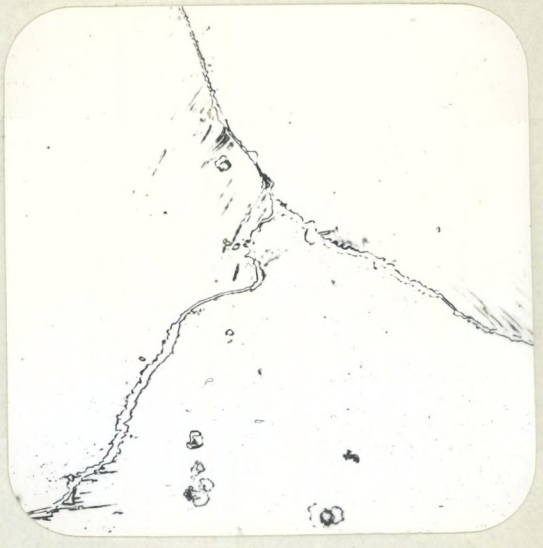
Figure 2.

X500, picral etch.
PHOTOMICROGRAPH SHOWING
DETAIL OF GRAIN
BOUNDARY CARBIDES.

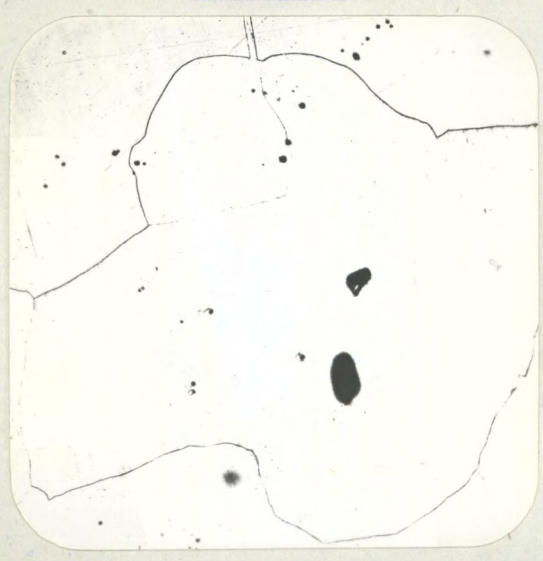
Figure 3.

A piece, 2" x 2" x $\frac{1}{2}$ " in size, was cut from the sample. This piece was heated at 1940° F. for 3 hours and then water-quenched. The resultant structure is shown in Figure 3, a photomicrograph taken at a magnification of 100 diameters. Note that the grain boundaries appear to be rather heavy. Figure 4, at 250 diameters, shows that this heavy grain boundary is not continuous in all places. Figure 5, at 2000 diameters, shows in detail the structure of the grain boundary.

The sample heat-treated in these Laboratories showed some material precipitated on the grain boundaries. This material is undoubtedly carbide. The conditions of this heat treatment were known to be good and the quench was more severe than that commonly encountered in industrial practice.

X100, picral etch.
PHOTOMICROGRAPH SHOWING STRUCTURE
AFTER WATER-QUENCHING PIECE 2" x
2" x 1/2" FROM 1940° F.
Note heavy grain boundaries.

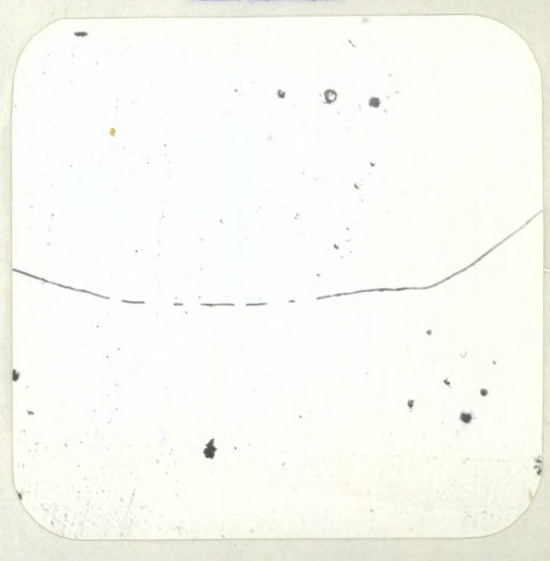
Figure 4.

X200, picral etch.
SAME AS FIGURE 3.
SHOWS DISCONTINUOUS,
HEAVY GRAIN BOUNDARIES.

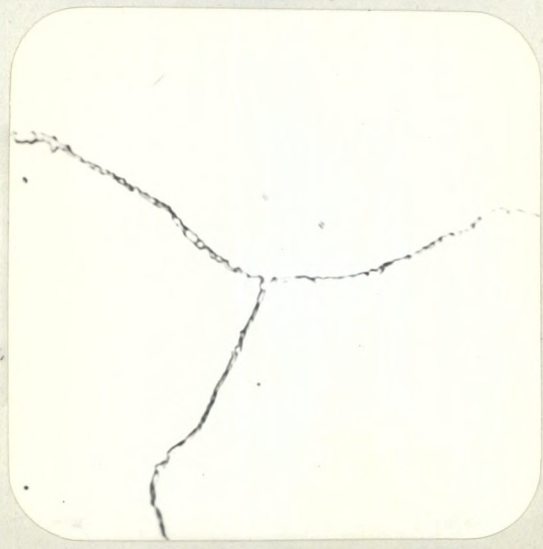
Figure 5.

X2000, picral etch.
SAME AS FIGURE 5.
SHOWS DETAILS OF GRAIN BOUNDARY STRUCTURE.
