ORE DRESSING AND METALLURGICAL LABORATORIES.

Investigation No. 1641.

Examination of Broken Austenitic Manganese
Steel Dipper Tooth.

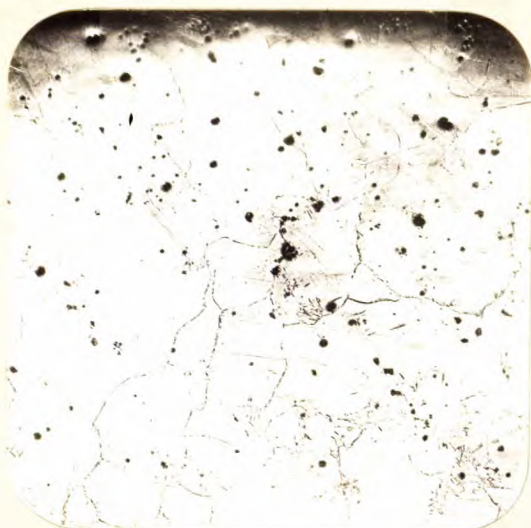
Figure 1.

Figure 1 shows the structure at the surface. Note that for a depth of about one or two grains the structure is normal for properly heat-treated manganese steel, while farther below the surface carbides begin to appear.

PHOTOMICROGRAPH SHOWING
STRUCTURE AT SURFACE
OF BROKEN TOOTH.

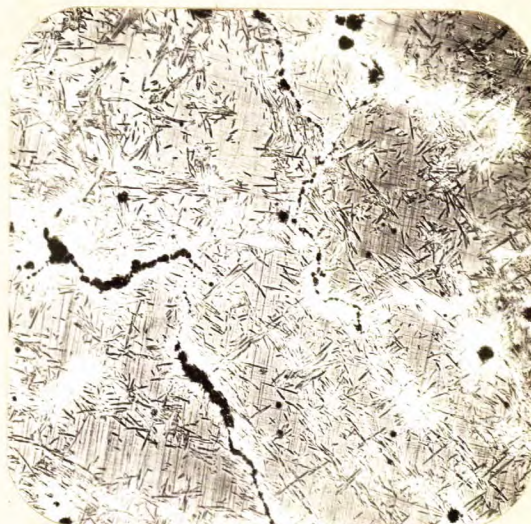
Figure 2.

Figure 2 shows the structure existing about $\frac{1}{2}$ inch below the surface. There are many carbides present and, also, cracks along the grain boundaries.

PHOTOMICROGRAPH SHOWING STRUCTURE
AT A DISTANCE OF ABOUT $\frac{1}{8}$ INCH
BELOW THE SURFACE OF BROKEN TOOTH.

Note increased amount of carbides.

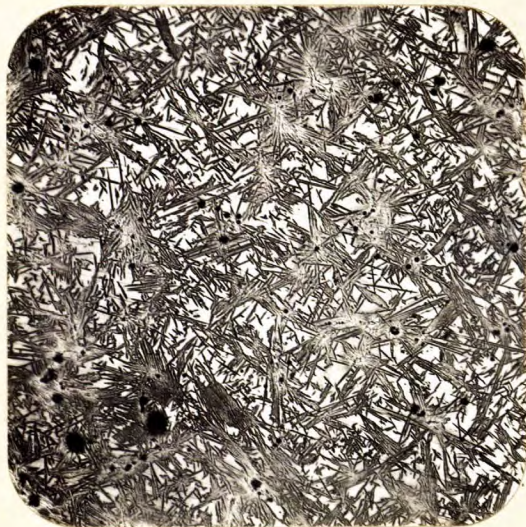
Figure 3.

Figure 3 is the structure at the centre of the section. Note the abundance of acicular carbide. This is the characteristic "as cast" structure.

1. The carbides present in the tooth as received were formed during quenching because the carbon was too high and the manganese too low to prevent their formation.

2. The presence of this massive acicular carbide is responsible for the failure of the tooth.

PHOTOMICROGRAPH SHOWING
STRUCTURE AT CENTRE
OF SECTION.

It is recommended that an effort be made to hold the carbon within the limits of 1.0 to 1.3 per cent and the manganese within the limits of 11 to 14 per cent.

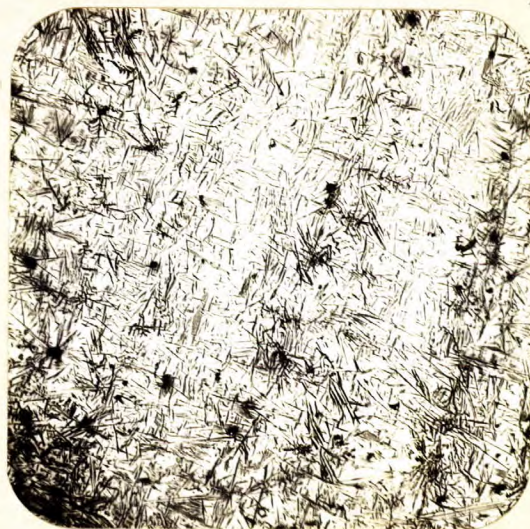
Figure 4.

The remaining portion of the broken tooth was heated at 1940° F. for 6 hours and then water-quenched. The observed structure was similar in all respects to the structure before this heat treatment. The structure existing about 1 inch below the surface after this heat treatment is

shown in Figure 4, at a magnification of 30 diameters. Note the presence of acicular carbides.

PHOTOMICROGRAPH SHOWING STRUCTURE
1 INCH BELOW SURFACE AFTER COMPLETE
TOOTH WAS HEATED AT 1940° F. FOR
6 HOURS AND WATER-QUENCHED.

Note presence of carbides.

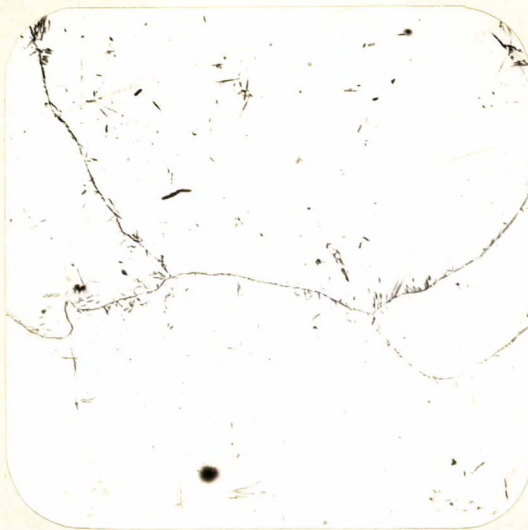
A piece, about 2" x $1\frac{1}{8}$ " x $\frac{3}{4}$ ", cut from the tooth, was heated to 1940° F. for 3 hours and water-quenched. The structure obtained by this treatment is shown, at X100 magnification, in Figure 5. Note that there are still some carbides present, although their amount has been greatly reduced.

PHOTOMICROGRAPH SHOWING STRUCTURE
AFTER HEATING PIECE, 2 x 1½ x ¼
INCHES IN SIZE, AT 1940° F. FOR
3 HOURS AND WATER-QUENCHING.

Note presence of carbides
at grain boundaries.
