ORE DRESSING AND METALLURGICAL LABORATORIES.

Investigation No. 1645.

Examination of Two 40-mm. Brass Cartridge Cases.

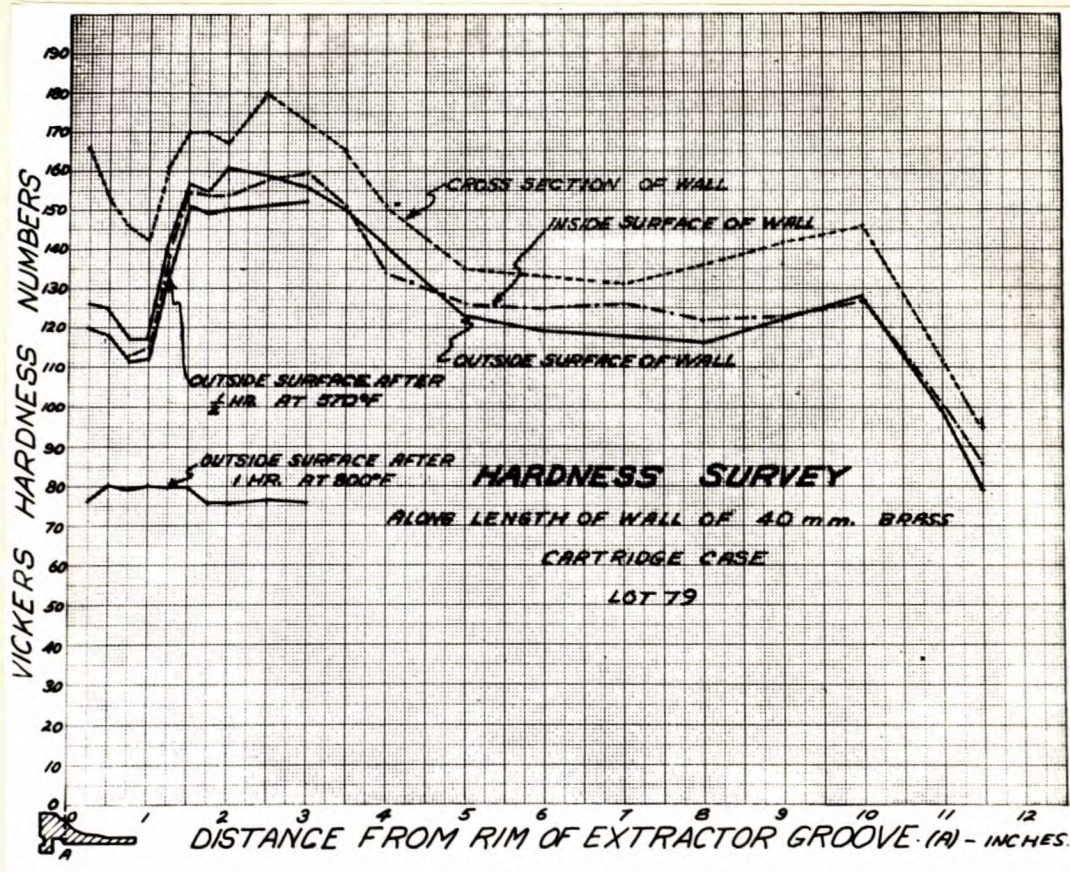
VARIATION OF HARDNESS OVER LENGTH OF CASE, LOT NO. 79.

Note drop in hardness near base.

Both cases exhibit a marked drop in hardness at a point about one inch from the base. This may be clearly seen in Figures 1 and 2. This region near the base is cold-worked by two processes: the forging (heading) of the base, and the drawing of the walls. Thus, if the effects of these two processes overlap, or, on the other hand, do not meet, the region will receive either too much cold work or not enough. If it receives too much there is an excellent possibility that some recrystallization may occur during the stress-relief anneal, with a resultant softening of the material near the base. If it does not receive enough cold work, the material will again be soft.♦

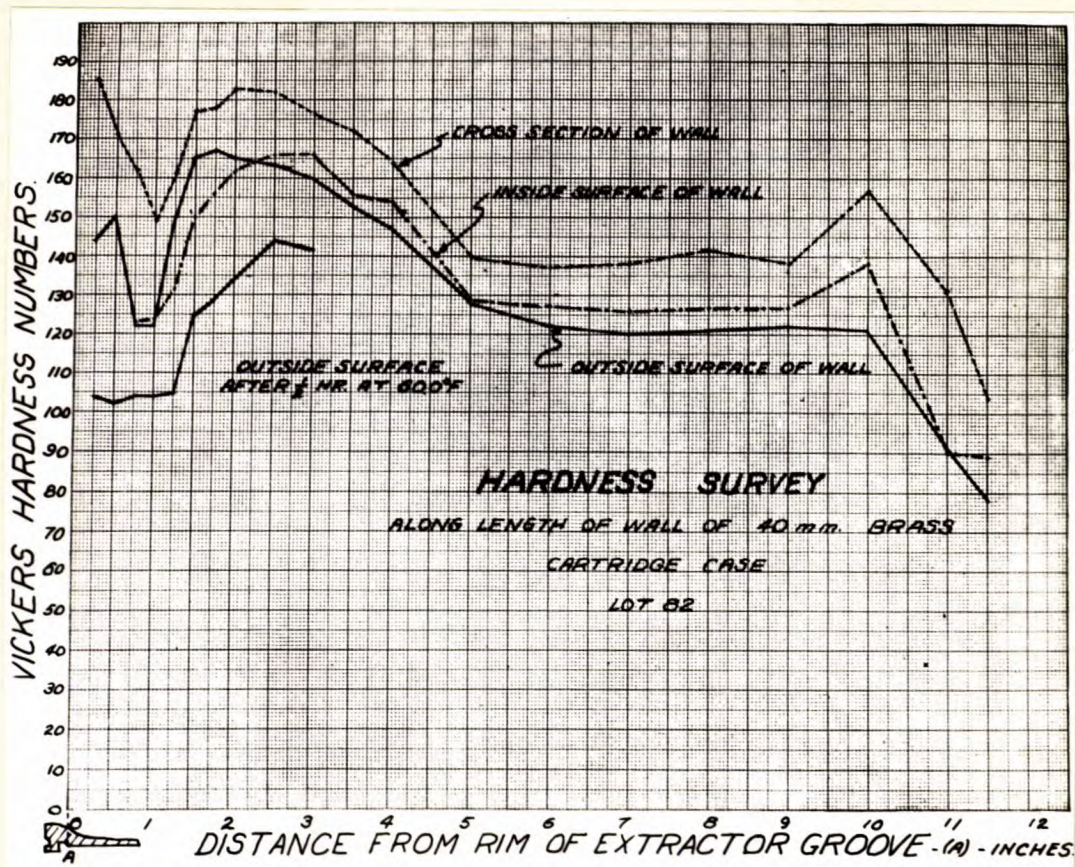
Figure 2.

VARIATION OF HARDNESS OVER LENGTH OF CASE, LOT NO. 82.

Note drop in hardness near base.

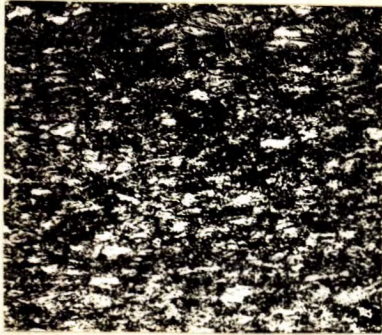
Figure 3.

Location,  $\frac{1}{4}$  inch  
from base.

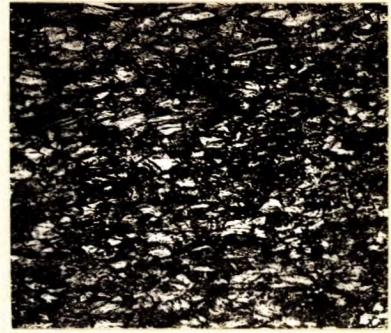
Figure 6.

Location,  $1\frac{1}{2}$  inches  
from base.

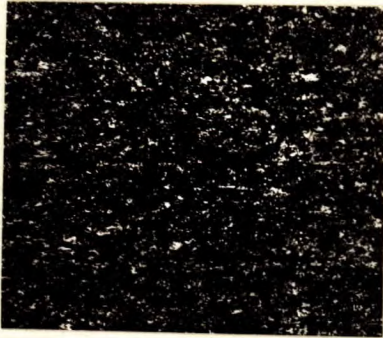
Figure 4.

The microscopic examination reveals that the material near the base (Figures 4, 5, and especially 10) shows evidence of recrystallization. Farther away the material has a typical cold-worked structure (Figures 7 and 11). Figure 8 (near the mouth) shows annealed material.

Location,  $\frac{5}{8}$  inch  
from base.

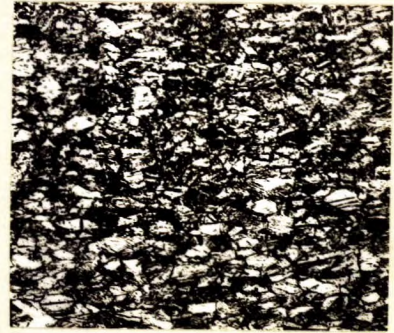
Figure 7.

Location,  $2\frac{1}{2}$  inches  
from base.

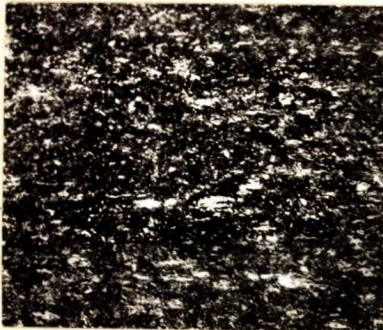
Figure 5.

Location, 1 inch  
from base.

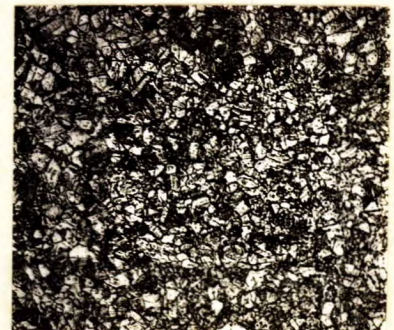
Figure 8.

Location, 8 inches  
from base.

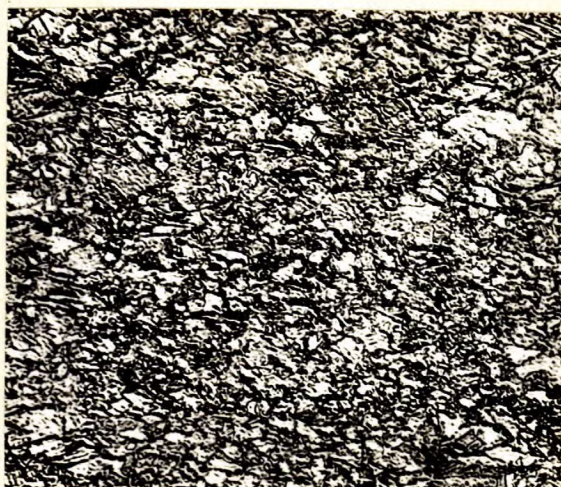
Figure 9.

Location,  $\frac{1}{4}$  inch from base.

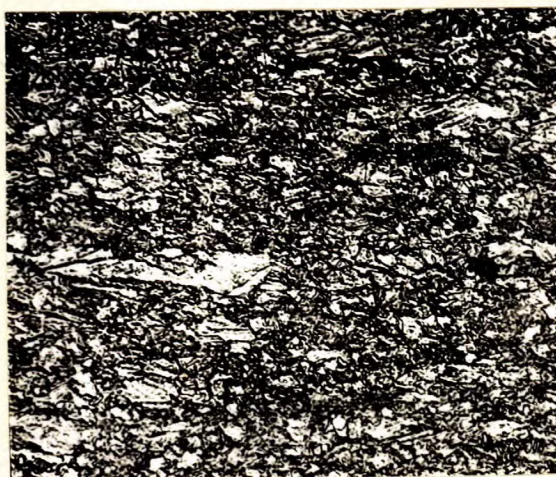
Figure 10.

Location, 1 inch from base.

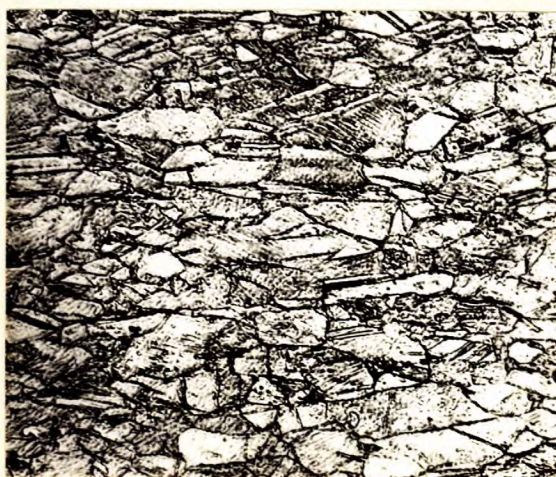
Figure 11.

Location,  $1\frac{1}{2}$  inches from base.

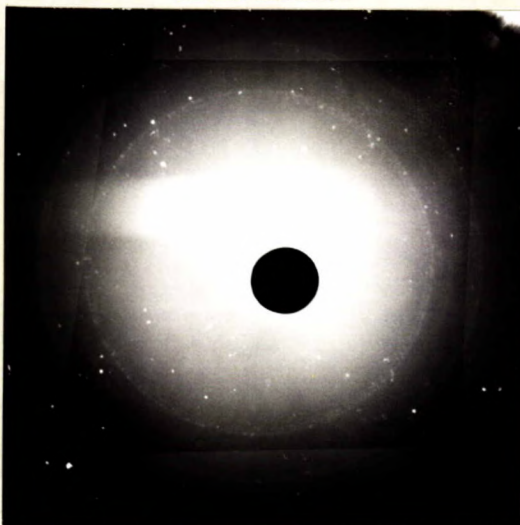
Figure 12.

(CASE FROM LOT NO. 82).

Pattern obtained from a location one inch from the closest edge of the extracting groove. Note the random dispersion of spots and the well-defined rings.

The pattern (Figure 12) one inch from the extracting groove of the case from Lot No. 82 shows rather well-defined Debye-Scherrer rings with a background having individual interference spots. According to G. L. Clark, in "Applied X-Rays" (page 505; McGraw-Hill Book Co. Inc., 1940), these background spots appear when the grain size increases to around  $10^{-3}$  cm., or larger, in diameter. The presence and perfection of these spots, then, indicate that there are rather large ordered arrangements of sub-grains in this part of the cartridge case. (By an ordered sub-grain structure is meant a rearrangement of the fragmented crystallites which has not proceeded far enough to be detected by ordinary microscopic practice.)

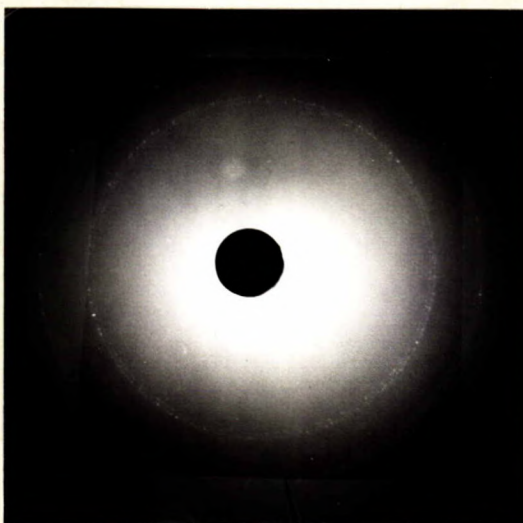
Figure 13.

(CASE FROM LOT NO. 79).

Pattern obtained from a location one inch from the closest edge of the extracting groove.

Note well-defined rings.

Since the pattern one inch from the extracting groove of the case from Lot No. 79 does not show background spots, the cold work, draw temperature, or grain size for this case was not the same as for Lot No. 82. This is in agreement with the fact that the hardnesses differ. The amount of cold work imparted and the subsequent annealing temperature largely determine some of the metallurgical characteristics of the sample and, consequently, the X-ray diffraction pattern obtained from it.\*

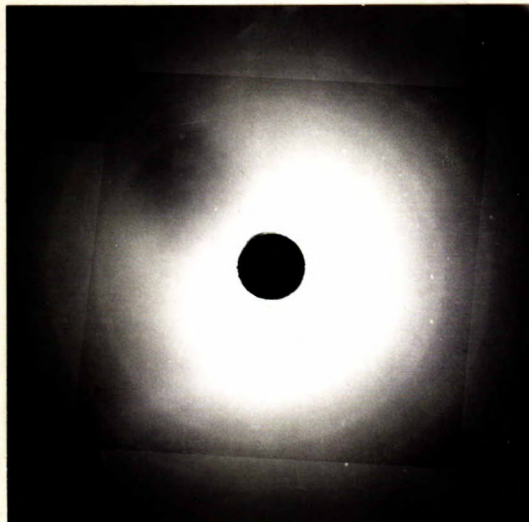
Figure 14.

(CASE FROM LOT NO. 79).

Pattern obtained from a location  $2\frac{1}{2}$  inches from the closest edge of the extracting groove.

Note diffuse rings.

The pattern from a similar location on the case from Lot 82 has the same appearance.

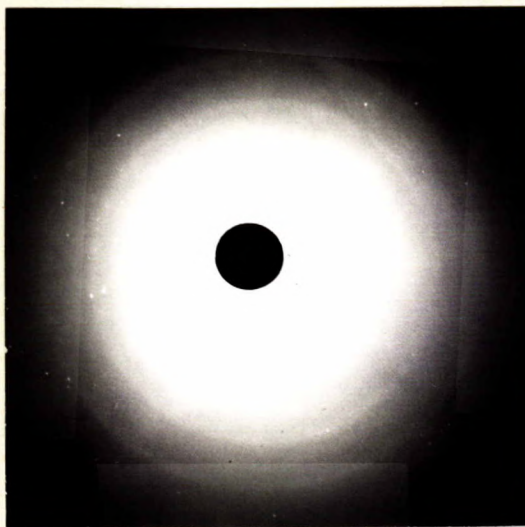
Figure 15.

(CASE FROM LOT NO. 79).

Pattern obtained from a location  $2\frac{1}{2}$  inches from the closest edge of the extracting groove.

This case was given a 570° F. draw for one-half hour. The drop in hardness at this location was 8 points Vickers. Note the presence of a few spots. Compare with Figure 14.
