R E P O R T
of the
ORE DRESSING AND METALLURGICAL LABORATORIES.

Investigation No. 1646.

Examination of 6-pdr., 7-cwt. Brass Cartridge Cases.

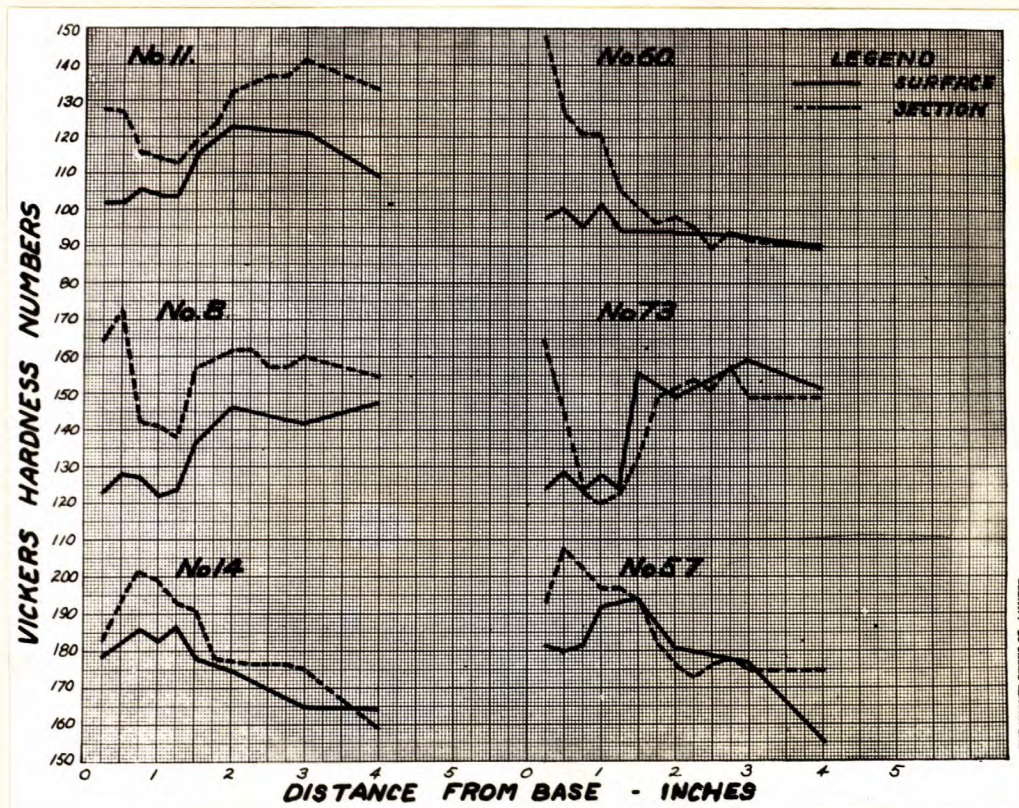
Figure 1.

HARDNESS SURVEY ON SURFACE AND CROSS-SECTION OF WALL OF 6-PDR. CARTRIDGE CASES - AS RECEIVED.

Examination of six of the first lot of cases received indicated that two types of defect existed. The hardness tests along the length of the cases showed that Cases Nos. 11 and 60 were soft along their whole length and that Cases Nos. 8 and 73 were soft near the base but reached a normal hardness about $1\frac{1}{2}$ inches from the base. Cases Nos. 14 and 57, however, were of normal hardness along the whole length (see Figure 1).

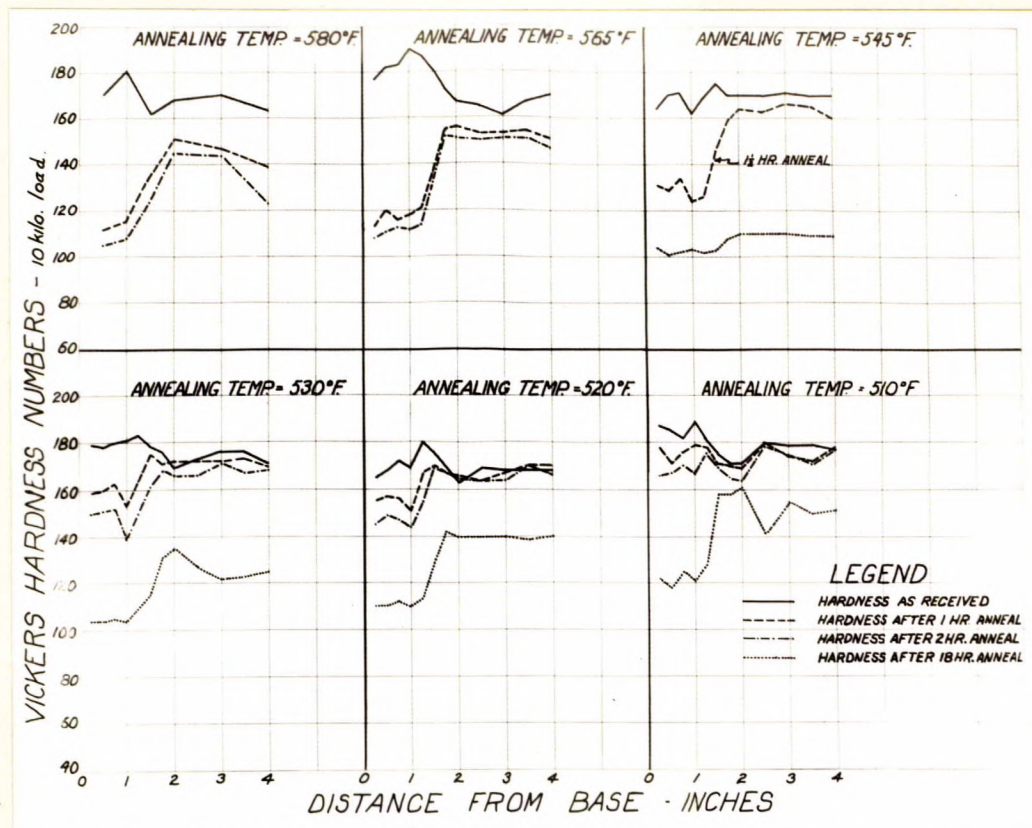
Figure 2.

VARIATION IN HARDNESS OF 6-PDR. CARTRIDGE CASES
AFTER ANNEALING AT DIFFERENT TEMPERATURES AND TIMES.

The annealing experiments, the results of which are shown in Figure 2, showed that there was a slight lowering of hardness due to recrystallization even after annealing for 1 hour at 510° F. (265° C.), and that after annealing for 2 hours a further lowering of hardness occurred. On examination of Figure 2 it will be seen that, in all instances, the most marked lowering of hardness occurred at a point about one to one-and-a-half inches from the base. This indicates that the material at this point has a greater tendency to recrystallize than the rest of the material because it has received a greater amount of cold work during the manufacturing process.

If the case is allowed to remain at the stress-relief annealing temperature for a sufficient length of time (18 hours), a lowering of the hardness along the whole length of the case occurs resulting in a "dead soft" case. This is seen in Figure 2 at an annealing temperature of 545° F. (285° C.), and, less markedly,

In order to avoid these defects it would be advisable to lower the temperature of the stress-relief anneal to 500 to 510° F. (260-265° C.) and to take precautions to ensure that no case remains in the annealing furnace for more than one hour.

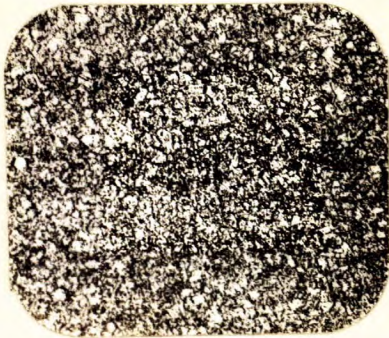
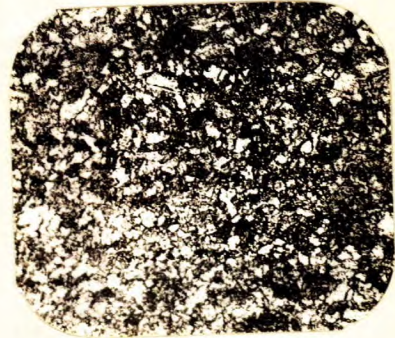
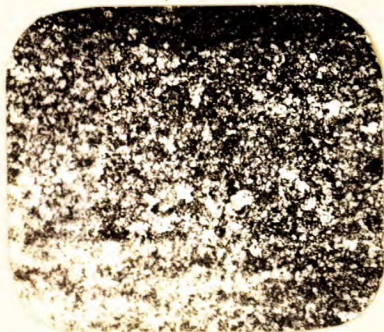
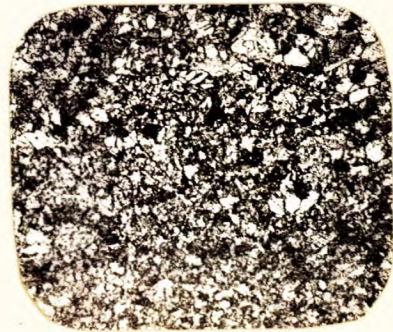
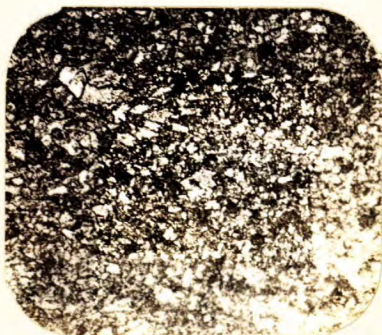
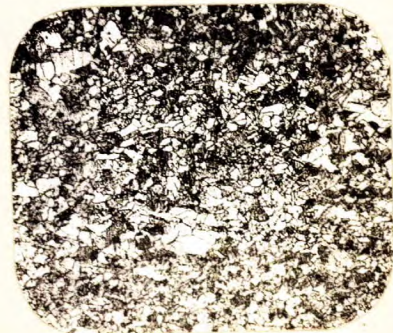
PHOTOMICROGRAPHS FROM CASE NO. 60.

A strip about $\frac{1}{4}$ inch wide was cut from each case and prepared for metallographic examination. Photomicrographs were taken to illustrate the structure at various points along the wall and are shown herein. Figures 3 to 8 were taken from Case No. 60, which was soft along its whole length. All these photomicrographs show recrystallization of the material, with variable grain size. Figures 9 to 14 were taken on Case No. 73, which was soft near the base. The material near the base (Figures 9 to 12) shows evidence of recrystallization. Figures 15 to 20 were taken on Case No. 14, which had a normal hardness. Heavily cold-worked material is seen.

Microscopic examination of longitudinal strips from Cases Nos. 11 and 60 showed that the material had recrystallized (see Figures 3 to 8).

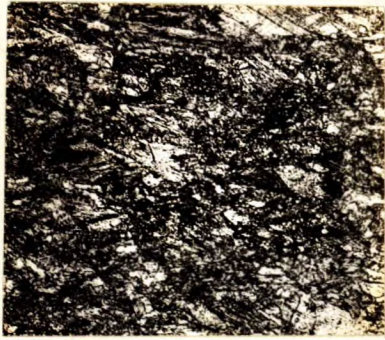
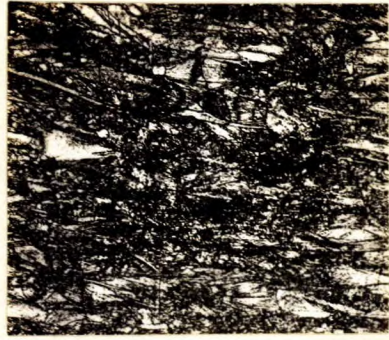
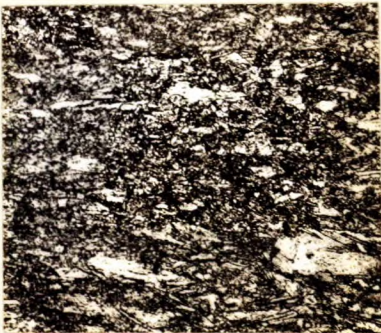
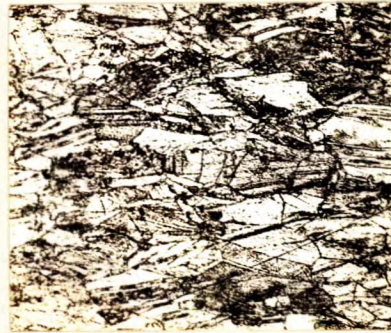
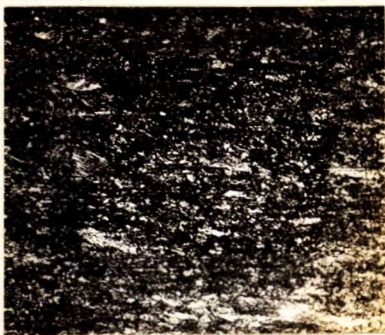
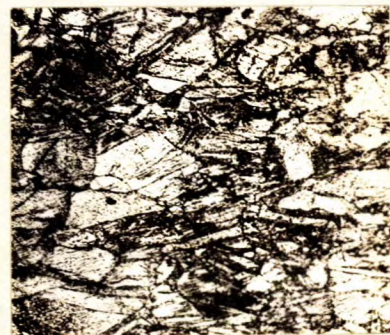
PHOTOMICROGRAPHS FROM CASE NO. 73.

were soft near the base, and of Cases Nos. 14 and 57, which were of normal hardness, indicated, by comparison of the structures of the materials, that there is some evidence of recrystallization in the material near the base in Cases Nos. 8 and 73 (compare Figures 9 to 14 with Figures 15 to 20).
