O T T A W A      May 22nd, 1944.

R E P O R T  
of the  
ORE DRESSING AND METALLURGICAL LABORATORIES.

Investigation No. 1650.

Metallurgical Examination of Snowmobile  
Track Reinforcing Cleats.

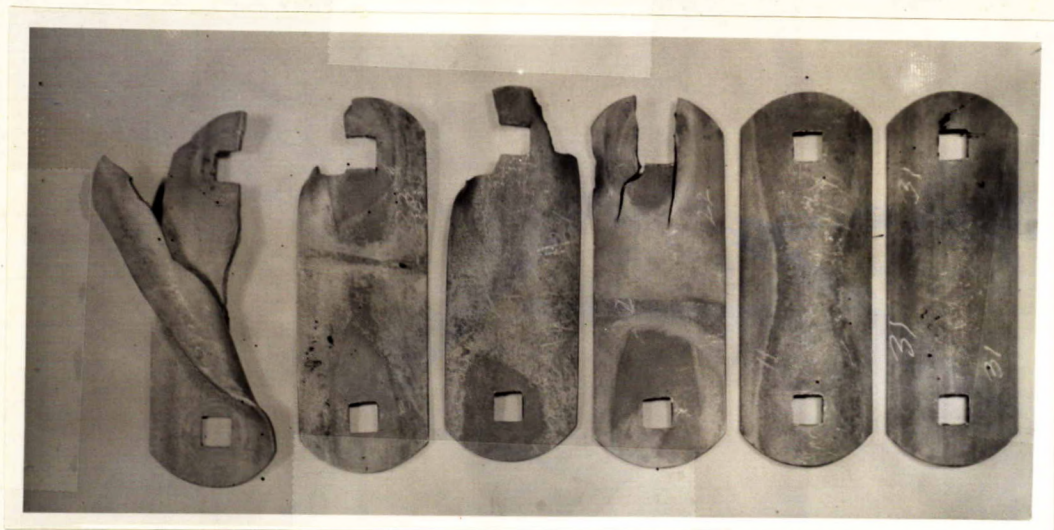
Figure 1.

Figure 1 depicts the four broken and the two unbroken cleats as they were received.

CLEATS AS RECEIVED.

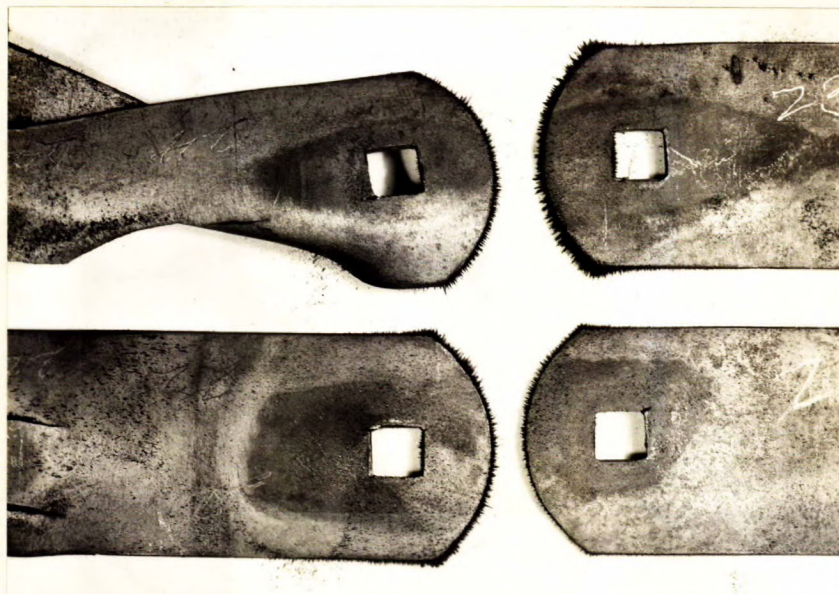
All the cleats were magnafluxed. Examination revealed cracks at the square corners of the bolt holes on the four cleats that failed. These are shown in Figure 2. The other cleats were free of cracks.

MAGNAFLUXED CLEATS.

Note cracks at bolt hole corners.

The magnaflux examination showed the presence of small cracks at the corners of the unbroken bolt holes of all the broken cleats. The sharp corners may possibly be stress raisers, since all the failures seem to start at these points. To insure against this possibility it may be advisable to increase the radius of the corners.

1. Notwithstanding the carbon content the cleats should be hardened and drawn to the specified hardness.
2. A greater radius at the bolt-hole corners is preferable, although with the cleats heat-treated properly a

a change may not be necessary.

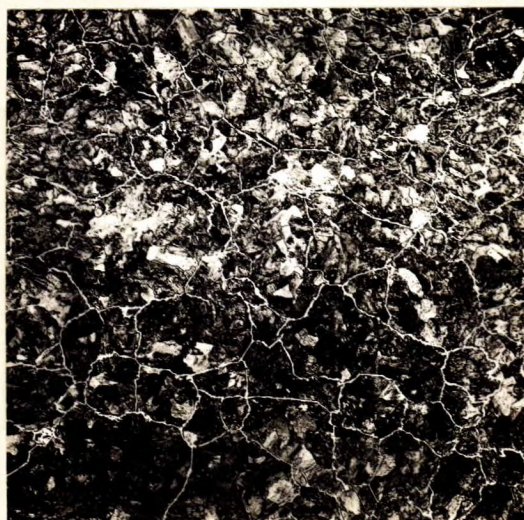
Figure 3.

X100, nital etch.  
0.41 PER CENT CARBON: GRAIN SIZE, 1-3.

The chemical analyses indicate that the unbroken cleats have lower carbon contents than those which were broken. Variation in grain size is also observed; the former (0.41 C) has a coarse grain size, 1-3, whereas the latter (0.60 C) is fine-grained, 7-8.

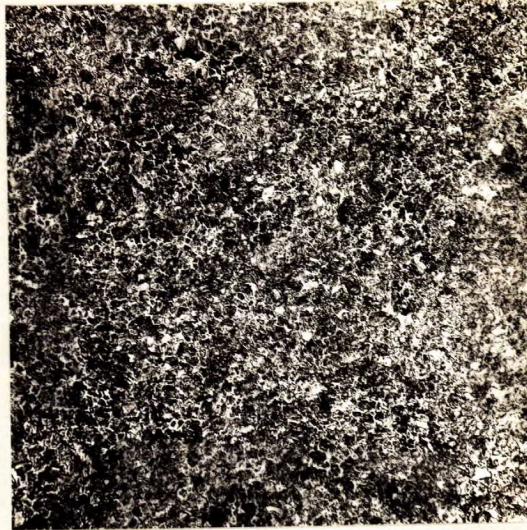
Figure 4.

0.60 PER CENT CARBON: GRAIN SIZE, 7-8.

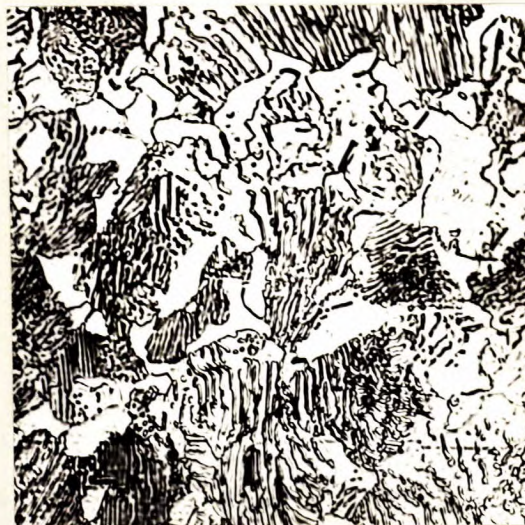
Figure 5.

ANNEALED STRUCTURE TYPICAL OF ALL THE CLEATS.

Lamellar pearlite and ferrite.

the 42  $\pm$ 3 specified. The hardness and the microstructure both indicate that none of the cleats (broken, unbroken, and unused) was quenched and drawn; they all appear to be in the annealed state. It could be expected that if the cleats were heat-treated to the proper hardness by oil-quenching from 1550° F. and drawing, satisfactory service performance would result. If higher hardness, higher tensile strength is required over the present specified 42  $\pm$ 3, it should be possible to obtain 50 Rockwell 'C', with excellent properties, by austempering a coarse-grained SAE 1060 steel.

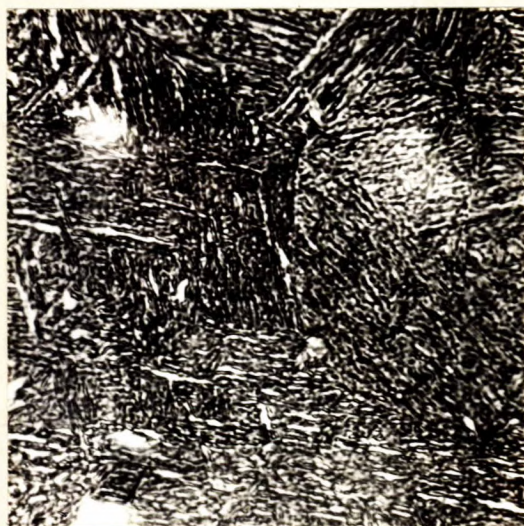
Figure 6.

STRUCTURE OF A QUENCHED-AND-DRAWN CLEAT.

Tempered martensite.
