ORE DRESSING AND METALLURGICAL LABORATORIES.

Investigation No. 1651.

Metallurgical Examination of C.D.P. Track Shoes  
to Determine Cause for Early Change in Pitch.

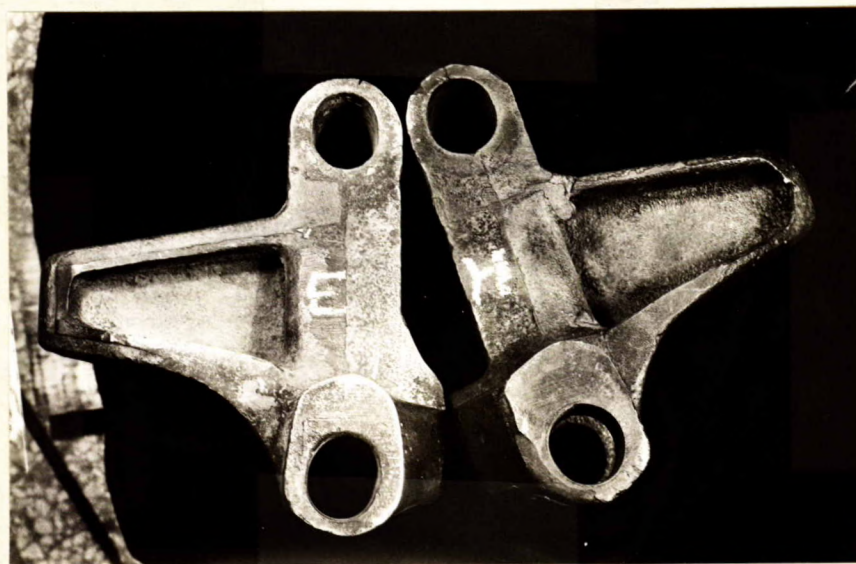
Figure 1.

Figures 1 and 2 show the "as received" condition of the shoes.

All test work done in order to determine the reason for change in pitch was carried out on the two single shoes (shown in Figure 1), as these were considered fully representative of the lot.

FAILED SHOES AS RECEIVED.  
Note deformation of eyehole.

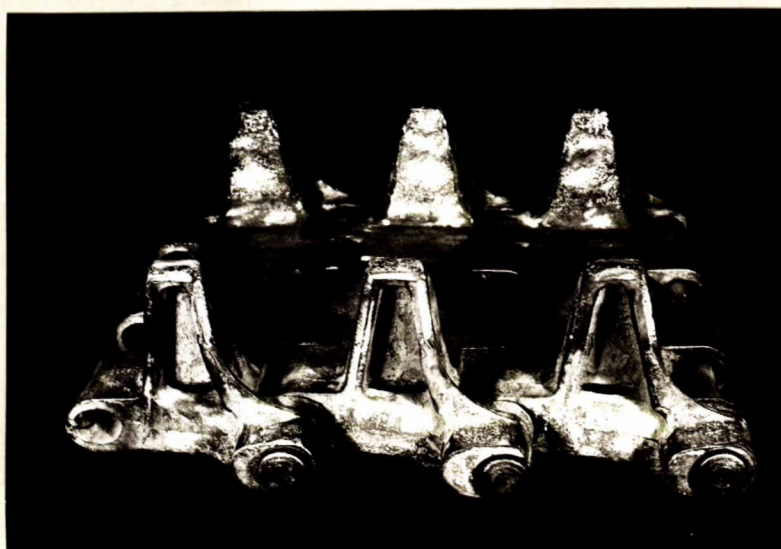
Figure 2.

THREE FAILED ELECTRIC STEELS  
SHOES LINKED TOGETHER.

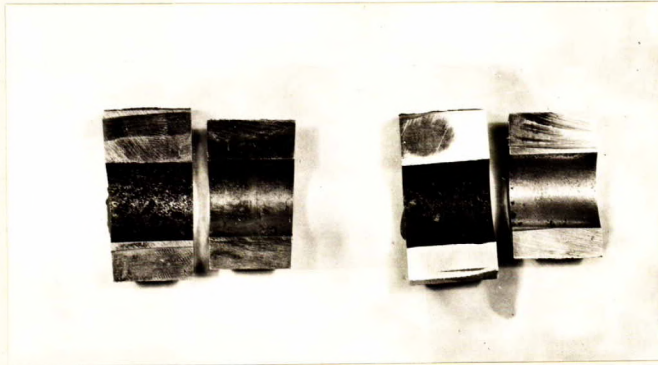
Figure 3.

Upon close examination it was obvious that much wear had occurred upon the outer surface of the eyehole walls; while the inner walls appeared as an "as cast" surface, indicating infrequent contact of the pin with this face. Figure 3 shows portions cut from the eyehole of both the Hull and Electric Steels failed shoes. The condition of the differential wear within the eyehole is more pronounced in the case of the Electric Steels shoe.

PORTIONS CUT FROM EYEHOLE OF HULL (left, above)  
AND ELECTRIC STEELS (right, above) SHOES.

Note: The right sample of each pair is the outer wall;  
the left sample, the inner wall.

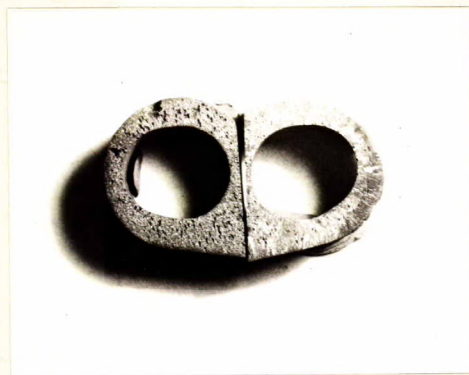
Figure 4.

It was interesting to note the effect which the severe etching had had upon the different samples. Figure 4 shows how much more pitted the Electric Steels shoe became, indicating a dirtier casting.

4. The Electric Steels shoe is of a much finer grain and is not as clean as the Hull shoe.

SHOWING PITTING AFTER SEVERE ETCHING.

Left side, Electric Steels shoe;  
right side, Hull shoe.

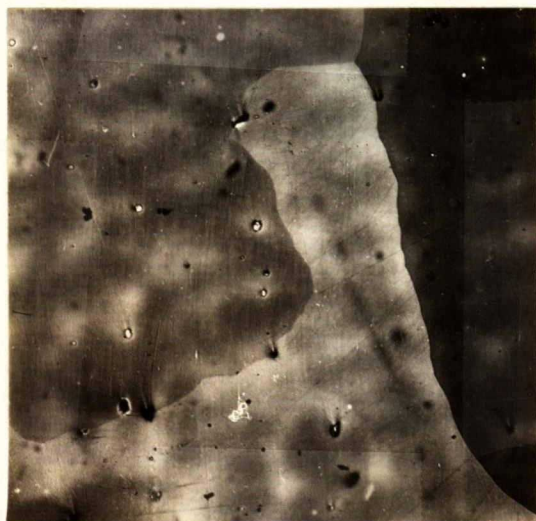
Figure 5.

Samples cut from the eyehole wall of each shoe were examined at 100 diameters after a picral etch. Figures 5 and 6, photomicrographs of the two shoes which failed before 1,100 miles, indicate the considerable difference in their grain sizes. Also, slip bands are quite prevalent in the case of the Electric Steels shoe, and this condition is a definite indication of cold work. Figure 7 shows the Hull shoe which passed the 3,000-mile test. It, like Figure 5, shows large grains but no signs of slip bands.

X100, picral etch.

HULL SHOE (FAILED),  
AS RECEIVED.

Note large grains and  
absence of slip bands.

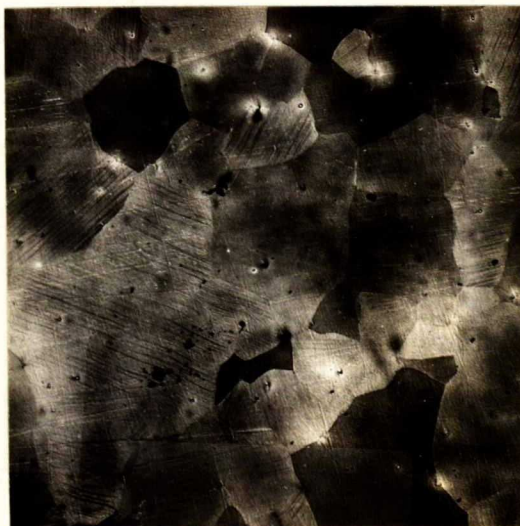
Figure 6.

The greater the amount of cold work the more severe and prevalent is the appearance of slip bands. Comparing the appearance of these lines definitely shows a greater amount of deformation present in the case of the Electric Steels shoe.

X100, picral etch.

ELECTRIC STEELS SHOE (FAILED),  
AS RECEIVED.

Note smaller grain size and  
presence of slip bands.

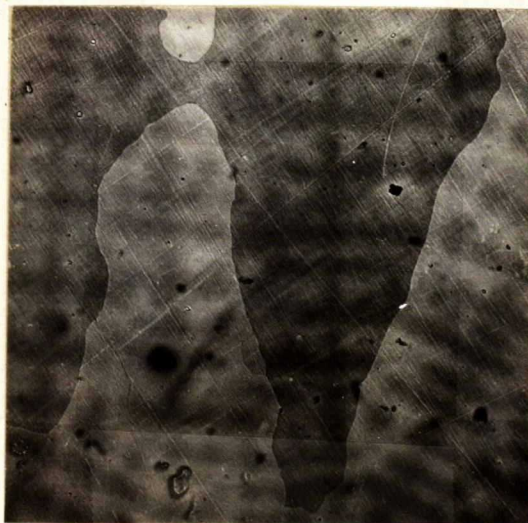
Figure 7.

X100, picral etch.

HULL SHOE WHICH PASSED 3,000-MILE  
TEST, AS RECEIVED.

Note large grain size, and  
absence of slip bands.

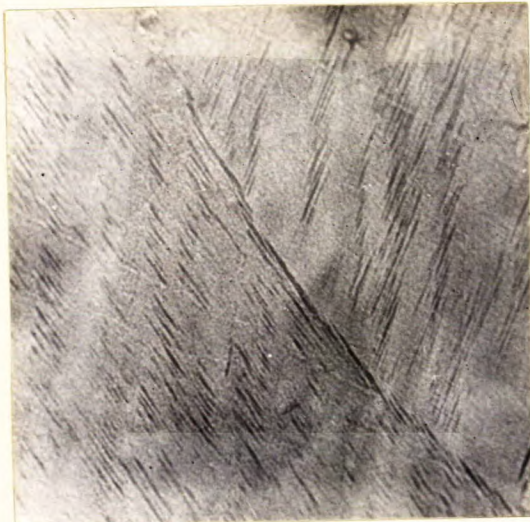
Figure 8.

Sections from all the shoes were heated to 800° F. for 1 hour and air cooled. This method of bringing out slip bands has been recommended by Krivobok.<sup>6</sup> Figures 8 and 9 indicate slip to be present in both the Hull and the Electric Steels shoes which had not passed the 1,100-mile test, while the photomicrograph (Figure 10) from the 3,000-mile shoe shows no sign of any slip within the grains.

Upon heating of these austenitic manganese steels, the austenite goes through a partial transformation, precipitating carbide. The scattered appearance of the product, as shown by Figure 10, indicates the absence of cold work, while the decided orientation of the particles in Figure 8 shows that there must have been some deformation.

X1000, picral etch.

HULL SHOE (FAILED),  
AFTER DRAWING TO 800° F.

Orientation of carbides within  
grains indicates cold work.

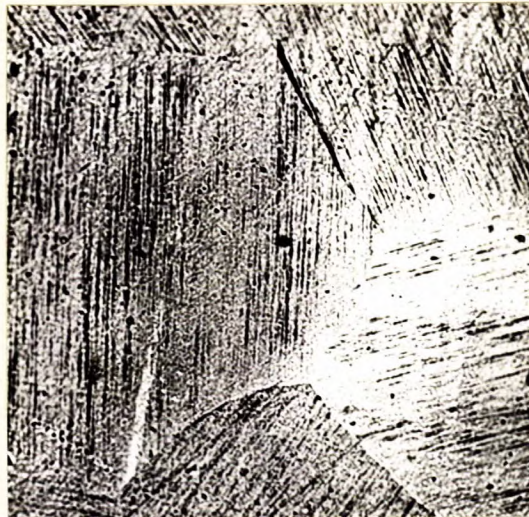
Figure 9.

X1000, picral etch.

ELECTRIC STEELS SHOE (FAILED),  
AFTER DRAWING TO 800° F.

Original slip bands indicating cold  
work are even more pronounced than  
before heat treatment.

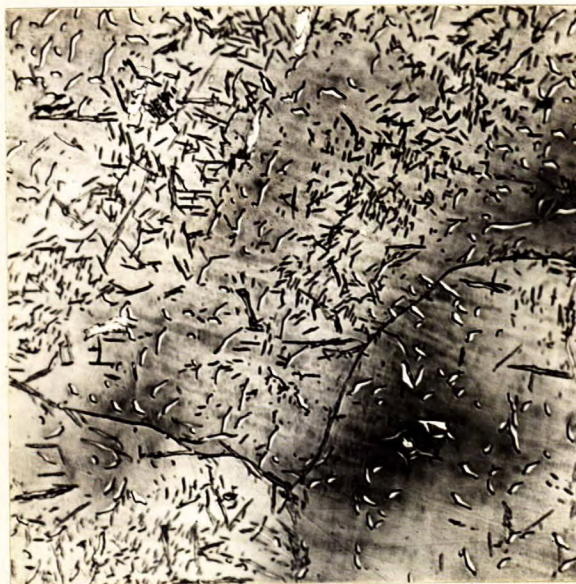
Figure 10.

X1000, picral etch.

HULL SHOE WHICH PASSED 3,000-MILE TEST,  
AFTER DRAWING TO 800° F.

Scattered appearance of carbides indicates  
that there has been no cold work.
