## R E P O R T

ORE DRESSING AND METALLURGICAL LABORATORIES.

Investigation No. 1653.

Metallurgical Examination of Ten C.D.P. Track Pins  
of Low Surface Hardness and Low Impact Strength.

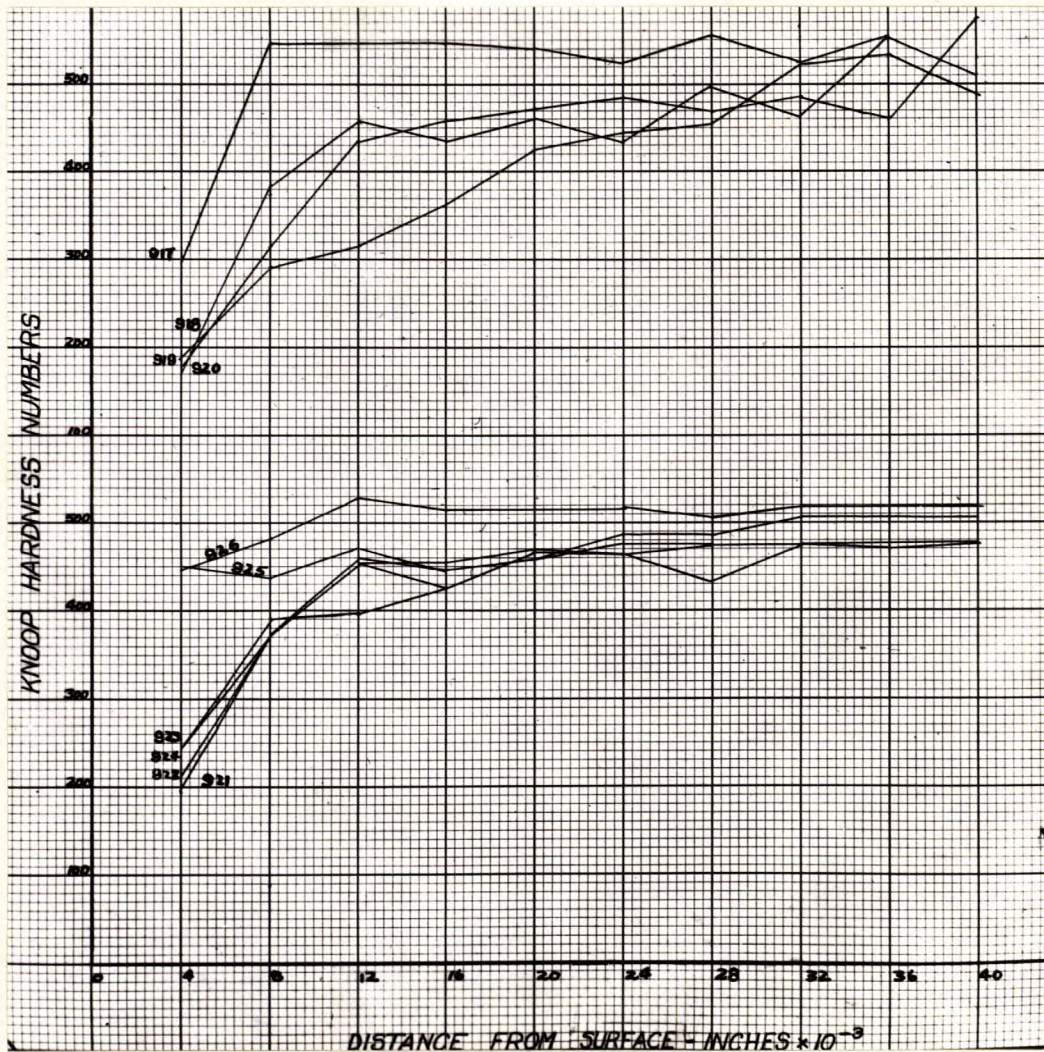
surface are shown in Figure 1.

The reportedly low surface hardness of Pins Nos. 917 to 924 was found to vary between 28 and 41 Rockwell 'C'. Chemical analysis, microscopic examination and hardness surveys substantiated one another in showing this low surface hardness to be the result of a partially decarburized zone, 0.008 to 0.016 inch in depth. The core hardness of these pins was, with one exception, 44 to 45 Rockwell 'C' and in agreement with Specification O.A. 217. Pin No. 917, however, had a core hardness of 32 to 35 Rockwell 'C'.

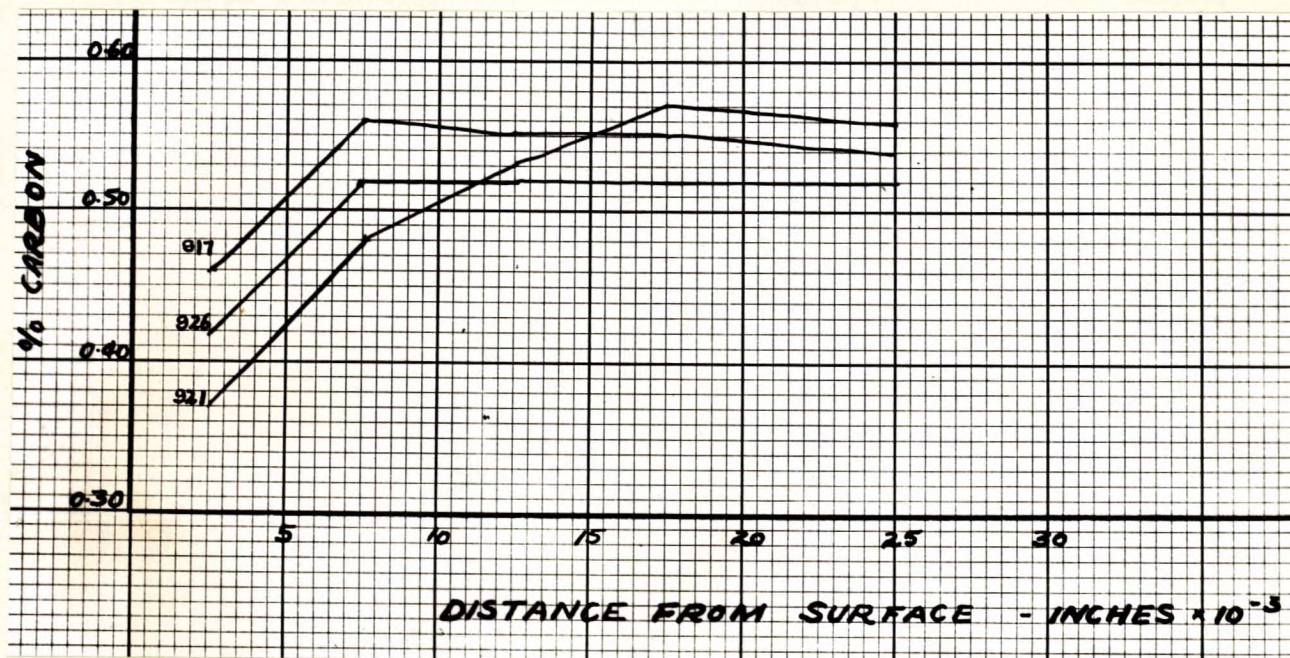
surface is shown in Figure 2.

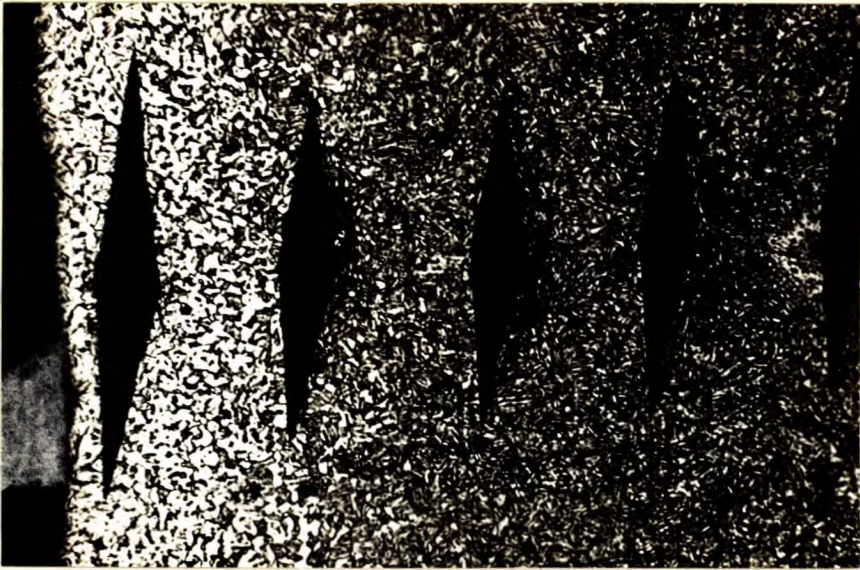
Figure 3.

Microscopic examination of longitudinal specimens showed a partially decarburized zone, 0.007 to 0.016 inch in depth, at the surface of the eight pins which had low surface hardness. Figure 3, a photomicrograph at X250 magnification, shows a typical decarburized area with a line of Tukon hardness impressions across it.

X250, etched in 2 per cent nital.  
TUKON HARDNESS IMPRESSIONS ACROSS  
DECARBURIZED AREA.

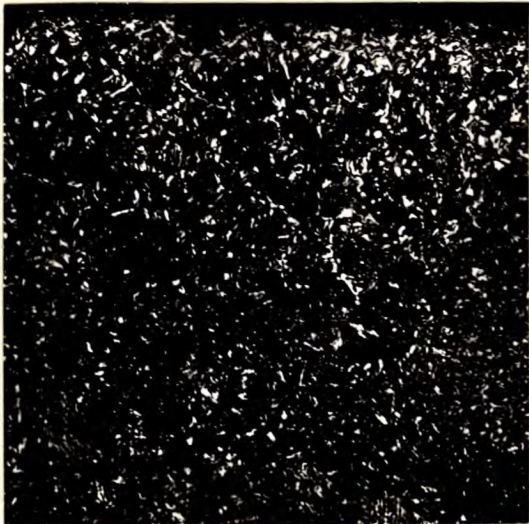
Figure 4.

The pins which failed under impact test, Nos. 925 and 926, are only slightly decarburized, as shown in Figure 4, a photomicrograph at 250 diameters. Some of the white particles shown in Figure 4 are very suggestive of cementite. Etching with Murakami's reagent, the usual etch for cementite, failed to substantiate this.

The microstructure at the surface of both pins contains small white particles very similar in appearance to cementite. These particles are whiter and sharper than the surrounding particles of ferrite. Etching with Murakami's reagent (which did not show cementite present in this instance) is not considered dependable for silico-manganese steel. Therefore, it is not unlikely that cementite is present in the microstructure of the metal adjacent to the surface. Previous experience with S.A.E. 9255 pins has shown that whenever this

condition exists, a marked reduction in the impact strength of the pin may be expected.

X250, etched in  
2 per cent nital.  
SURFACE, PIN NO. 926.

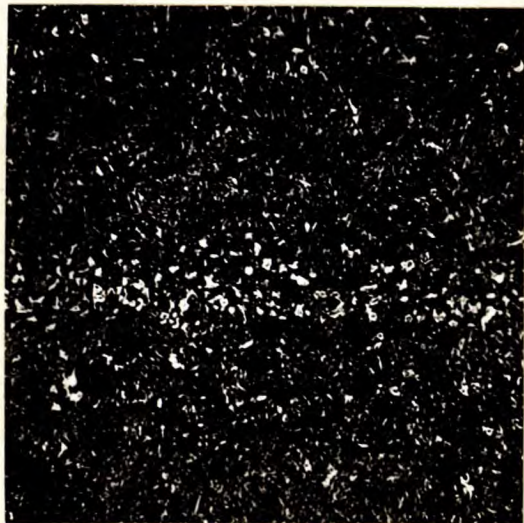
Figure 6.

In Pin No. 917, however, the banded appearance was due to bands of ferrite which had precipitated as shown in Figure 5 (a photomicrograph at X100). The same condition, although to a lesser degree, was found in the core structure of Pin No. 926 (see Figure 6).

Pin No. 925 had a normal quenched-and-drawn microstructure in the core. Pin No. 926 contained some ferrite in banded areas as described above. This condition explains the slightly low core hardness of 40 to 42 Rockwell 'C'.

X250, etched in  
2 per cent nital.  
CORE, PIN NO. 926.

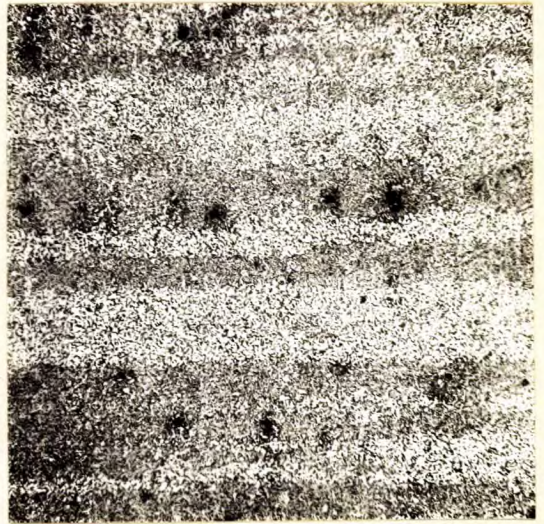
Figure 5.

Microscopic examination of Pin No. 917 showed a core structure of tempered martensite banded with ferrite. The ferrite was present in patches and not formed about the grain boundaries. This is a characteristic of a pin quenched from a temperature below the upper critical. This was substantiated

It is interesting to note that in Pin No. 917 these bands of ferrite are accompanied by a silicon content of 2.32 per cent. It should be pointed out that the possibility exists of the formation of ferrite in longitudinal bands being caused by silicon segregation which raised the critical temperature in these areas. Consequently, the usual quenching temperature, 1600° to 1640° F., was below the upper critical of the pins at these points.

X100, etched in  
2 per cent nital.  
CORE, PIN NO. 917.

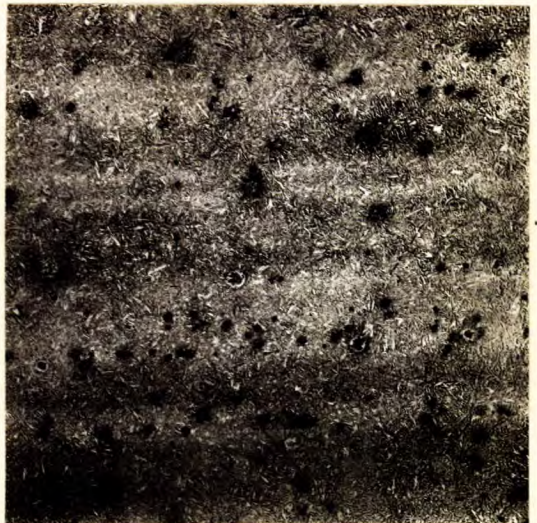
Figure 7.

Figure 7 shows the microstructure of Pin No. 917 after the specimen was requenched from 1700° F. and drawn for 30 minutes at 850° F. There is no ferrite present.

by re-quenching the specimen from 1700° F. and drawing at 850° F. for 30 minutes. As shown in Figure 7, no ferrite is present.

X100, etched in  
2 per cent nital.  
CORE, PIN NO. 917.  
Oil-quenched from 1700° F.
