ORE DRESSING AND METALLURGICAL LABORATORIES.

Investigation No. 1660.

Examination of CTL-112 Guide Rod Nuts
with Projection Welded Flanges.

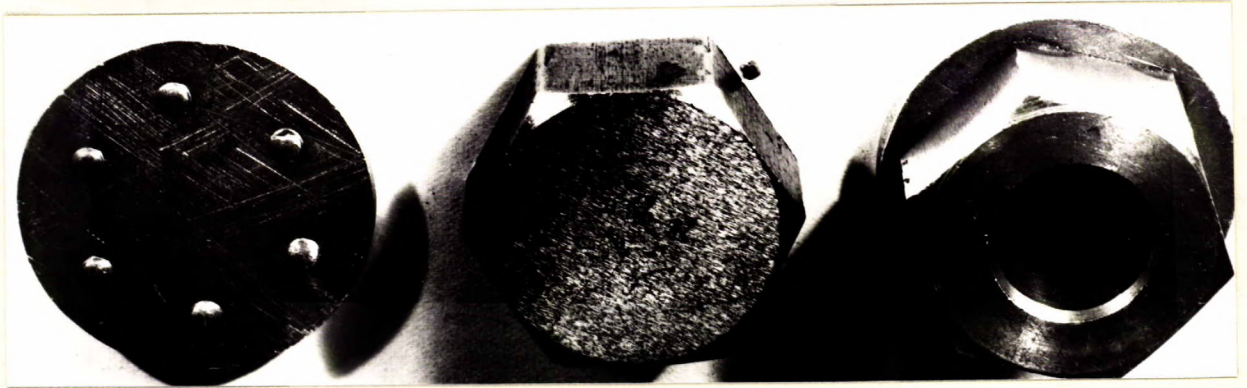
Figure 2.

SAMPLES AS RECEIVED.

From left to right: embossed flange plate,
section of hexagon bar stock, and welded assembly.

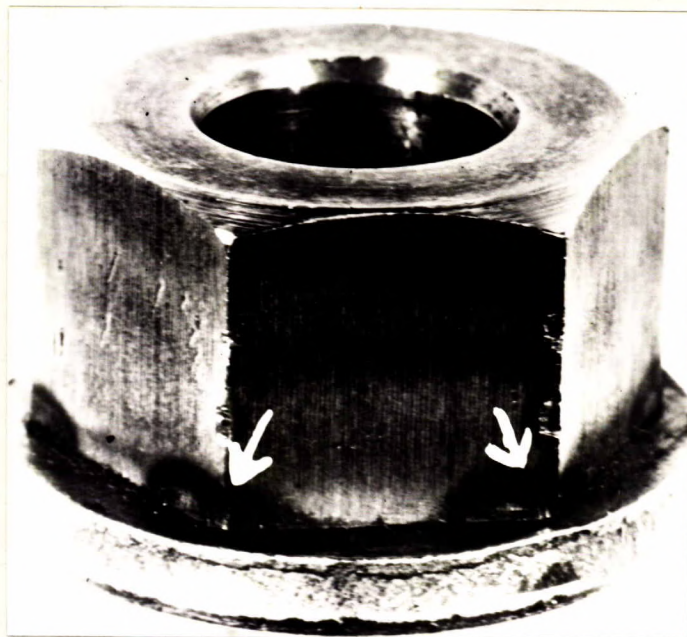
Figure 3.

WELDED ASSEMBLY AS RECEIVED.

Note weld areas at points of nut and also
lack of complete penetration of weld metal.

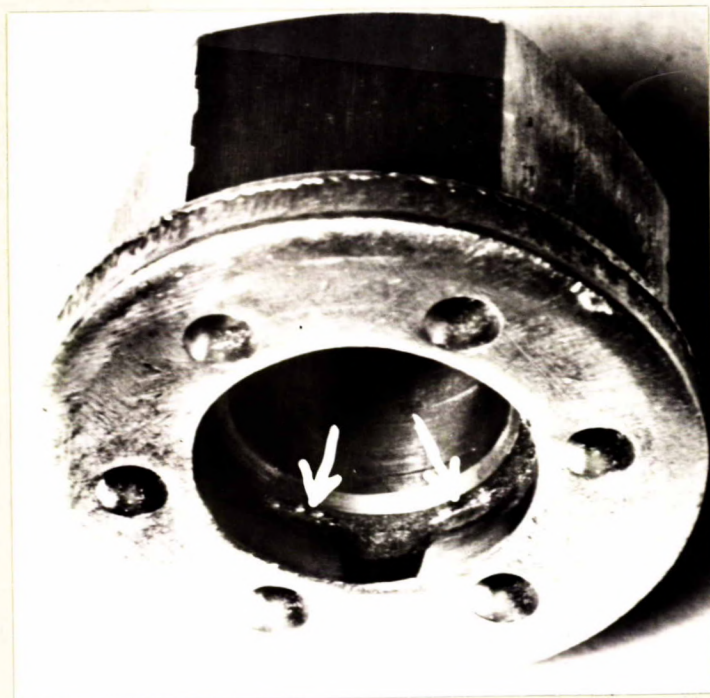
Figure 4.

WELDED ASSEMBLY AS RECEIVED.

Note complete penetration of weld metal.

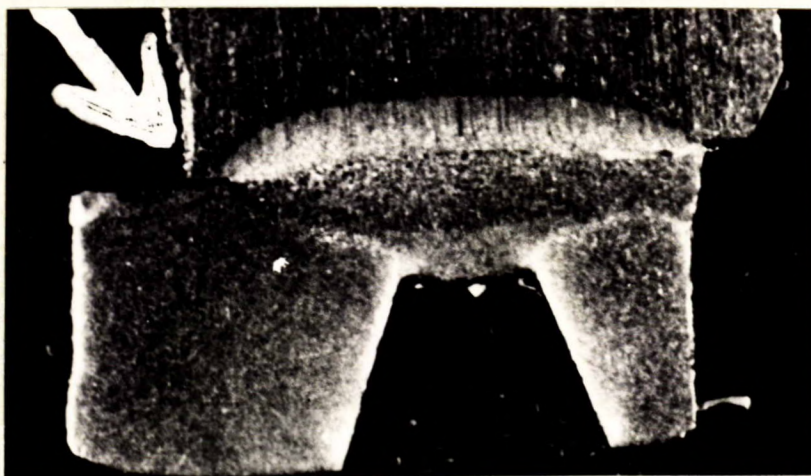
Figure 5.

A visual examination of the welded assembly revealed that from the centre of the weld the molten metal had penetrated completely to the inside of the nut, whereas penetration had not been secured from the centre to the outside. This is confirmed by the macroscopic and microscopic examinations.

POLISHED AND ETCHED MACRO SAMPLE.

Note lack of penetration to outside of nut material. Note also good penetration of projection into the nut material.

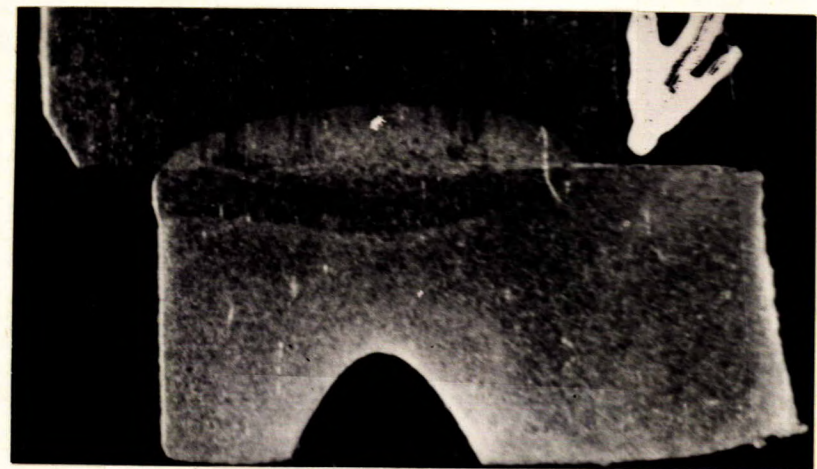
Figure 6.

POLISHED AND ETCHED MACRO SAMPLE.

Note lack of penetration to outside of nut material. Note also good penetration of projection into nut material.

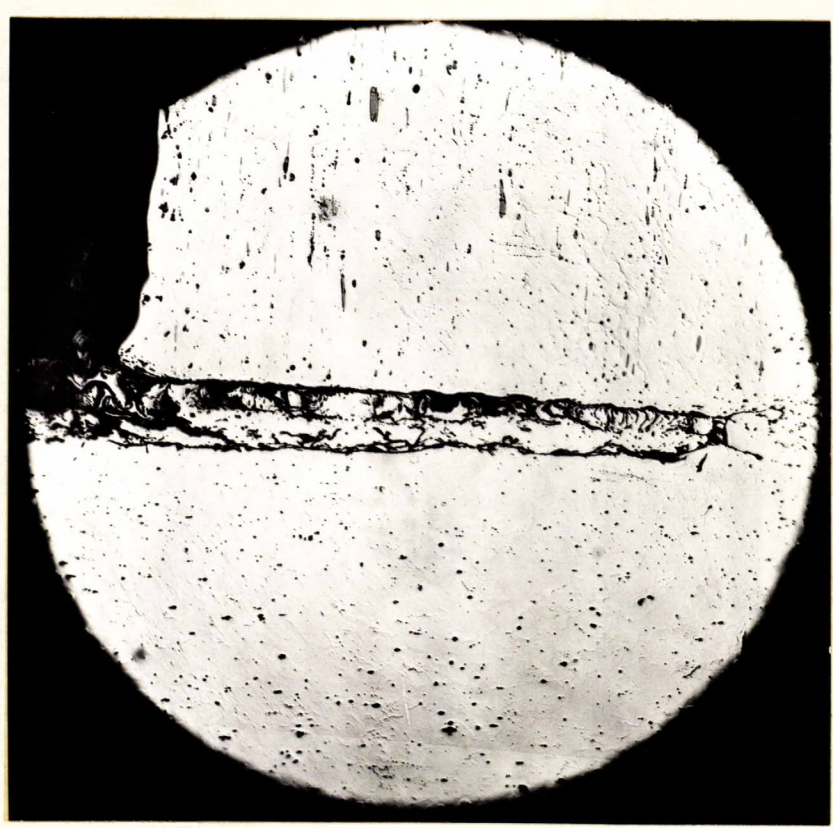
Figure 7.

diameter. The lack of fusion towards the outside of the nut is to be expected, since the width of material is $3/8$ inch at the welding zone.

X80, unetched.

AREA OF LACK OF FUSION TOWARD OUTSIDE OF NUT MATERIAL.

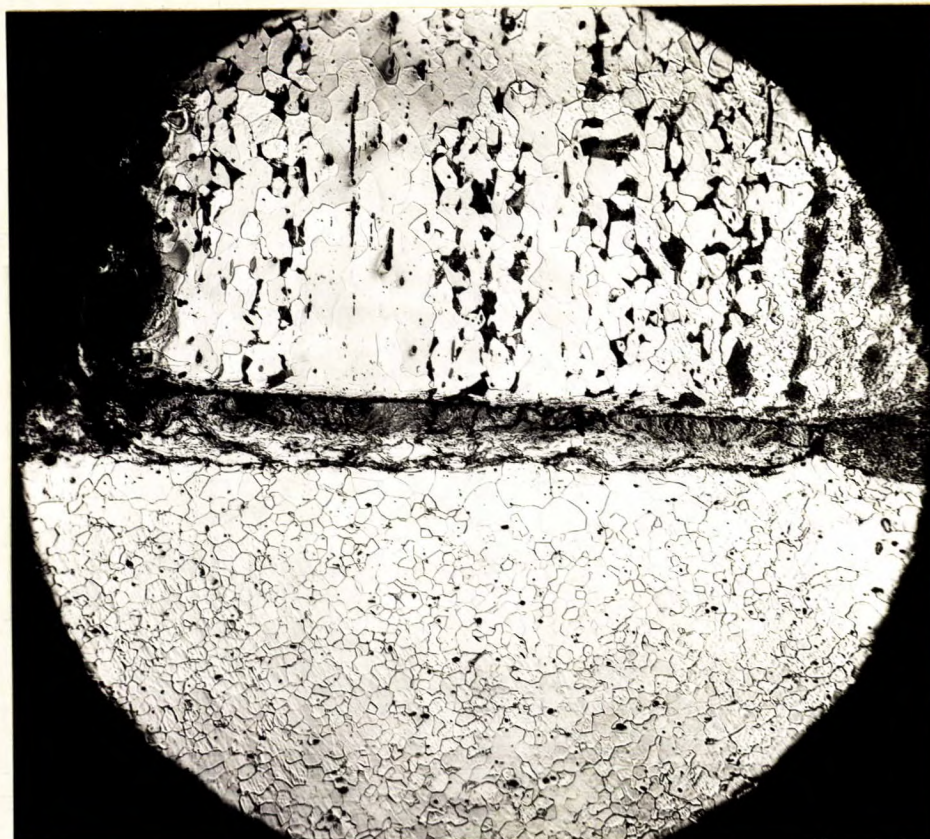
X100, etched in 2 per cent nital.
SAME AREA AS FIGURE 7, AFTER ETCHING.

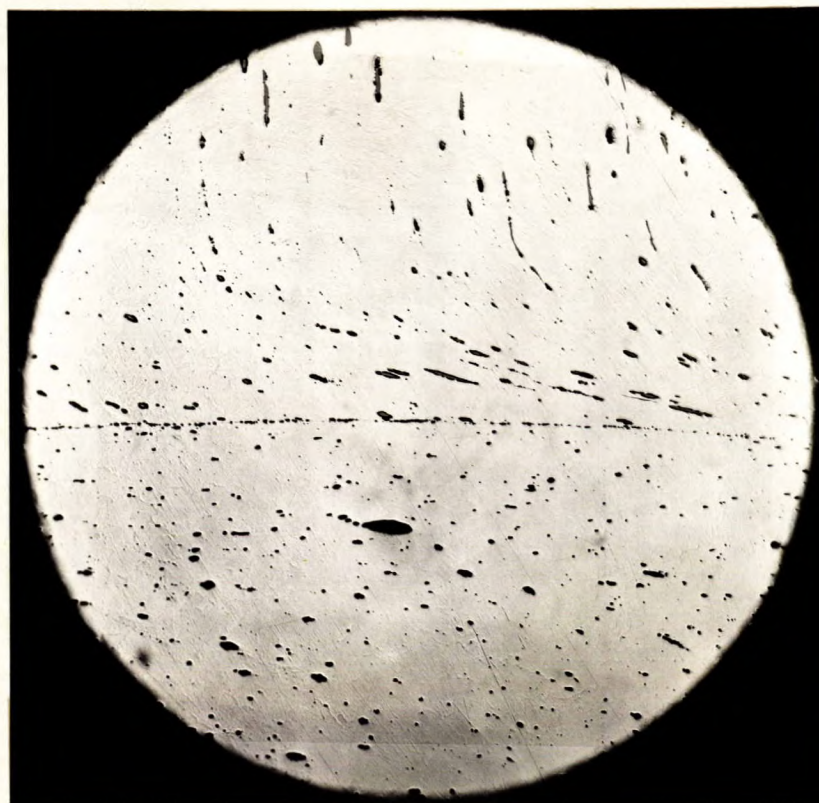
Figure 9.

X80, unetched.
TYPICAL FUSION LINE.
Note sulphide inclusions.

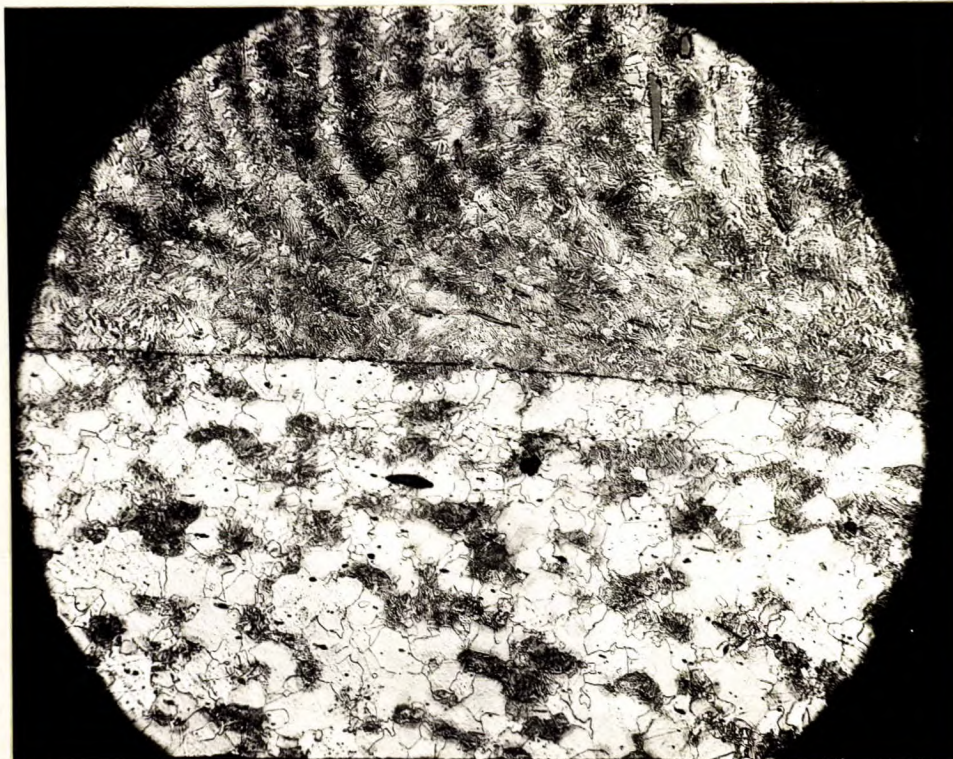
Figure 10.

X100, etched in 2 per cent nital.
SAME AREA AS FIGURE 9, AFTER ETCHING.

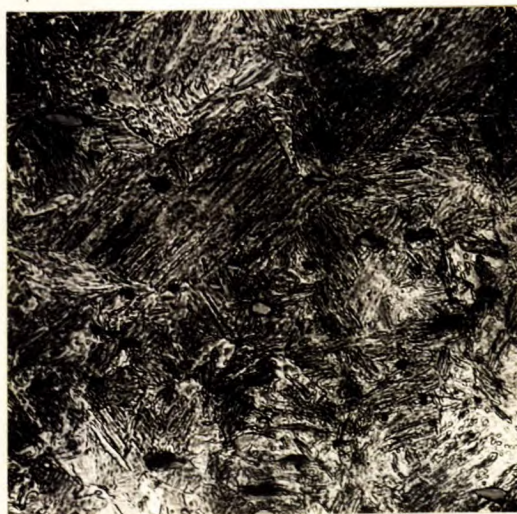
Figure 11.

The presence of low-carbon martensite along the fusion line of the nut material is to be expected in this type of welding. Under very severe impact conditions this hardened zone might produce brittle cracking. However, should this occur the condition can be rectified by following the welding operation closely with several surges of current. This would retard the cooling rate and prevent the formation of martensite.

The hardness readings show nothing abnormal. The high hardness of the heat-affected zone of the nut material confirms the formation of martensite which was detected in the microscopic examination.

X500, etched in 2 per cent nital.
MARTENSITIC STRUCTURE OF HEAT-AFFECTED
ZONE OF NUT MATERIAL.
Hardness, 405 Vickers.

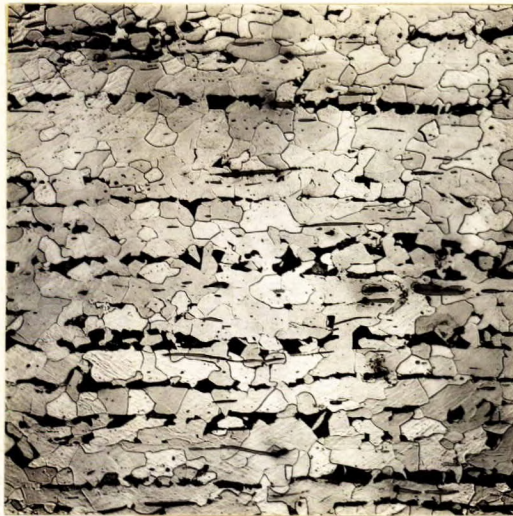
Figure 12.

The normal structures of the nut and flange materials reveal nothing unusual. The nut material shows the banded structure characteristic of hot-rolled steel and also numerous manganese sulphide inclusions which are typical of free-machining steels. The flange material is apparently a low-carbon steel. Unfortunately, insufficient material was available for chemical analysis of this part.

X100, etched in 2 per cent nital.

BANDED STRUCTURE OF NORMAL NUT MATERIAL,
TYPICAL OF HOT-ROLLED STEEL.

Note numerous manganese sulphide inclusions.

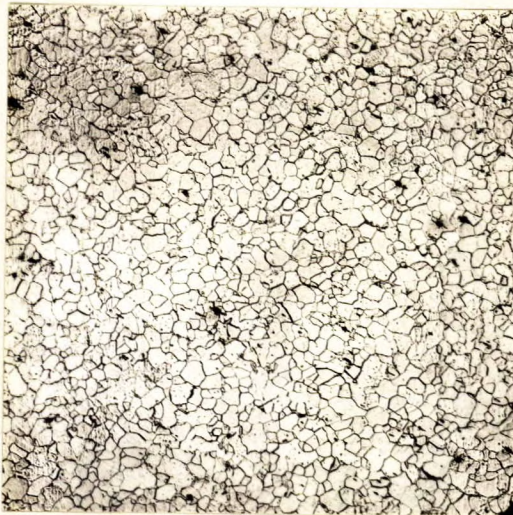
Figure 13.

X100, etched in 2 per cent nital.

STRUCTURE OF FLANGE MATERIAL, TYPICAL
OF LOW-CARBON STEEL.
