ORE DRESSING AND METALLURGICAL LABORATORIES.

Investigation No. 1662.

Metallurgical Examination of Steel
Plate from German Scout Car.

June 12th, 1944.

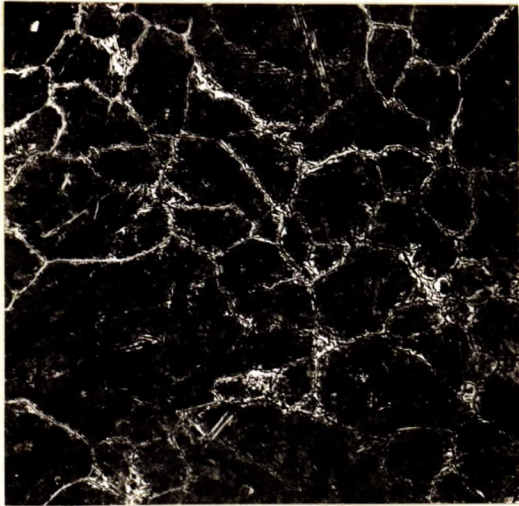
Figure 1.

Specimens from each plate were given a standard carburizing treatment for McQuaid-Ehn test, polished, etched in 4 per cent picral, and examined for grain size. Figure 1 shows a McQuaid-Ehn grain size of 1-2 (ASTM Standard) for Plate No. 1, while Plate No. 2 had a fine McQuaid-Ehn grain size, 5 (see Figure 2).

The difference in grain size, as determined by fracture and McQuaid-Ehn tests, is probably the fault of the latter test. The carburizing of such a low-carbon steel would make the grain in the case larger than the grain in the core, due to the lowering of the critical temperature in the outer zone. This would produce a greater grain-coarsening action in the case, due to the increased heating above critical temperature.

MCQUAID-EHN GRAIN SIZE
FOR PLATE NO. 1.

ASTM rating: 1-2.

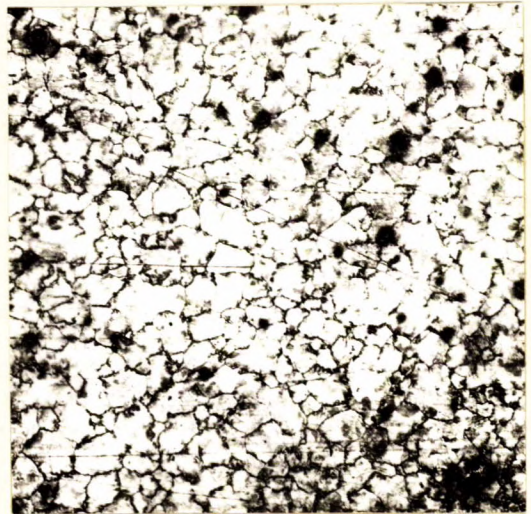
Figure 2.

MCQUAID-EHN GRAIN SIZE
FOR PLATE NO. 2.

ASTM rating: 5.

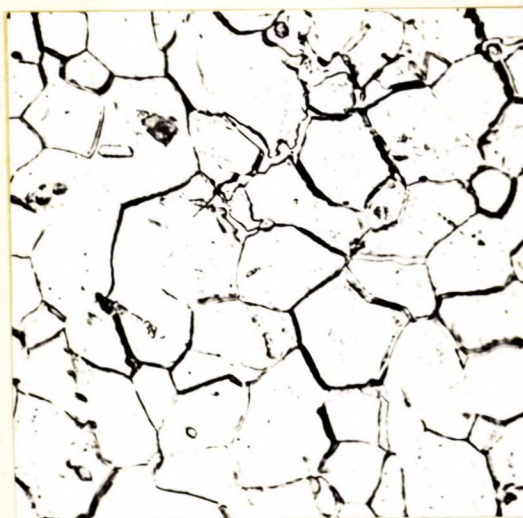
Figure 5.

Figure 5 is a photomicrograph of Plate No. 1, showing the structure to be made up entirely of ferrite grains. It is of interest to note the overlapping effect of the grains within a grain, indicated by a double-line boundary.

The "overlapping" phenomenon of the ferrite grains would indicate that cold rolling was given at some time during the fabrication of the steel sheet. Since the grains are not elongated the cold work would be followed by a stress-relieving anneal, which conforms to normal practice.

MICROSTRUCTURE OF PLATE NO. 1.

Note overlapping grains of ferrite,
indicated by a double-line boundary.

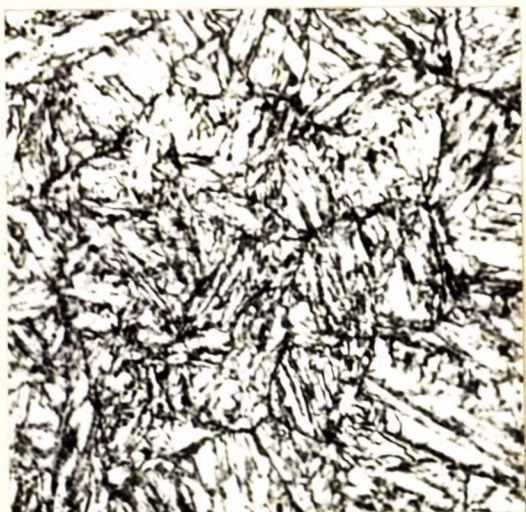
Figure 6.

Figure 6 (photomicrograph of sample cut across the rolling direction) shows the structure of the No. 2, bullet-proof plate to be mainly tempered martensite. However, it will be noticed that there are also present some areas with the acicular structure of a bainite product.

possibly have been made to improve the quality of the quenched product. The upper nose of the "S"-curve is moved well to the right by 1 per cent chromium and there is also the formation of a lower nose which would produce bainite on continuous cooling. Thus, quenching may be at such a rate as to produce a combination of bainite and martensite which on tempering would yield a product having toughness combined with strength.

MICROSTRUCTURE OF PLATE NO. 2,
SHOWING TEMPERED MARTENSITE
BAINITE STRUCTURE.

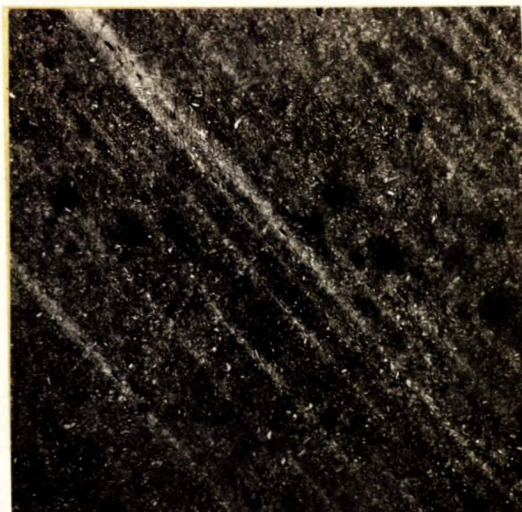
Figure 7.

A sample cut in the rolling direction shows decided banding, which is a very common occurrence with high-silicon steels. (See Figure 7).

A theory advanced as to the cause of banding in these steels is that proeutectoid ferrite formed during annealing would have a high percentage of silicon dissolved in it. This would make these ferrite areas more resistant to carbon solution than the remainder of the steel, thus developing the segregated portion which shows up as light etching.

MICROSTRUCTURE OF PLATE NO. 2.

Note segregated banding.
