R E P O R T  
of the  
ORE DRESSING AND METALLURGICAL LABORATORIES.

Investigation No. 1663.

Examination of a Fractured Steel Control Rod  
for a 4" Mk. XIX Gun Twin Mounting.

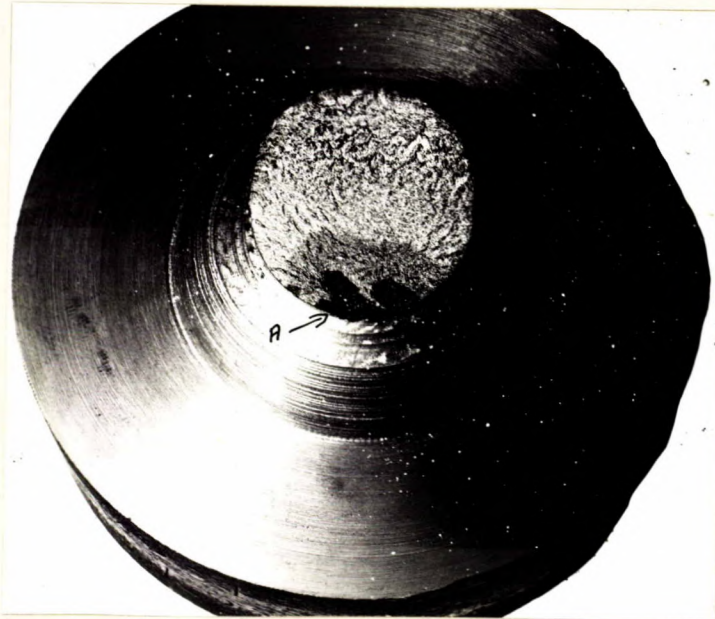
Figure 1.

Figures 1 and 2 show the ends of the fracture of the semi-machined steel forging in the "as received" condition. It is thought that no significance should be attached to the dark areas at "A" as they are probably oil stains.

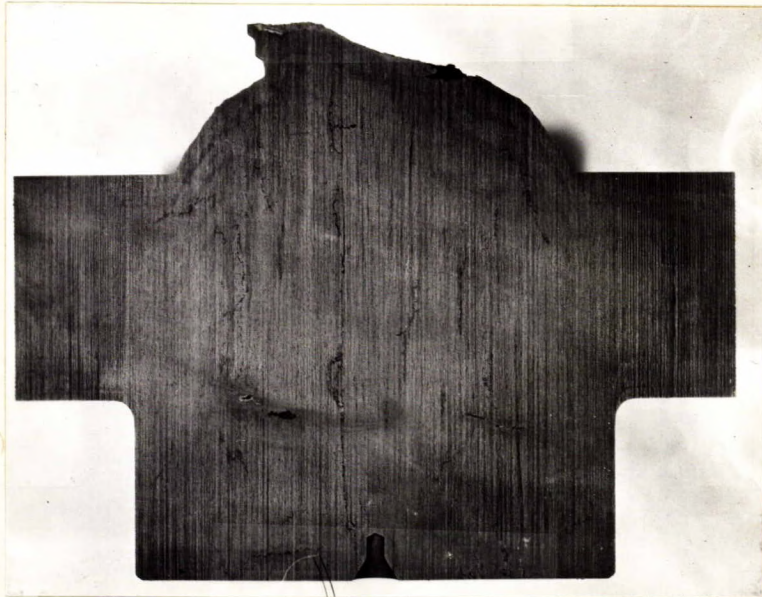
Figure 3.

Figure 3 shows the cross-section of the heavy end of the forging shown in Figure 1. A number of cracks and cavities were observed in the metal. The other half of this section and a cross-section of a portion of the rod adjacent to the fracture were polished on a surface grinder and then macro-etched for 45 minutes in a solution of 50 per cent hydrochloric acid in water

1. The failure of the forging was due to unsound metal and, possibly, the presence of a few hydrogen flakes.

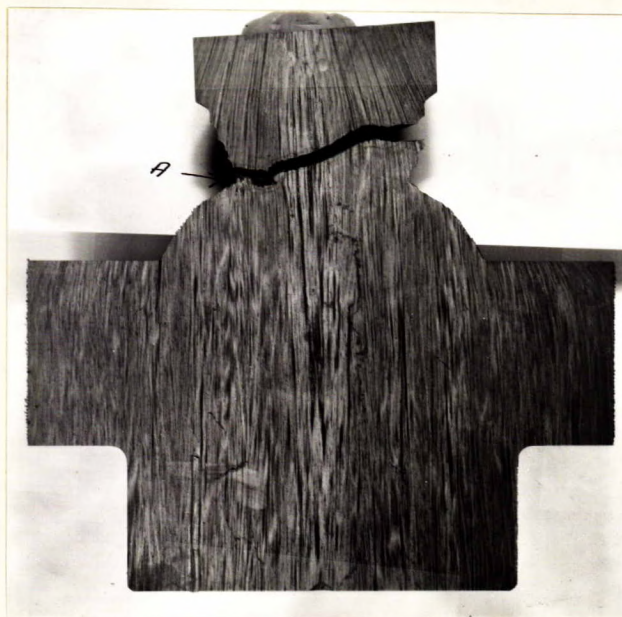
heated to 160 to 175° F. The flow lines of the two macro-etched cross-sections are illustrated in Figure 4.

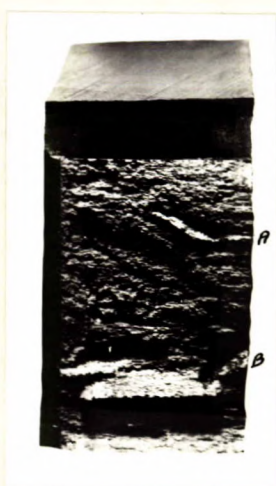
A cross-section of the forging was fractured and examined for hydrogen flakes. Some flakes were observed in the steel at the locations marked A and B in Figure 5. Cracks and porous metal were also noted. These are shown in Figure 6.

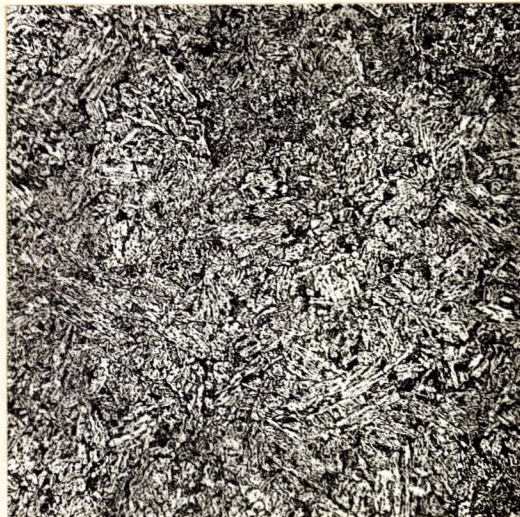
Figure 8.

Figures 8 and 9 show the nital-etched structure of the "as received" steel at X100 and X1000 magnifications respectively. The structure consists of ferrite, the iron content (the light etching material), and fine pearlite, the iron-iron carbide constituent (the dark etching material). The structure is typical of a normalized-and-drawn steel of this composition. There appears to be a fairly coarse distribution of carbides.

STRUCTURE OF STEEL "AS RECEIVED".

Harden in oil from 1500° F.;  
Time, 1 hour per inch.

Temper at 1100° F.;  
Time, 4 hours per inch.

Cool in air from the draw.

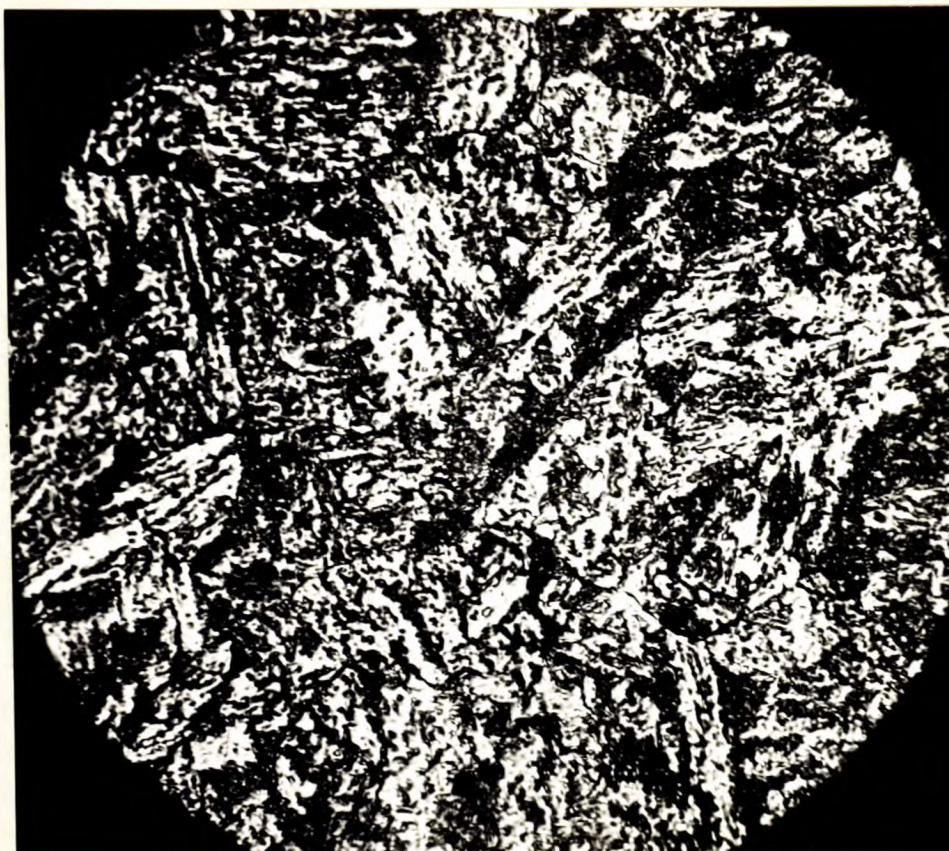
Figure 9.

X1000, etched in 2 per cent nital.  
STRUCTURE OF STEEL "AS RECEIVED".

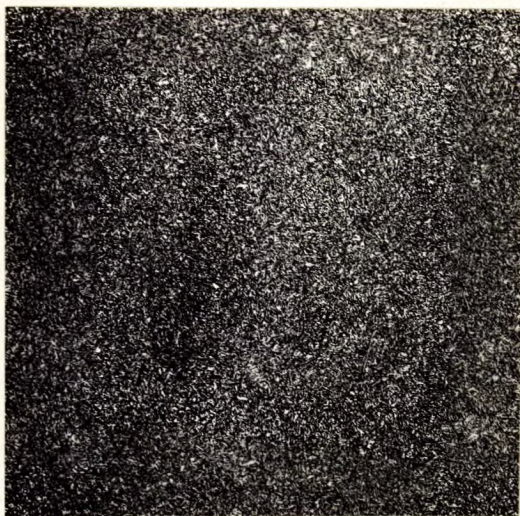
Figure 10.

The structure of the steel after being heat-treated in these Laboratories is shown in Figures 10 and 11. The structure consists of tempered martensite and is much finer than the "as received" structure.

X100, etched in 2 per cent nital.  
STRUCTURE AFTER OIL QUENCH AT 1500° F.  
AND DRAW FOR 12 HOURS AT 1100° F.

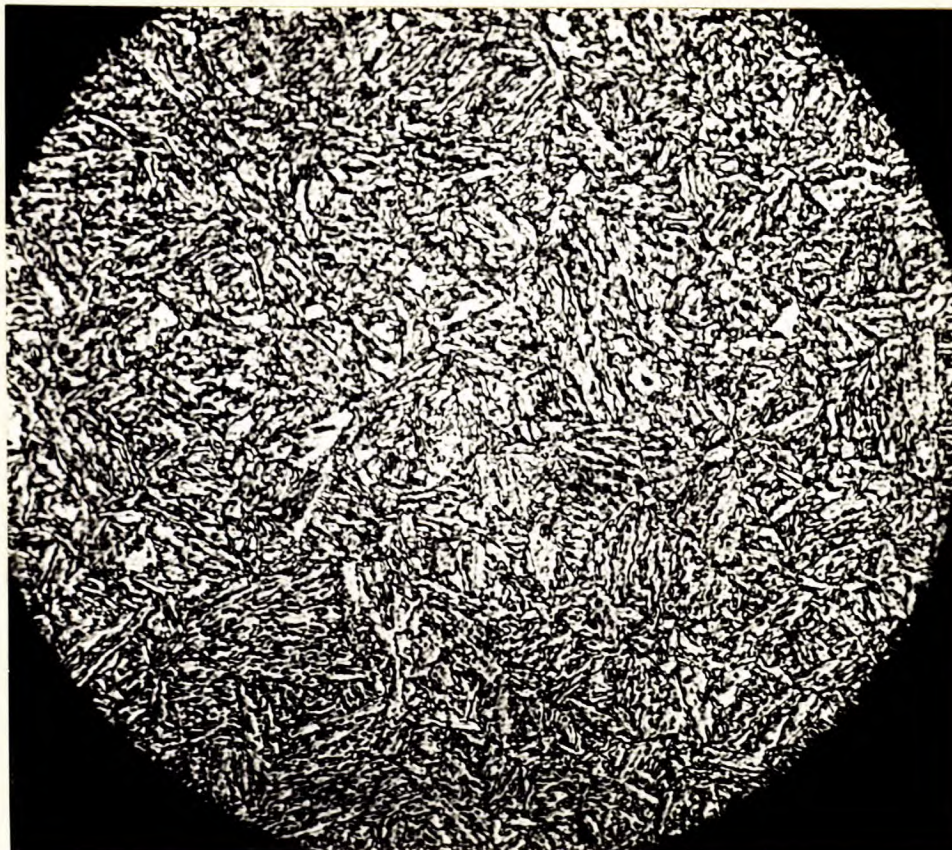
Figure 11.

X1000, etched in 2 per cent nital.  
STRUCTURE AFTER OIL QUENCH AT 1500° F.  
AND DRAW FOR 12 HOURS AT 1100° F.

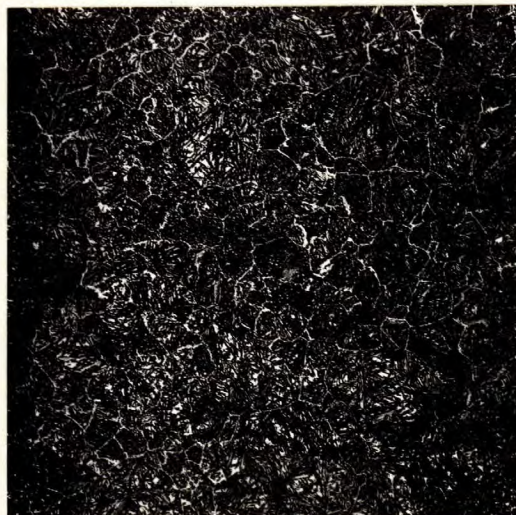
Figure 12.

The grain size of the steel was determined by the  
McQuaid-Ehn method and was found to be 6 (see Figure 12).

X100, etched in 2 per cent nital.  
CARBURIZED AT 1700° F.  
AND SLOWLY COOLED.  
Grain size, 6.
