ORE DRESSING AND METALLURGICAL LABORATORIES.

Investigation No. 1664.

Examination of Armoured Snowmobile Wheel Assembly.

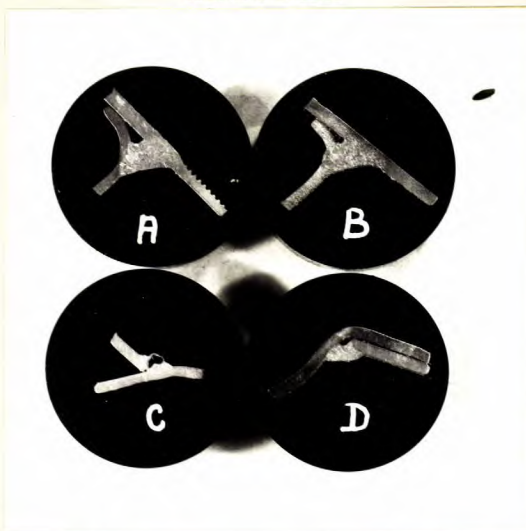
Figure 1.

Figure 1 is a photograph of the welded sections examined. These samples were etched in 10 per cent nitric acid in an attempt to show some difference between the weld metal and the parent metal. Sections B, C and D show a slight coarsening of grain in the weld metal, but there was a very little difference to be noted.

The welding is generally fair, some improvement being possible. Section C (see Figure 1) shows a tack weld with a large gas inclusion. This was the only gross welding defect noted.

PHOTOGRAPH OF WELDED SECTIONS EXAMINED.

A and B, hub section; C, disc section; and D, rim section.

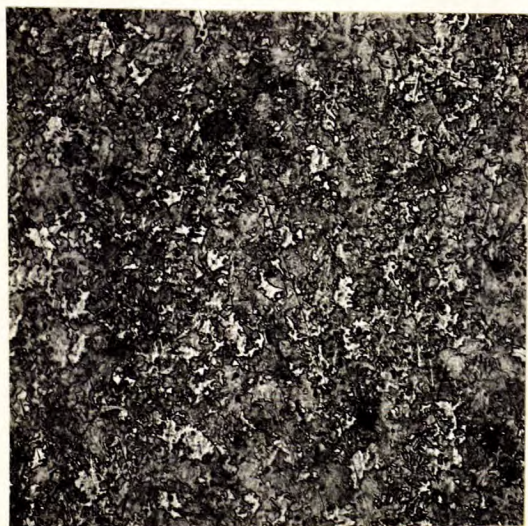
Figure 2.

Figures 2, 3 and 4, at a magnification of 100 diameters, show respectively the normal structure, the heat-affected zone and the weld metal of the section of hub examined. The hub metal in the heat-affected zone appears to be low-carbon martensite with some ferrite.

The chemical analysis shows that the material used in the hub does not meet the specifications for SAE 1020 steel but does agree with the nominal specification for SAE 1010 steel. Chemical analysis also shows that the disc and rim sections were made from a very low carbon steel. This indication is further borne out by the microstructure.

X100, nital etch.
NORMAL STRUCTURE,
HUB METAL.

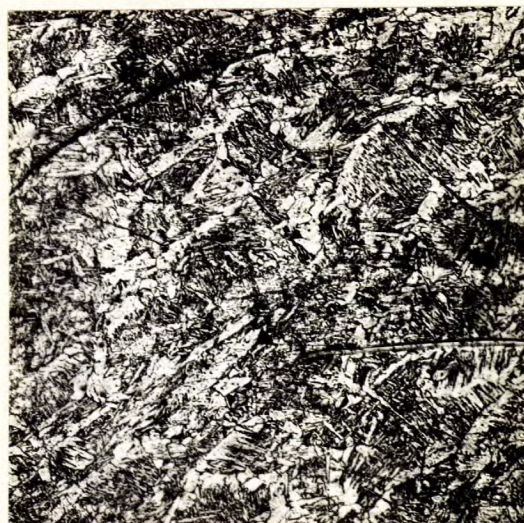
Figure 3.

X100, nital etch.
HEAT-AFFECTED ZONE,
HUB METAL.

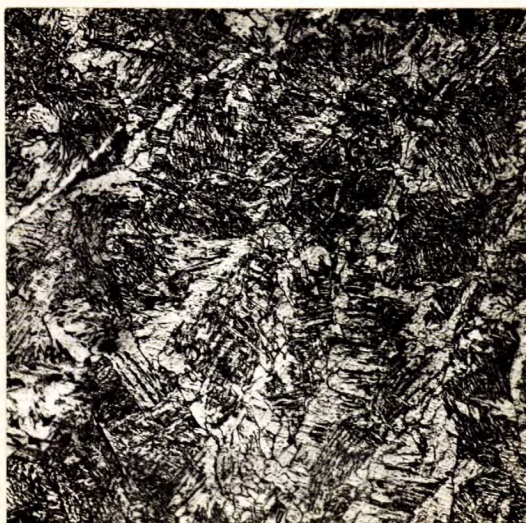
Figure 4.

The structure of the weld metal is very similar to that of the hub, both being low-carbon material.

X100, nital etch.
WELD METAL, HUB SECTION.

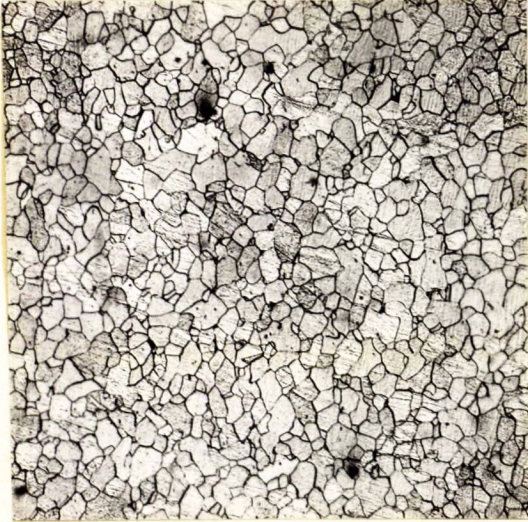
Figure 5.

Figures 5 and 6, at a magnification of 100 diameters, show the disc and rim metals respectively. These structures, ferrite with some free carbides, are normal for steel having a carbon content of less than 0.05 per cent.

DISC METAL.

Ferrite with some
free carbides.

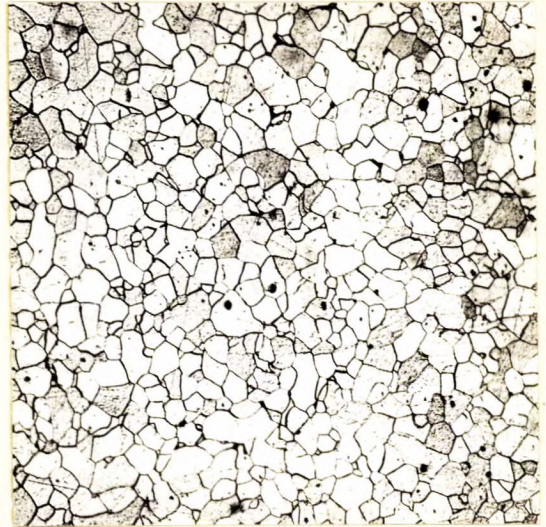
Figure 6.

RIM METAL.

Ferrite with some
free carbides.
