ORE DRESSING AND METALLURGICAL LABORATORIES.

Investigation No. 1665.

Further Investigation of 21-Inch-Torpedo
Connecting Rods.

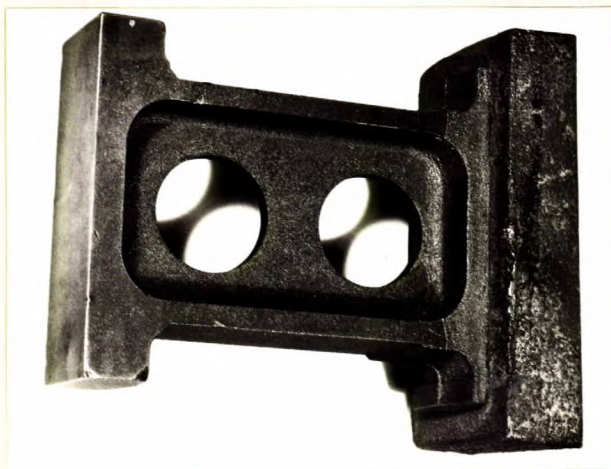
Figure 1.

GENERAL VIEW OF 21-INCH-TORPEDO CONNECTING ROD,
U.S. PRODUCTION, SHOWING BRONZE ON ONE END.

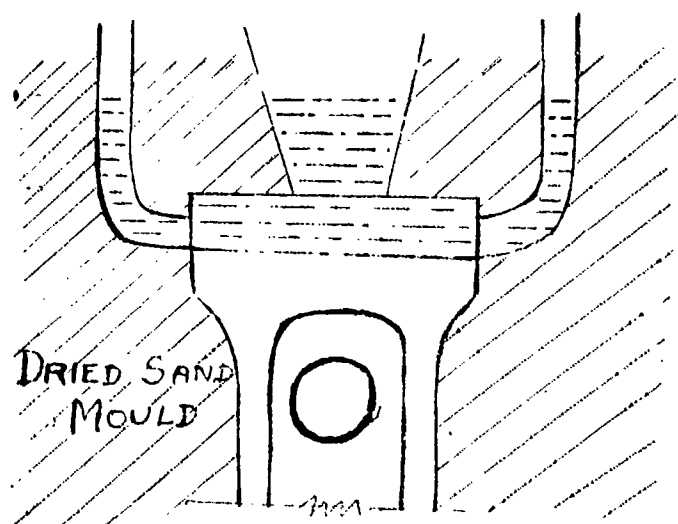
Fig. 2

The Canadian Westinghouse method of "burning-on" the bronze employs a closed, dried-sand mould with a stationary central gate and with two risers from either end to receive the excess metal (see Figure 2). A modification of this method, employing a "pencil" gate (see Figure 3) was tried, the object being to permit a more uniform flow of the molten metal onto the surface of the steel, thus minimizing the shock effect.

CANADIAN WESTINGHOUSE
OPEN GATE METHOD

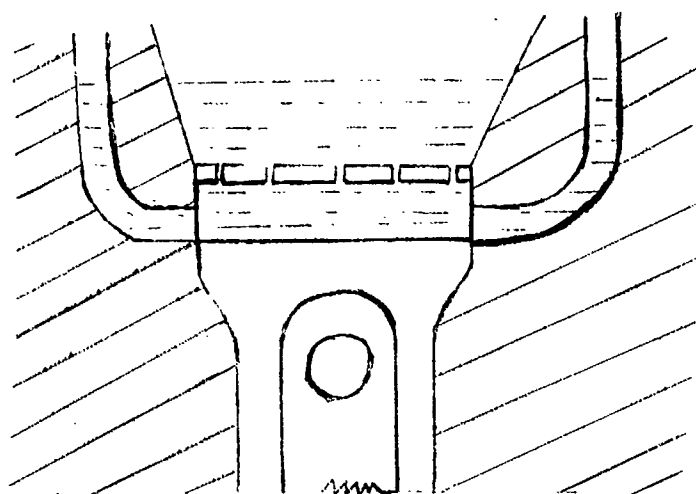
Fig. 3

CANADIAN WESTINGHOUSE
PENCIL GATE METHOD

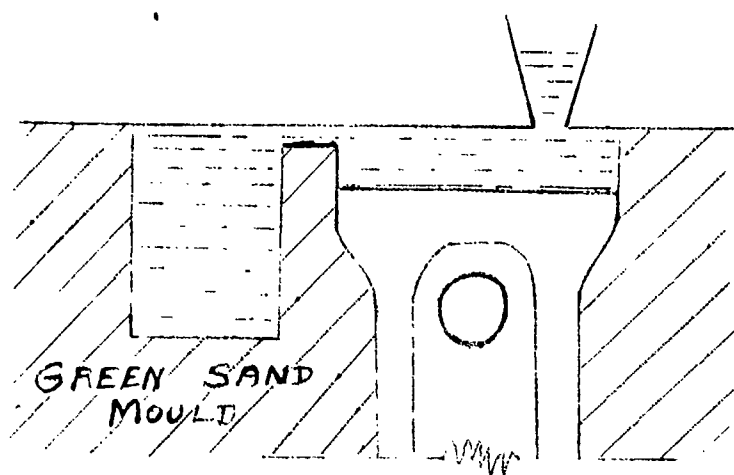
Fig. 4

the steel, which is similar to the "Peter Brotherhood's Overflow Method" of England, consists of casting in an open "green sand" mould, with a trough placed at one end of the rod to receive the excess metal used in the burning-on operation (Figure 4). The stream of molten bronze is played from side to side over the surface of the steel.

AMERICAN PRODUCTION
METHOD

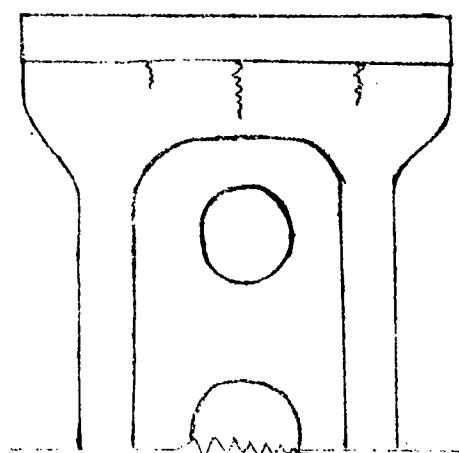
Fig. 5

In the Canadian Westinghouse production it was found that rather deep-seated cracks occurred in many connecting rods during the pouring operation. These cracks appeared to start at the steel-bronze interface and extended for a considerable distance down into the metal. Figure 5 shows the general disposition of the cracks.

SHOWING POSITION
OF CRACKS

1. The examination of the five specimens did not offer any definite clues as to the cause of the cracking.
2. It is recommended that experiments be conducted in which bronze is cast onto stress-free steel which has not been at any time subjected to a pickling operation.

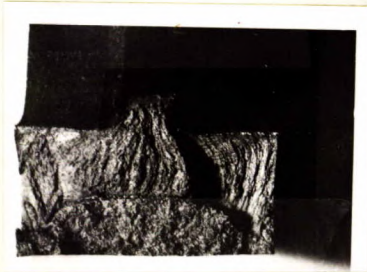
Figure 6.

Figure 6 shows the appearance of the fracture on the U.S. production. Note the fibrous structure and complete absence of penetration of the bronze. Figure 7 is the structure obtained on an open gate Westinghouse production, revealing a fibrous structure and slight penetration of the bronze. Figure 8 is

U.S. PRODUCTION, SHOWING
FIBROUS FRACTURE.
No penetration of bronze.

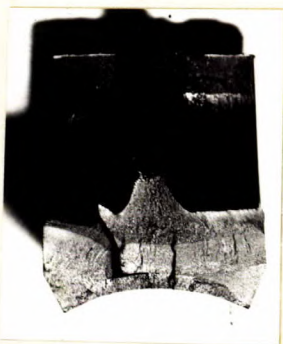
Figure 8.

also that of an open gate Westinghouse production, showing finer grain and less fibrous structure, with deep penetration of the bronze. Figure 9 shows the fracture obtained by breaking a sample poured by the pencil gate method. Note the fine grain, and the depth of penetration of the bronze.

WESTINGHOUSE OPEN GATE
PRODUCTION, SHOWING LESS
FIBROUS STRUCTURE AND DEEP
PENETRATION OF BRONZE.

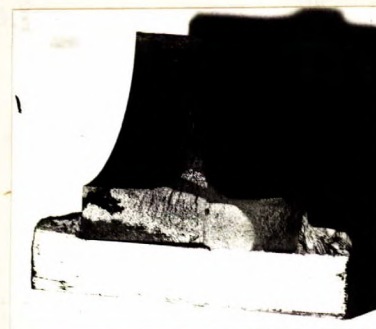
Figure 9.

WESTINGHOUSE PENCIL
GATE METHOD.
Note fine grain size and deep
penetration of bronze.

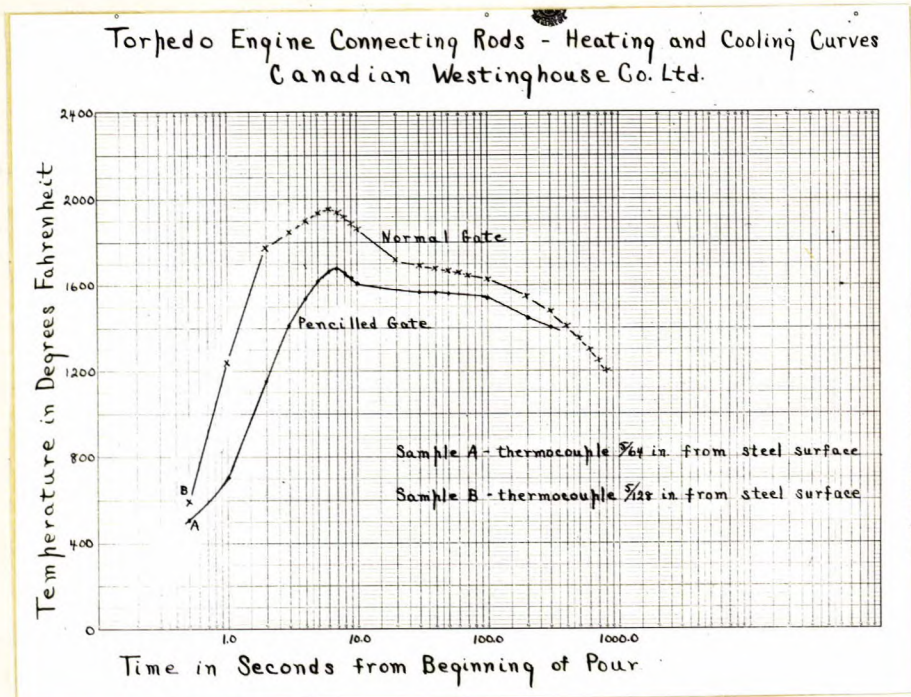
Figure 10.

Experiments were conducted at the Canadian Westinghouse Company Limited, Hamilton, Ontario, on March 23rd, to determine, by means of a Speedomax, the actual steel temperature during the "burning-on" operation, for both the Westinghouse open gate method and the pencil gate method. The results of these experiments are given in Figures 10 and 11.

The heating and cooling curves do not offer any evidence in explanation of the cracking.

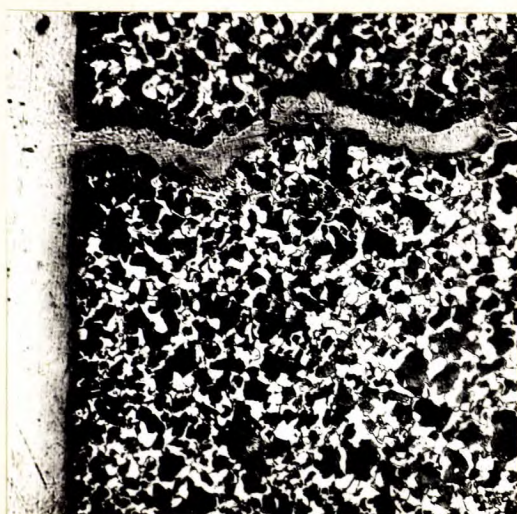
Figure 12.

Figures 12 and 13 show the penetration of the bronze into the steel. The bronze had been poured through a pencil gate. Note the intercrystalline penetration of the bronze (Figure 13).

X200, picral etch.
BRONZE-STEEL INTERFACE,
SHOWING PENETRATION OF
BRONZE INTO STEEL.

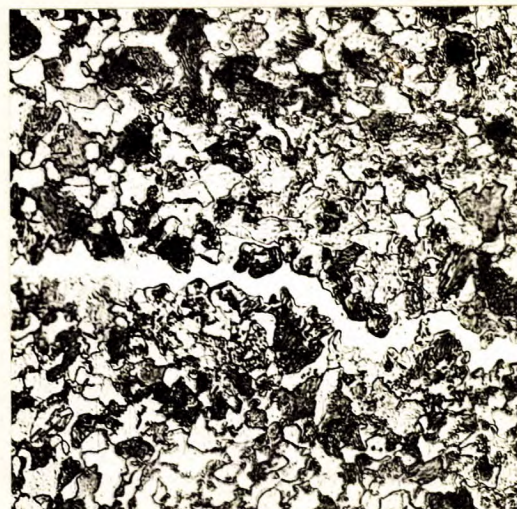
Figure 13.

X500, nital etch.
SHOWING INTERCRYSTALLINE
PENETRATION OF THE BRONZE.

However, the answer to the problem may be found in the effect of hydrogen introduced into the steel during the pickling operation. Quotations in support of this will be freely taken from a paper entitled "Penetration of Steel by Brass during Brazing and the Effect of Previous Pickling" in "The Metallurgist", supplement to "The Engineer", December 1934. This paper records the results of experiments on various grades of steel which had been pickled in 2:1 HCl and then dipped into the molten brass at 1100° C. It was found that intercrystalline penetration of the brass into the steel occurred invariably, due to the absorption of hydrogen during the pickling operation. In many cases the intercrystalline penetration opened out into lakes filled with brass.

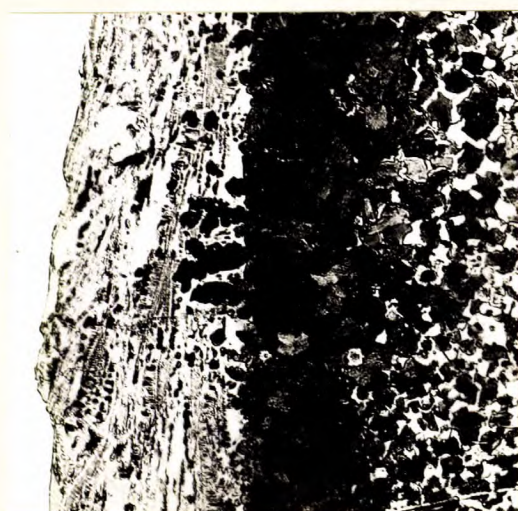
Figure 14.

Some of the specimens revealed a reaction product between the bronze and the steel. Figures 14 and 15, photomicrographs taken at magnifications of X100 and X1000 respectively, show this reaction product on a cracked open gate Westinghouse production. No evidence of this product was found on the U.S. production.

X200, nital etch.

SHOWING REACTION PRODUCT BETWEEN BRONZE AND STEEL.

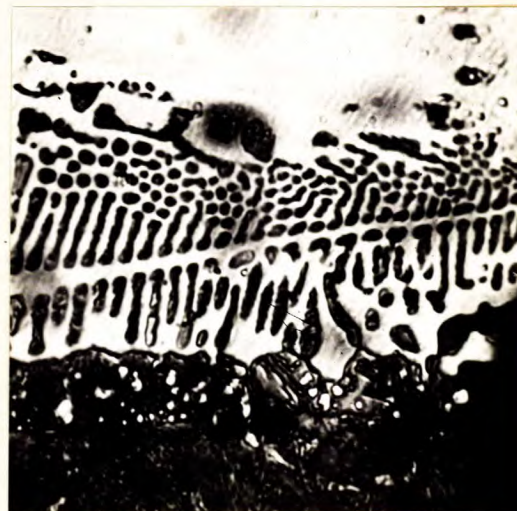
Figure 15.

X1000, nital etch.

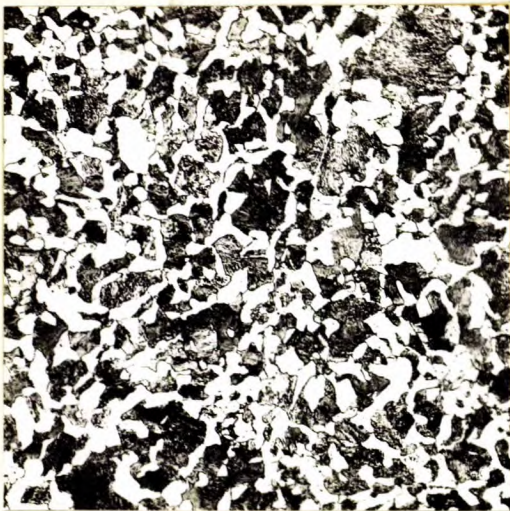
Figure 16.

X200, nital etch.
SHOWING ORIGINAL STRUCTURE
UNALTERED BY BURNING-ON
OF BRONZE.

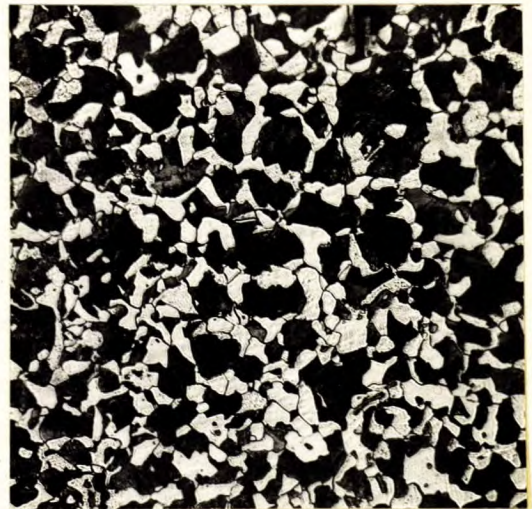
Figure 17.

X200, nital etch.
SHOWING STRUCTURE ALTERED
BY BURNING-ON OF BRONZE.

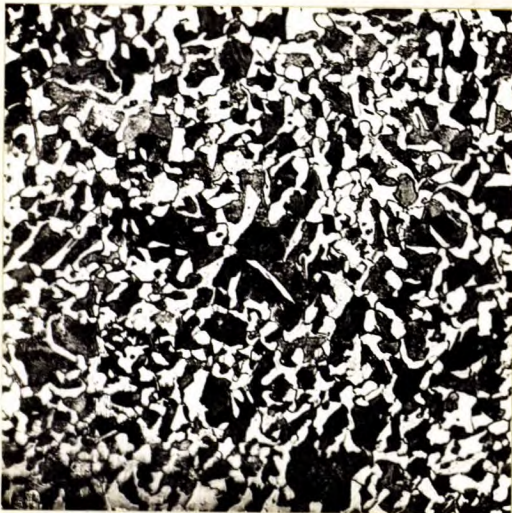
Figure 18.

Figures 18 and 19 show the altered and unaltered structures, respectively, of Canadian Westinghouse production which had not developed cracks.

X200, nital etch.
SHOWING ORIGINAL
UNALTERED STRUCTURE.

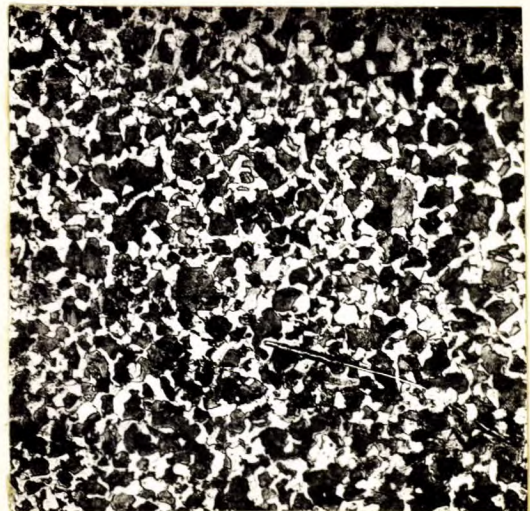
Figure 19.

X200, nital etch.
SHOWING STRUCTURE ALTERED
BY BURNING-ON OF BRONZE.

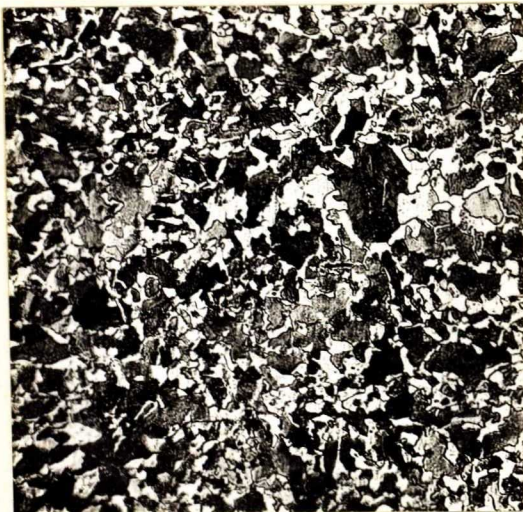
Figure 20.

Figures 20 and 21 show the altered and unaltered structures, respectively, of a Canadian Westinghouse pencil gate production rod which had cracked very badly during the pouring operation.

X200, nital etch.
SHOWING ORIGINAL
UNALTERED STRUCTURE.

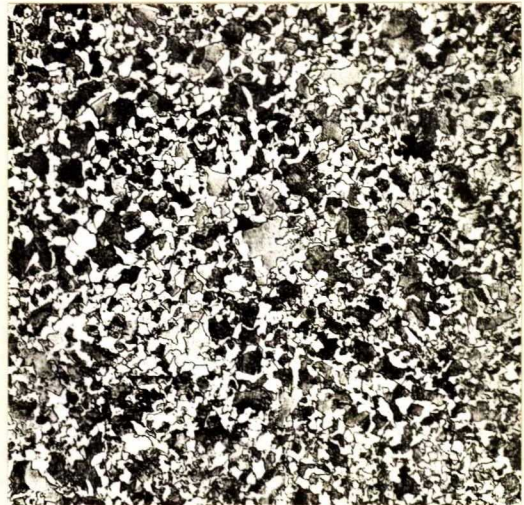
Figure 21.

X200, nital etch.
SHOWING STRUCTURE ALTERED
BY BURNING-ON OF BRONZE.

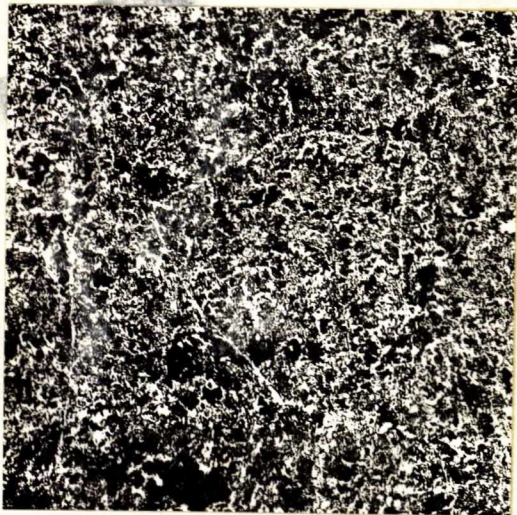
Figure 22.

Figure 22 is a photomicrograph of Sample No. WL 552, Canadian Westinghouse open gate production, showing large grains formed in the forging operation and not completely eliminated during the subsequent normalizing operation. This rod cracked during the pouring operation.

X100, nital etch.
CANADIAN WESTINGHOUSE
OPEN GATE PRODUCTION,
SHOWING LARGE FORGING GRAIN.

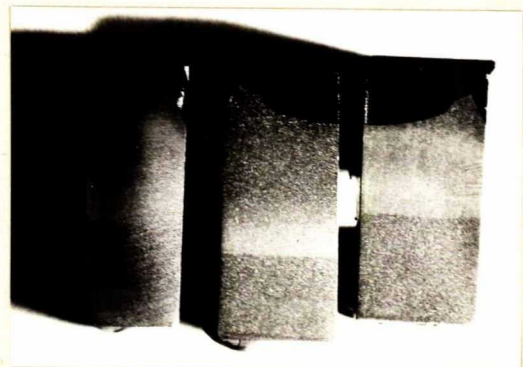
Figure 23.

It was noticed that the heat-affected zone on the U.S. production was slightly deeper than that of the Canadian Westinghouse open gate production which had developed cracking (see Figure 23). It is rather difficult to assign any importance to this, however.

Actual size, nital etch.
SHOWING HEAT-AFFECTED ZONE.
(U.S. production in centre;)
(Canadian Westinghouse open
(gate production on either
side.)

The slightly greater depth of penetration of the heat caused by the burning-on of the bronze, in the American sample, may or may not be of any significance. More samples would have to be examined before making any definite conclusions.
