June 22nd, 1944.

ORE DRESSING AND METALLURGICAL LABORATORIES.

Investigation No. 1668.

Examination of Self-Tapping Machine Screws.

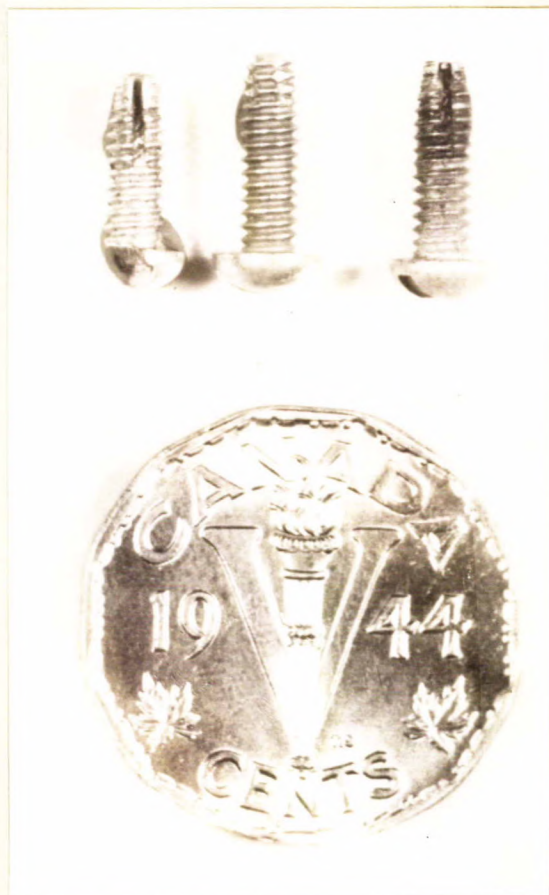
Figure 1.

The samples were given a careful visual examination. Some of the screws had failed by part of the head breaking away from the notch for the screw-driver, and others had broken part way down the shank. One of the screws had failed by stripping of the thread at the tip.

Two methods of notching the screws at the tip had been used. The defective screws had a single deep vertical cutting notch and the satisfactory screws had four shallow cutting notches. Figure 1 is an enlarged photograph showing two of the defective screws, with one of the satisfactory type in the middle. It can be seen that one of the defective screws has failed at the head and the other has failed by stripping of the thread at the tip. The five-cent piece is included for size comparison.

The difference in the method of notching the screws may well be the main cause of failures occurring on installation. Four notches, cut on a bias, as observed on the satisfactory

screws, should distribute the tapping stresses more evenly throughout the revolution than would a single notch cut vertically. The shallower cut possible with the four notches would also contribute to better stress distribution.

2. Some of the unsatisfactory screws were made from a non-carburizing grade of steel, which may account for their brittle behaviour.
3. The fact that a single tapping notch is used in the defective screws may be the chief cause of installation failure, as the screws with four tapping notches proved satisfactory.

1. Use a carburizing grade of steel.
2. Investigate the relative merits of single-notch and four-notch screws.
3. Keep the depth of case on screws uniform. A depth of 0.002 inch was observed on the satisfactory screws.
4. Adhere to carburizing practice recommended for the steel.
5. Adopt a practical test in determining whether the screws are satisfactory. Holes of appropriate size could be drilled in an iron block and the test made by driving screw samples into these holes.

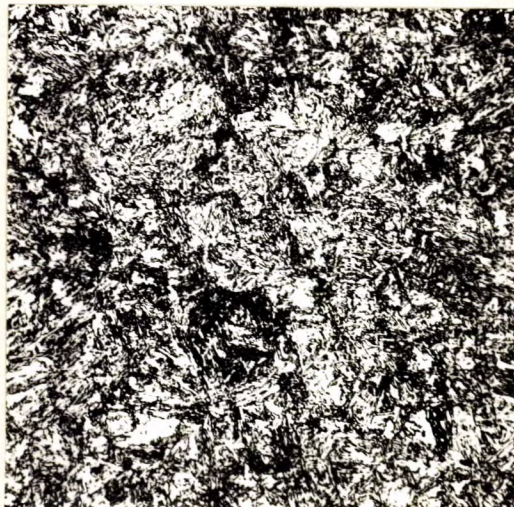
Figure 2.

Microscopic examination disclosed that all the screws had been lightly case-hardened. The cores consisted of low-carbon martensite. Figure 2 is a photomicrograph of a typical core structure.

MICROSTRUCTURE OF CORE.

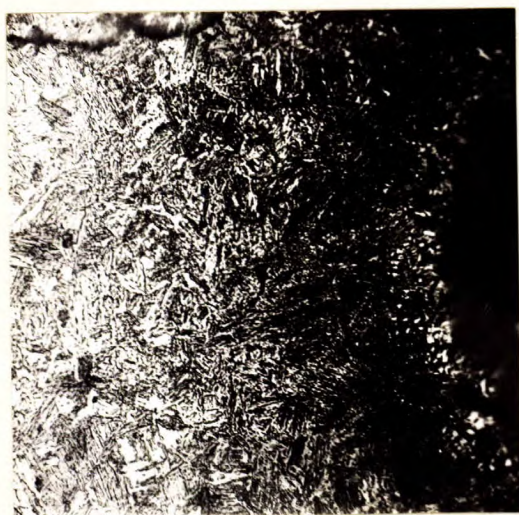
Figure 3.

The thickness of the cases varied considerably. The satisfactory screws had a case about 0.002 inch in thickness. The cases of the defective screws ranged in thickness from 0.002 to 0.0075 inch. Figures 3 and 4 are photomicrographs of two of the cases, taken at the base of the threads.

CASE OF SATISFACTORY SCREW.

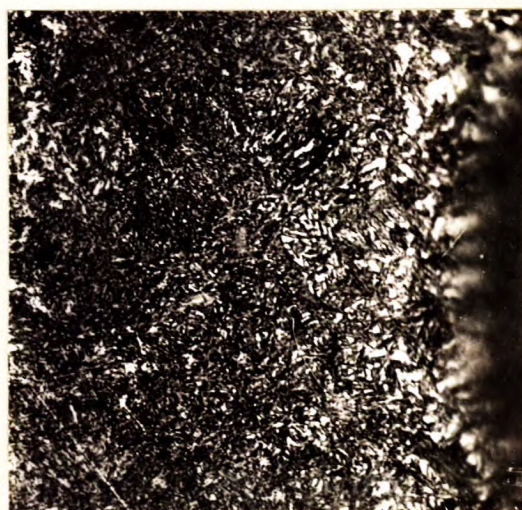
Figure 4.

CASE OF A DEFECTIVE SCREW.

A thick case is not needed on the screw, as the case has performed its function after one tapping operation. A thick case, as observed on some of the defective screws, lowers the shock resistance of the part.

4. The difference in the depth of case of some of the defective screws indicates that the heat treatment was not uniform.
5. The coarse structure observed on some of the defective screws indicates high quenching temperature, which would cause brittleness.

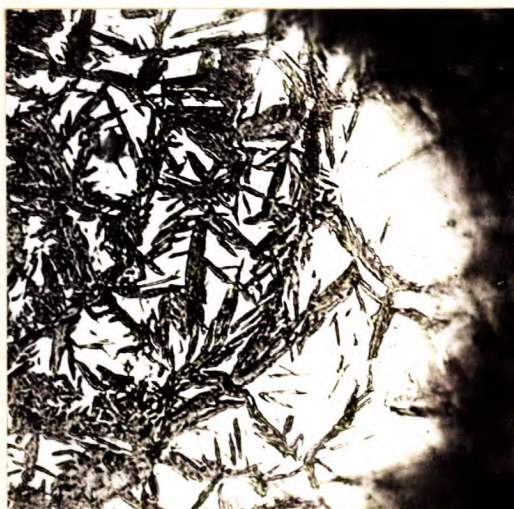
Figure 5.

Figure 5 shows a coarse martensitic structure observed in the thread of one of the defective screws.

COARSE MARTENSITIC STRUCTURE IN  
THREAD OF DEFECTIVE SCREW.

The coarse martensitic structure observed in some of the defective screws (see Figure 5) is caused by quenching from too high a temperature. This would definitely impair the toughness of the screw.

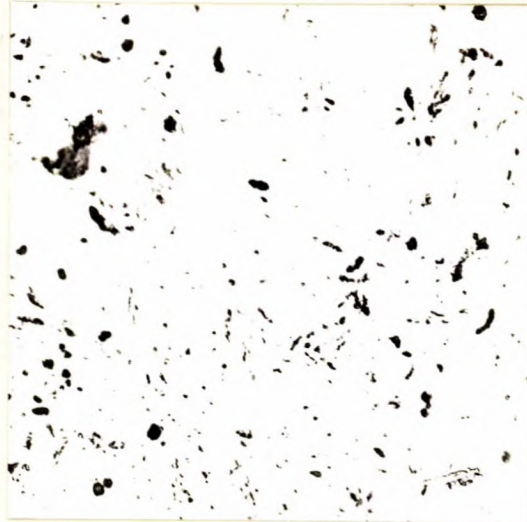
Figure 6.

The cases of the screws were examined for carbides. The good stock had no free carbides. Figure 6 shows the free carbides in the case of a defective screw.

FREE CARBIDES IN CASE OF DEFECTIVE SCREW.

Free carbides in a case, such as those shown in the case of a defective screw (Figure 8), are very detrimental, as

they lower both the impact and the fatigue strength of the part. Free carbides are caused by the rate of carburizing exceeding the rate of diffusion (from use of too active a carburizer, too high carburizing temperature, etc.).

6. The presence of free carbides in the case of some of the defective screws is a serious defect, from both the impact and fatigue standpoints.
7. There is evidence of a partial decarburization of the surface of the case of some of the defective screws, which would be detrimental to fatigue strength and also might lead to thread stripping on installation.

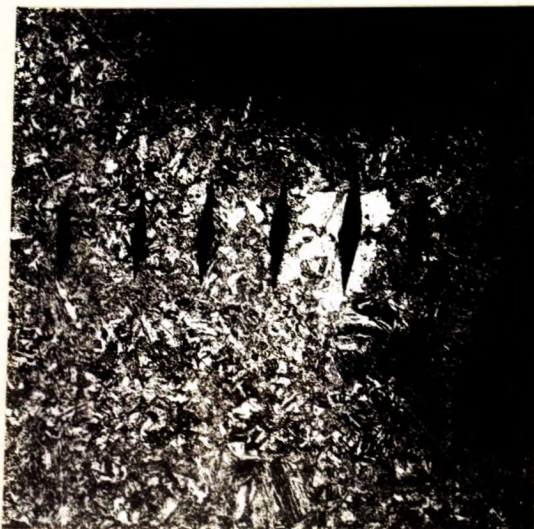
Figure 7.

Figure 7 shows the decarburized area below the case of a satisfactory screw. The hardness indentations of the Tukon tester show a hard case, a soft area of decarburization, and a hard core. Figure 8 shows how the hard case extends throughout the thread of one of the defective screws. It will be noted that the hardness indentations show a soft outer layer on the case in Figure 8.

X100, nital etch.  
DECARBURIZATION BELOW CASE  
OF SATISFACTORY SCREW.

<u>Satisfactory Screw</u> <u>(Figure 7)</u>	<u>Defective Screw</u> <u>(Figure 8)</u>
741	329
494	610
208	421
235	427
353	318
438	329
	274
	<u>281</u>

The decarburized area below the surface of the satisfactory screws (Figure 7) may act as a cushion for the case, and increase the toughness.

screws may help them to better resist the tapping forces.

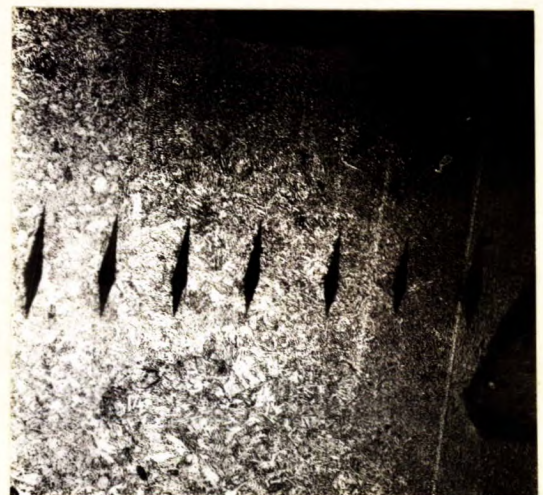
Figure 8.

X100, nital etch.  
SOFT OUTER LAYER OF CASE  
ON DEFECTIVE SCREW.

The soft surface of the case of one of the defective screws which failed by stripping of the thread is the result of either a partial decarburization or the presence of retained austenite. Both would be expected to lower the fatigue strength of the part. The case on this particular screw (Figure 8) is deeper and softer than that on the satisfactory article. Although thickening the case definitely leads to brittleness, it is thought that for this screw the effect would be cancelled out by the lower case hardness. Certainly, brittleness was not a factor in this thread stripping failure, which definitely occurred in installation. Low strength, probably brought about by decarburization, must have been responsible for this failure.
