O T T A W A June 28th, 1944.

R E P O R T
of the
ORE DRESSING AND METALLURGICAL LABORATORIES.

Investigation No. 1672.

Examination of Grizzly Tank Idler Wheel.

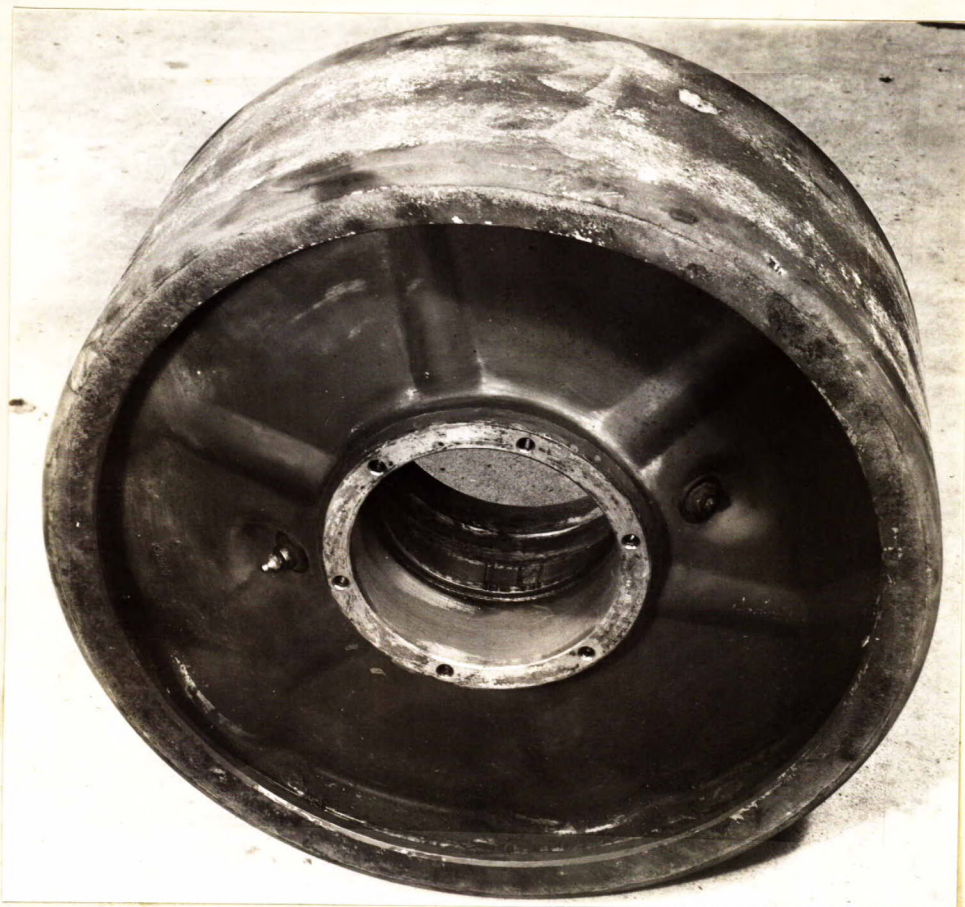
Figure 1.

GENERAL SHAPE OF IDLER WHEEL - AS RECEIVED.

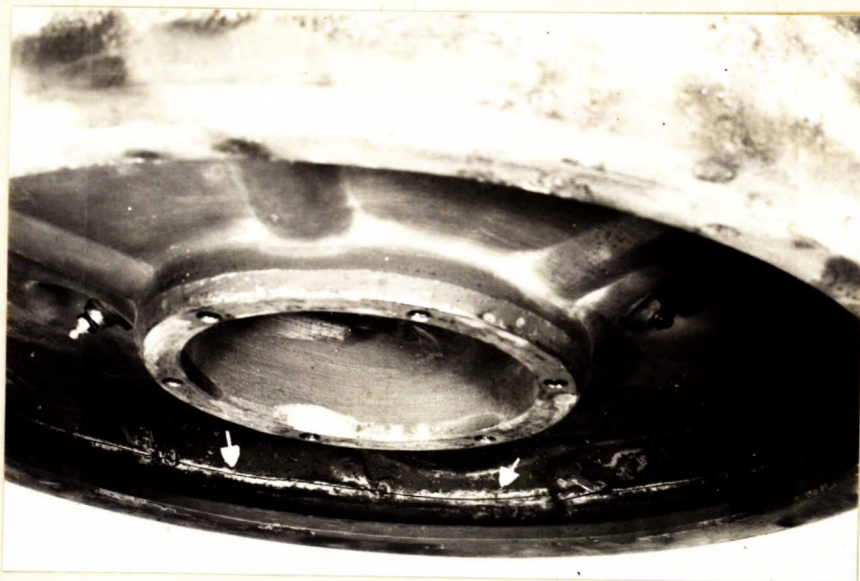
Figure 2.

A visual examination revealed that the disc-to-rim fillet weld had cracked around the complete periphery and that the disc-to-hub fillet weld on the opposite side (inside) of the wheel had also cracked around the complete periphery. An examination after sectioning showed that the fractured surfaces in both cases were very smooth and shiny, which is characteristic of fatigue failures of welds. It was also noted that by

CRACKED DISC-TO-RIM WELD.

Note that crack also runs through plug welds.

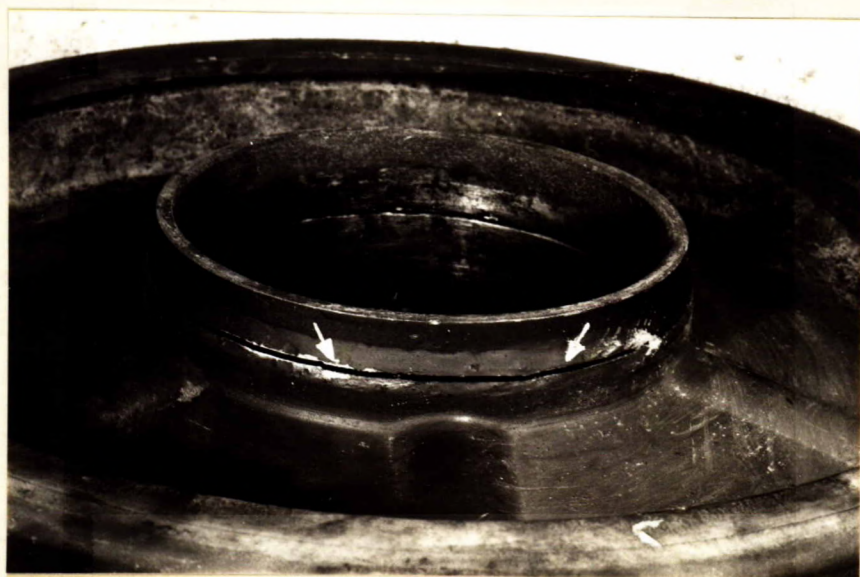
Figure 3.

CRACKED DISC-TO-HUB WELD.

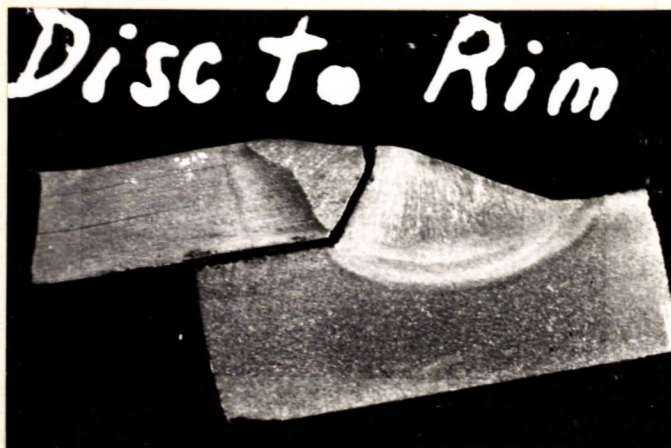
Figure 4.

MACRO SECTION OF DISC-TO-RIM WELD.

Note that crack runs through the root of the weld.

1. Every effort should be made to improve the welding technique used in making the plug welds.
2. Increased penetration at the roots of welds should be secured.

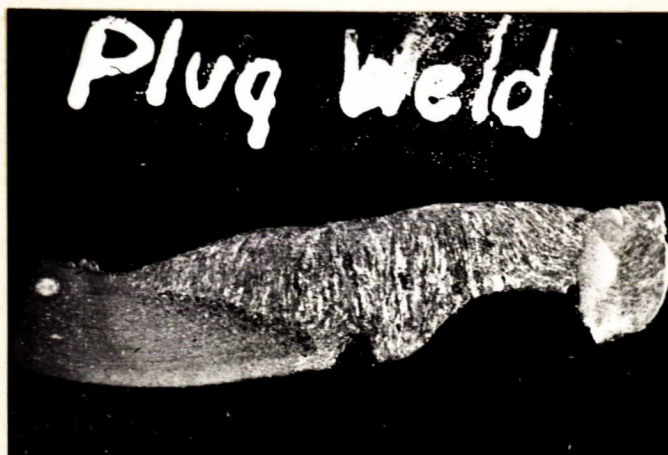
Figure 5.

far the great majority of the plug welds reinforcing the disc-to-rim weld were not fused at all to the rim but consisted of blobs of metal which in some cases towards the centre did not even touch the rim material. In other cases the centre of the weld adhered to the rim in the form of an icicle and fused to the disc only in a thin film.

The macro-examination shows that all welds are single-pass and penetration is generally fair. The cracked welds show no sign of distorted metal along the fractured edges, a further indication of fatigue. The plug weld (Figure 5) examined is of the type referred to above in which only a small part is fused to the rim, the remainder not touching the rim material. The welds joining the two halves of the hub are manifestly of a different type from the other welds. These welds show a lower penetration and considerable porosity.

TYPICAL SAMPLE OF PLUG WELD.

Note small area of fusion at left side.
Centre and right side of weld do not
touch the rim material.

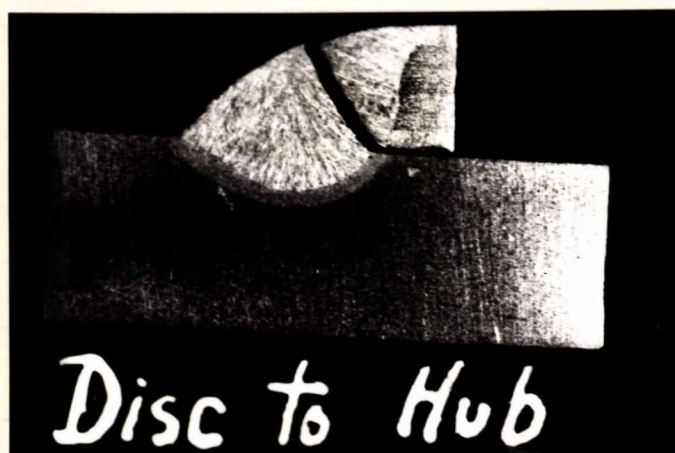
Figure 6.

MACRO SECTION OF DISC-TO-HUB WELD.

Note that crack runs through the root of the weld.

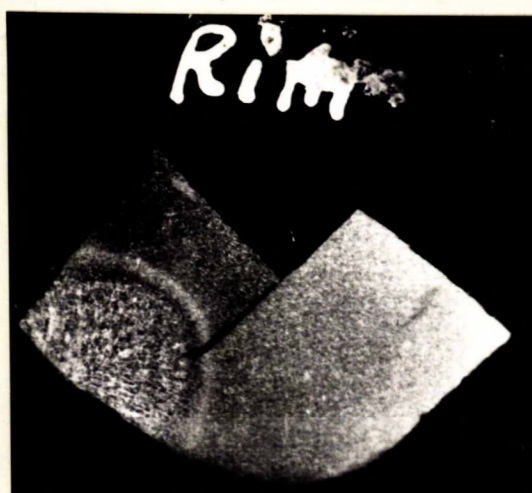
Figure 7.

MACRO SECTION OF RIM-TO-FLANGE WELD.

Note small area of incomplete penetration at root of weld.

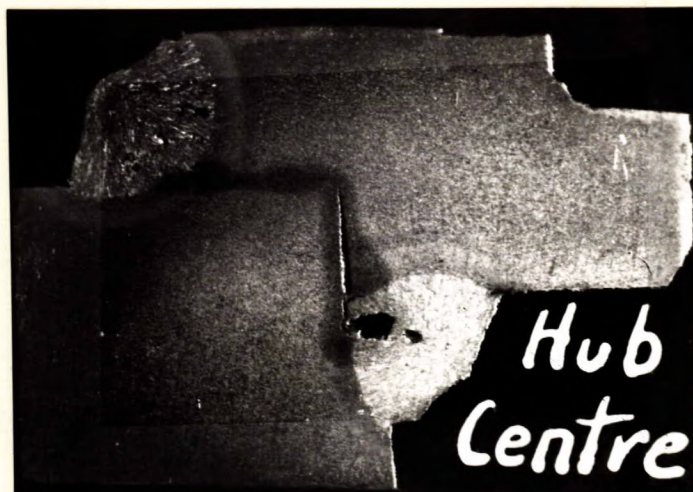
Figure 8.

WELDS JOINING TWO HALVES OF HUB.

Note considerable porosity.

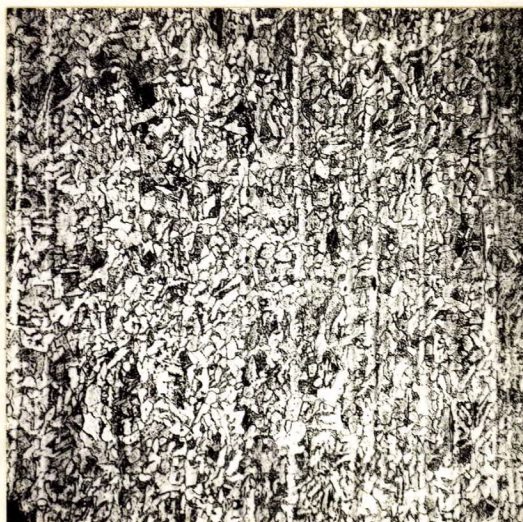
Figure 9.

STRUCTURE OF NORMAL DISC MATERIAL.

The typical banded structure of hot-rolled steel.

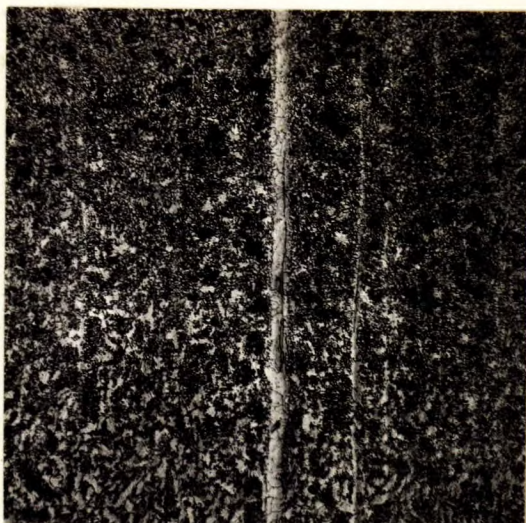
Figure 10.

STRUCTURE OF TRANSITION ZONE OF DISC MATERIAL.

Note banding around sulphide inclusions. Spheroidized pearlite in ferrite.

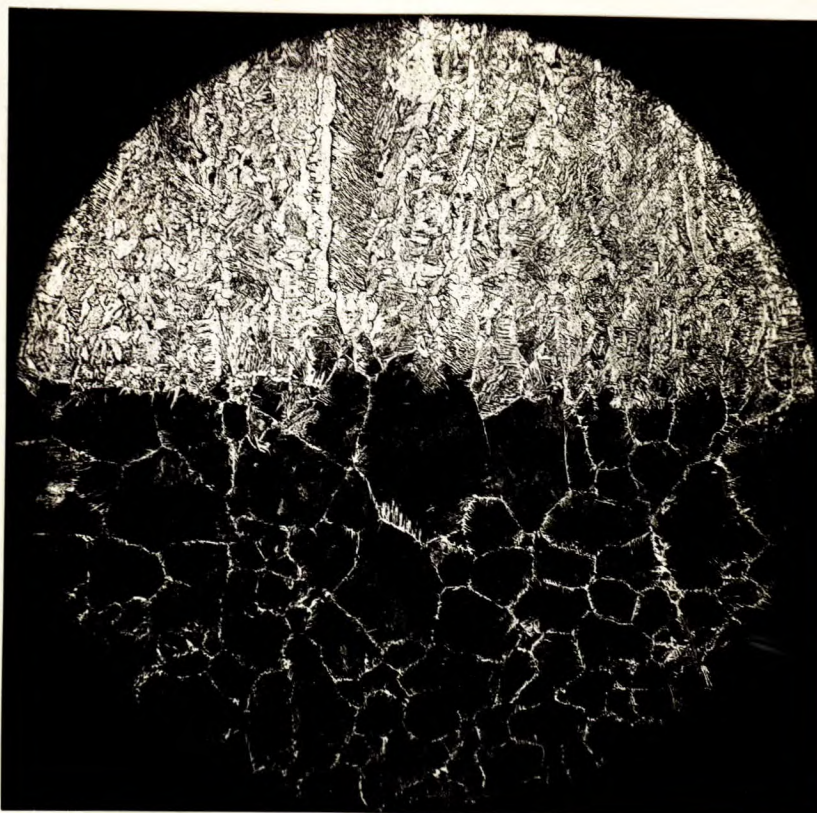
Figure 11.

STRUCTURE OF HEAT-AFFECTED ZONE AND
FUSION LINE OF DISC MATERIAL.

Coarse-grained pearlite with ferrite at grain boundaries.

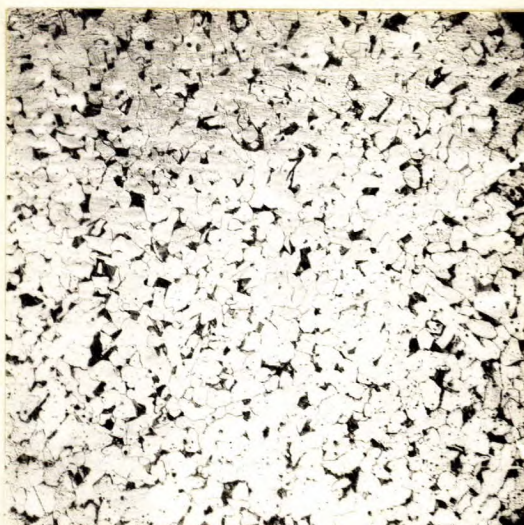
Figure 12.

STRUCTURE OF NORMAL RIM MATERIAL.

Annealed condition - pearlite
in a matrix of ferrite.

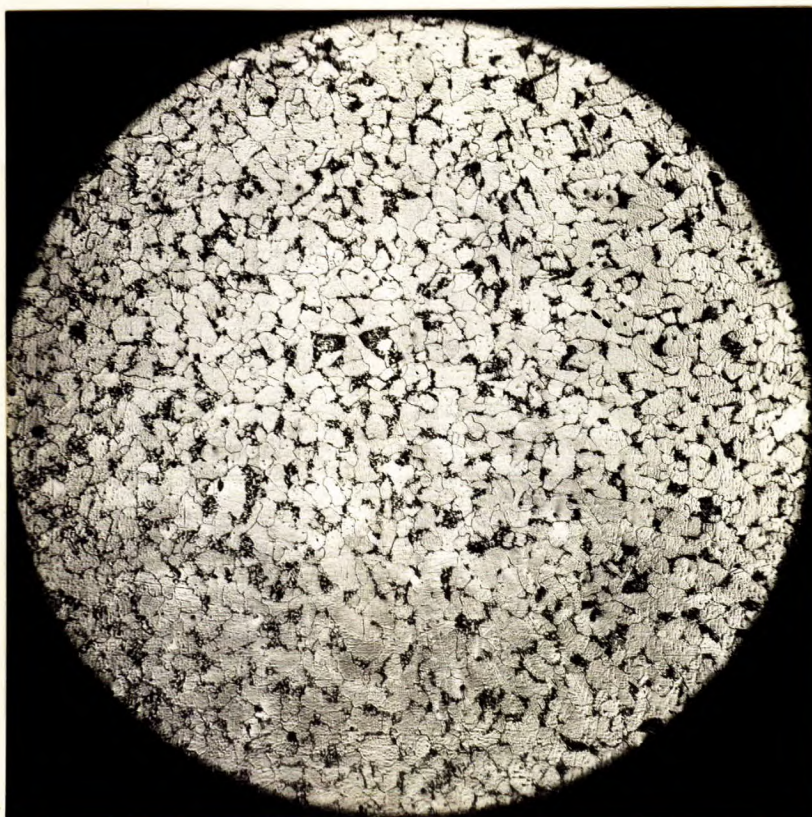
Figure 13.

STRUCTURE OF TRANSITION ZONE OF RIM MATERIAL.

Spheroidized pearlite in a matrix of ferrite.

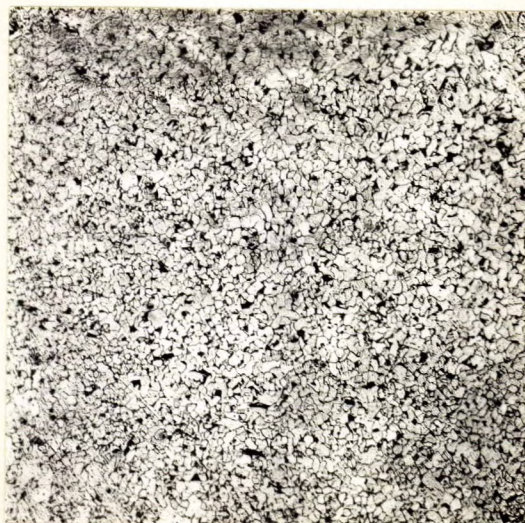
Figure 14.

STRUCTURE OF HEAT-AFFECTED ZONE OF RIM MATERIAL.

Note fine grain. Compare with Figure 12.
Pearlite in a matrix of ferrite.

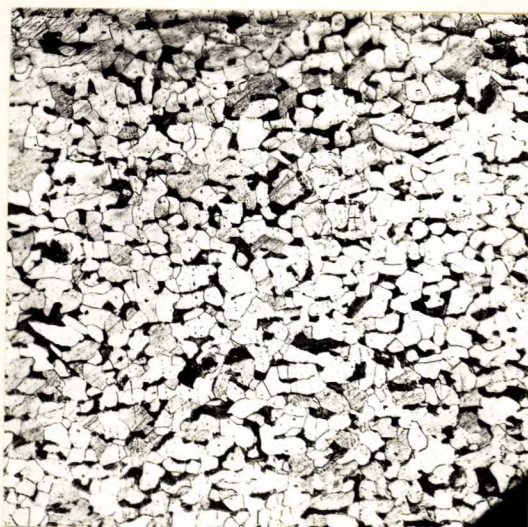
Figure 15.

STRUCTURE OF NORMAL HUB MATERIAL.

Annealed condition - pearlite
in a matrix of ferrite.

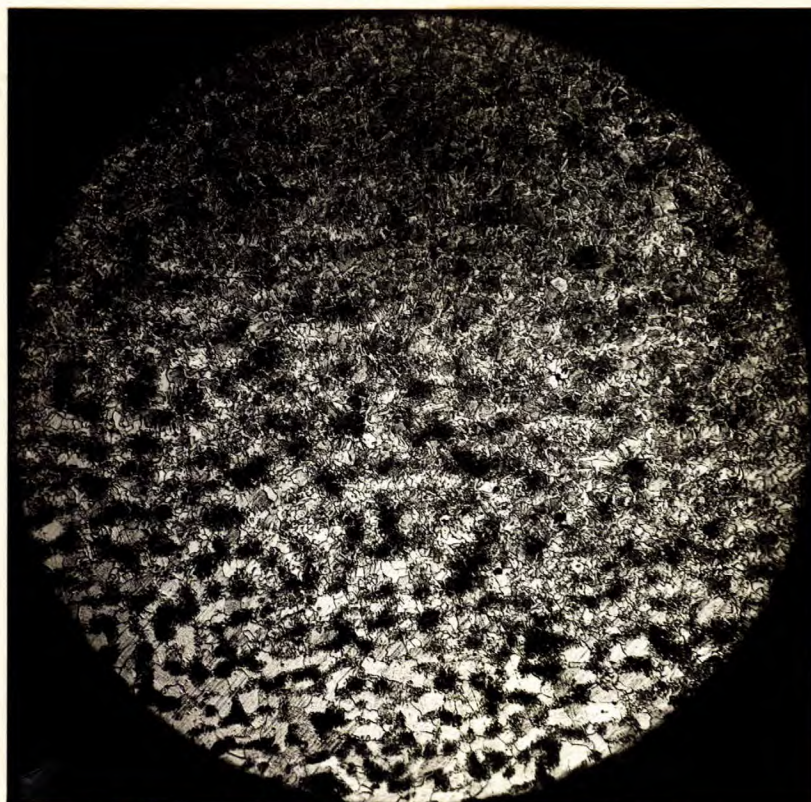
Figure 16.

STRUCTURE OF TRANSITION ZONE OF HUB MATERIAL.

Mostly spheroidized pearlite in a matrix of ferrite.

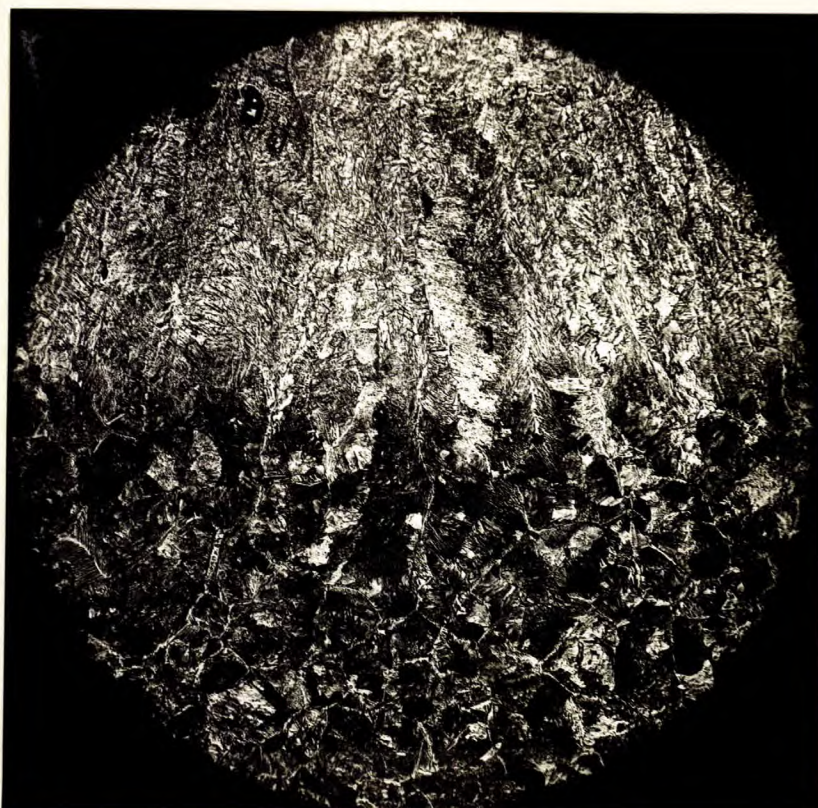
Figure 17.

STRUCTURE OF HEAT-AFFECTED ZONE AND
FUSION LINE OF HUB MATERIAL.

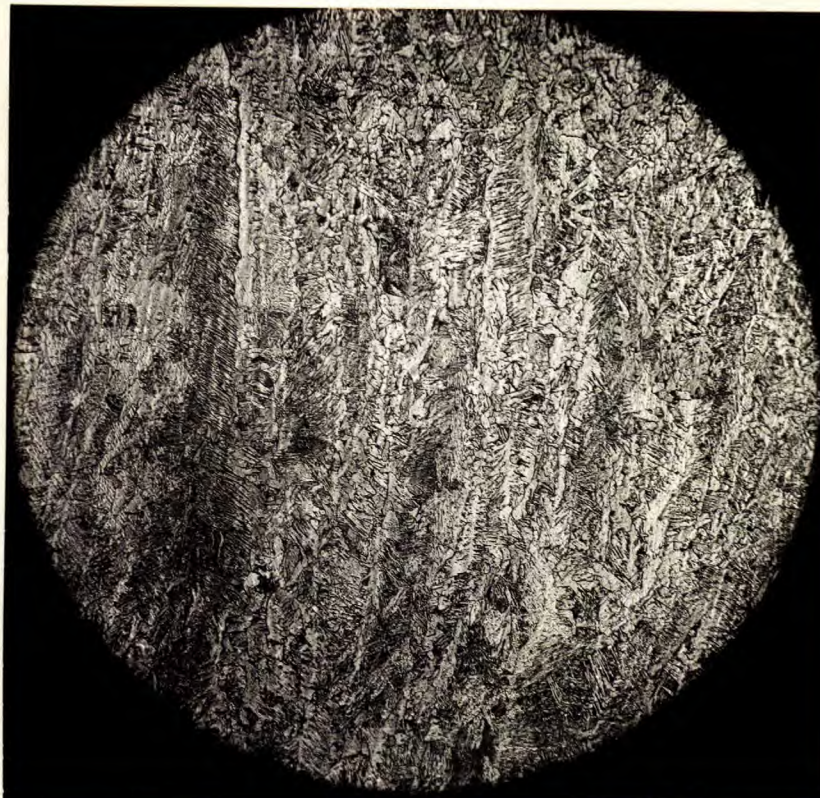
Figure 18.

STRUCTURE OF WELD METAL REPRESENTATIVE
OF ALL WELDS OTHER THAN HUB WELDS.

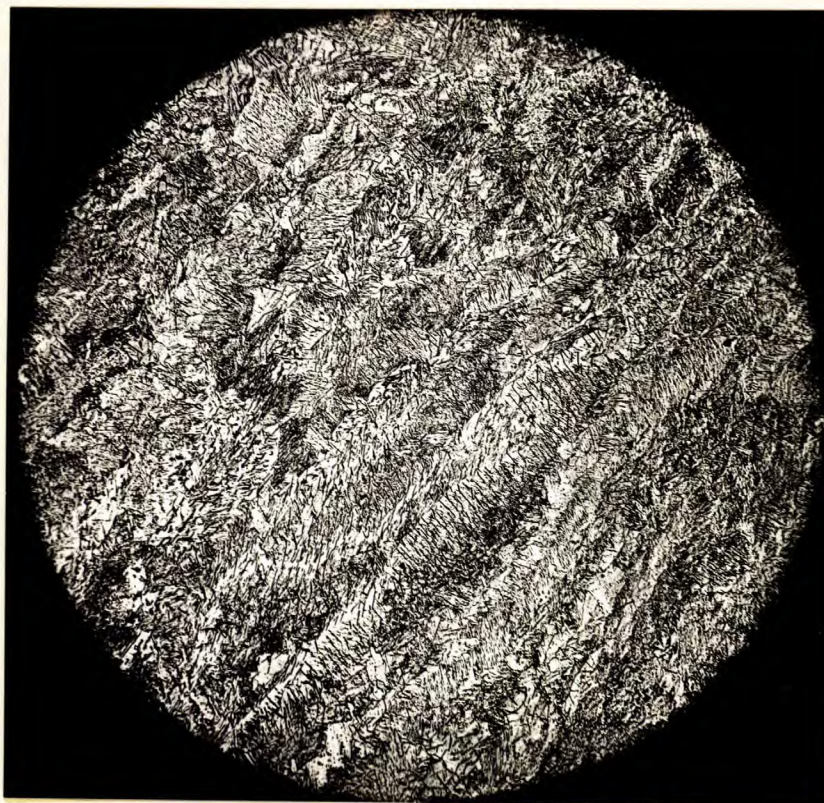
Figure 19.

A microscopic examination of the weld metal indicates the use of the standard coated electrodes for all welds but that joining the two halves of the hub. Here the porosity and needles of nitrides indicate the use of a bare or lightly

coated electrode.

STRUCTURE OF HUB WELD METAL.

Note black needles of nitrides, indicating use
of bare or lightly covered electrodes.

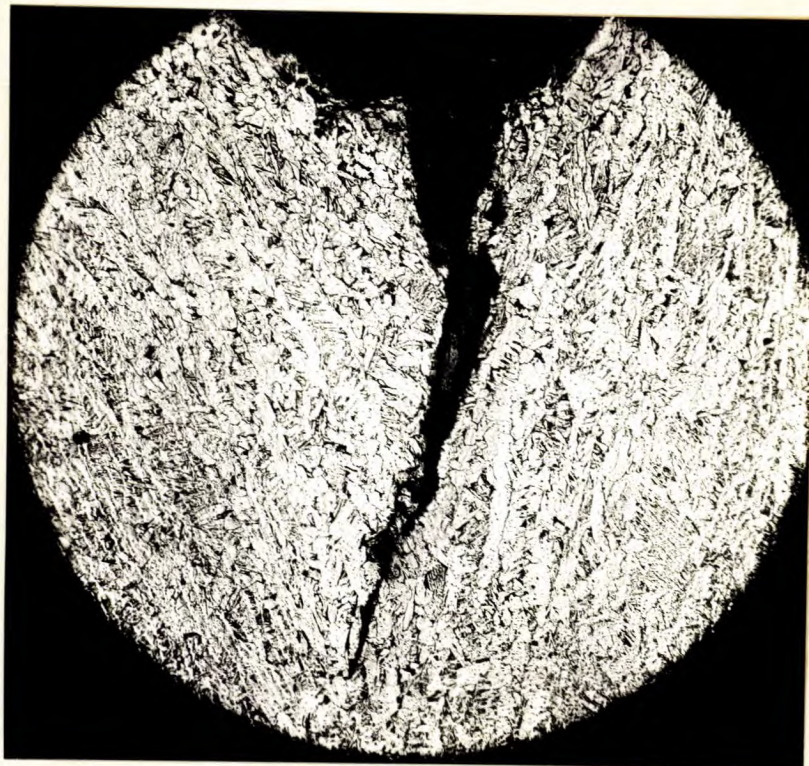
Figure 20.

Both the plug weld and rim-to-flange weld show small cracks. In the case of the plug weld, the crack originates in an area of lack of fusion at the root of the weld. In the rim-to-flange weld the crack has been caused by incomplete penetration at the root of the weld. Defects of this type act as severe stress raisers, with the result that the crack grows until it reaches the surface. The shiny surface of the fractured welds and the absence of distortion of the metal along the fractures point to failures as originating from this type of defect.

CRACK AT ROOT OF RIM-TO-FLANGE WELD, ORIGINATING
IN AN AREA OF INCOMPLETE PENETRATION.

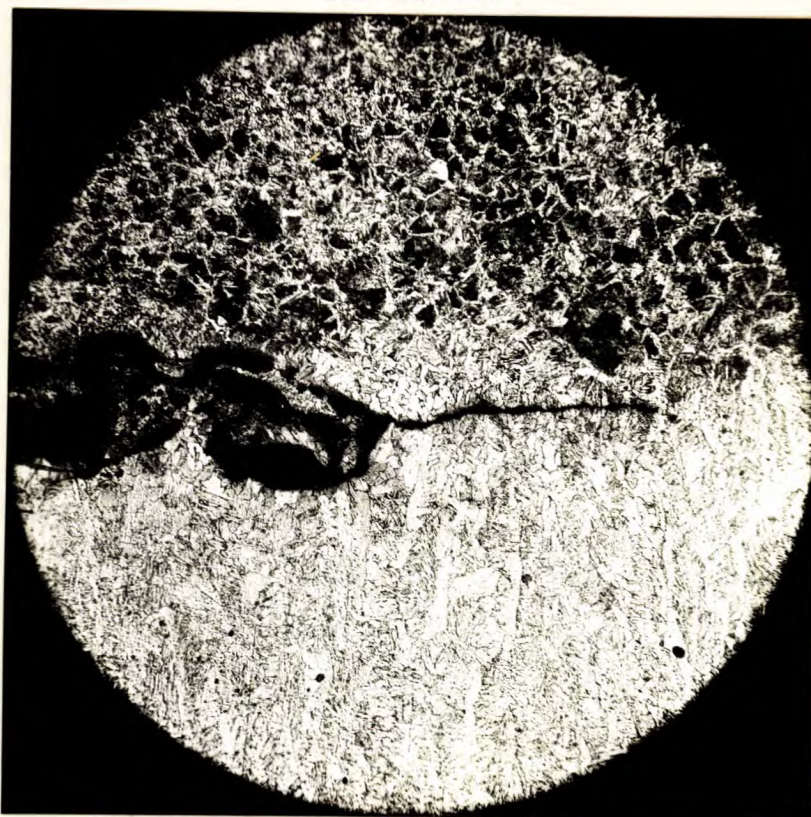
Figure 21.

CRACK CLOSE TO FUSION LINE OF A PLUG WELD.

Crack originating in an extensive area of
lack of fusion.
