July 3rd, 1944.

Investigation No. 1674.

Metallurgical Examination of Cam Shaft and
Injector Rolls from Cummins Diesel Engine.

Bureau of Mines
Division of Metallic
Minerals
Physical Metallurgy
Research Laboratories

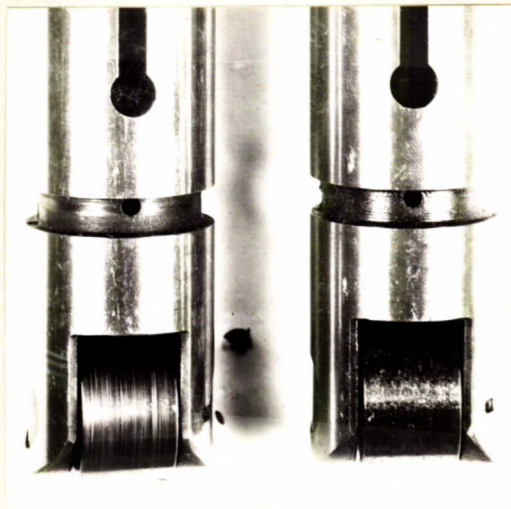
Figure 2.

INJECTOR ROLLS FROM DIESEL ENGINE.
(Approximately 3/4 actual size).

Note scored roller on right.

The microstructure of the injector rolls, shown in Figures 8, 9 and 10, i.e., martensite and finely distributed iron-chromium carbides, is normal for a steel of this composition, the distribution of the carbides being very satisfactory. Therefore, it may be concluded that the slight spalling in some of the rolls is due to the irregular wear of the broken portions of the cam shaft on the surface of the rolls.

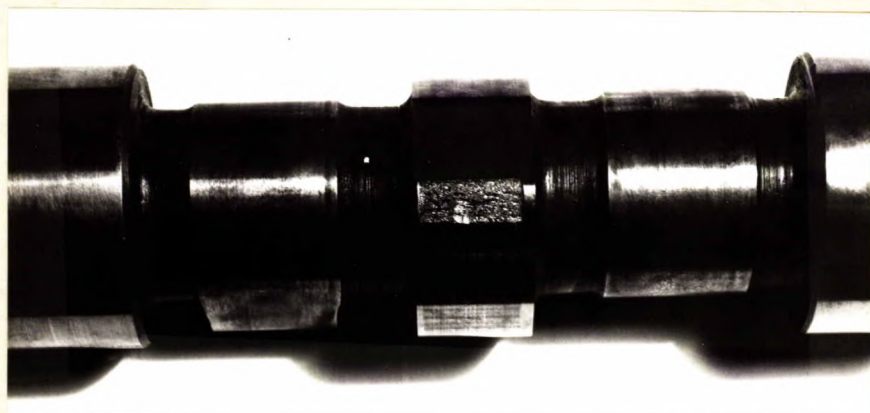
Figure 3.

out that there were areas (see Figure 3) in which the case had broken away from the core. The following tests were desired:

CAM SHAFT.

Note broken case at centre.

The presence of the large quantities of coarse carbides would indicate that the carbon content of the case is considerably above the eutectoid proportion. This is undoubtedly responsible for the failure of the case. The excess carbon has resulted from the use of a carburizer which is too highly energized.

1. It is recommended that the cam shafts be given a carburizing treatment which would result in a case whose carbon content is not greater than the eutectoid proportion. This may be accomplished by packing in a carburizer containing less energizer than that in use at present.

2. It is recommended that cam shafts which have thick cases, and particularly those whose cases contain large amounts of free carbides, be subjected to a diffusion treatment after carburizing and before hardening. This may be accomplished by heating in a furnace for two hours under a neutral atmosphere at the carburizing temperature, or by packing the shafts in old, used carburizer and heating for the same period of time. The parts are then cooled in air, and this is followed by the regular hardening operation.

It is suggested that consideration be given to the shotblasting of the shafts after machining, in order to increase their fatigue strength.

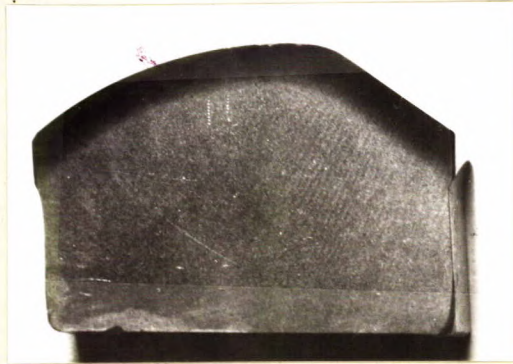
Figure 4.

polished, etched in nital, and examined for case depth. The case depth measured approximately 0.08 inch.

SECTION FROM CAM SHAFT,
SHOWING DEPTH OF CASE.

The depth of the case, 0.08 inch, may be considered satisfactory, since the minimum case depth specified for cam shafts is 0.06 inch. The depth of case would indicate that the cam shaft probably has been carburized by the "pack carburizing" method.

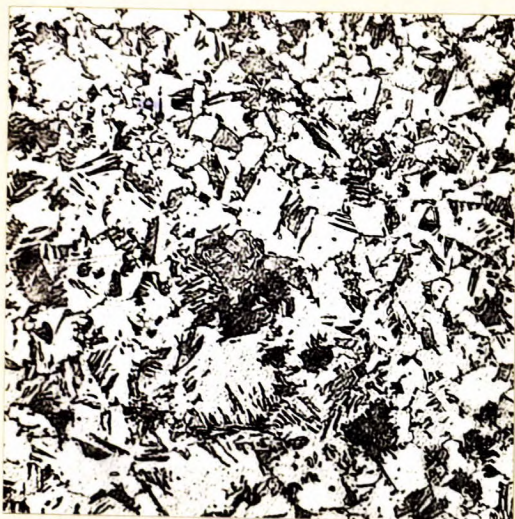
Figure 5.

MICROSTRUCTURE OF
CORE OF CAM SHAFT

The microstructure of the core consists of fine pearlite and ferrite, whereas that of the case is martensite and coarse carbides. Hence it may be concluded that the cam shaft was cooled fairly slowly from the carburizing temperature, probably by removing the boxes from the furnace and permitting the shafts to cool to room temperature in the carburizing boxes. The shafts were next heated to above the critical range of the case and then quenched, resulting in a case the average hardness of which is 59 Rockwell 'C'.

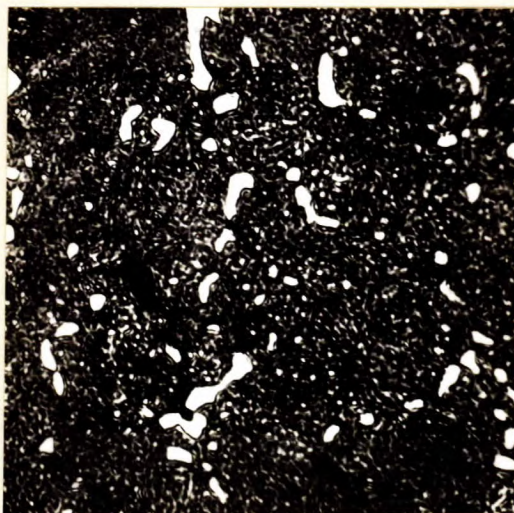
Figure 7.

SHOWING EXCESS CARBIDES
IN CAMSHAFT CASE.

However, it is possible to eliminate the deleterious effect of the too severe carburization by subjecting the steel to a diffusion treatment after carburizing. The diffusion treatment should be sufficiently long to lower the carbon content of the case approximately to the eutectoid composition.

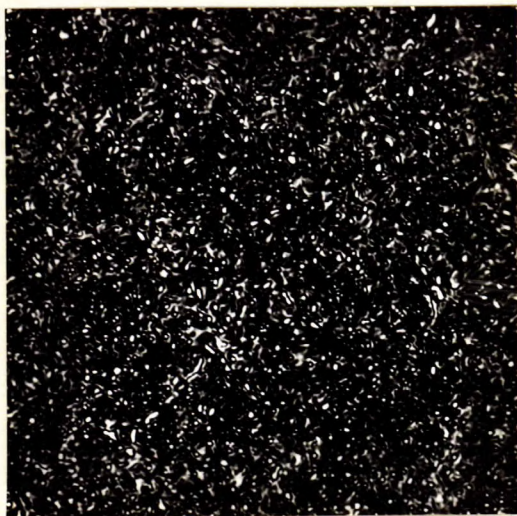
Figure 8.

MICROSTRUCTURE OF
INJECTOR ROLLS.

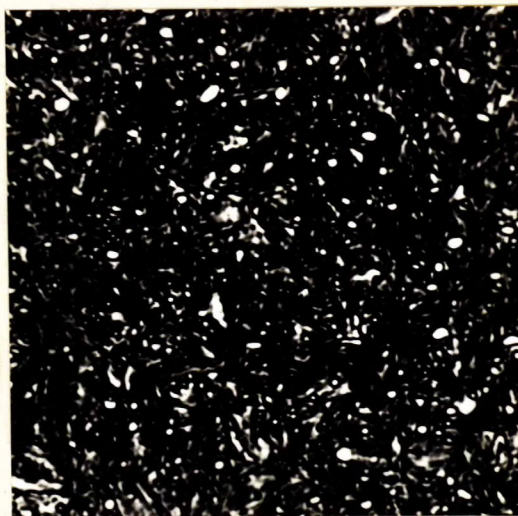
Figure 9.

MICROSTRUCTURE OF
INJECTOR ROLLS.

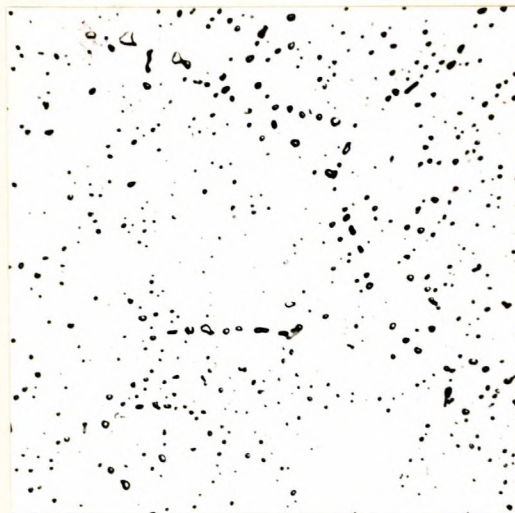
Figure 10.

SHOWING DISPOSITION OF
IRON-CHROMIUM CARBIDES
IN ROLLS.
