July 10th, 1944.

ORE DRESSING AND METALLURGICAL LABORATORIES.

Investigation No. 1676.

Examination of Defective Bronze Spigots
and Steel Studs from H.M.C.S. Amherst.

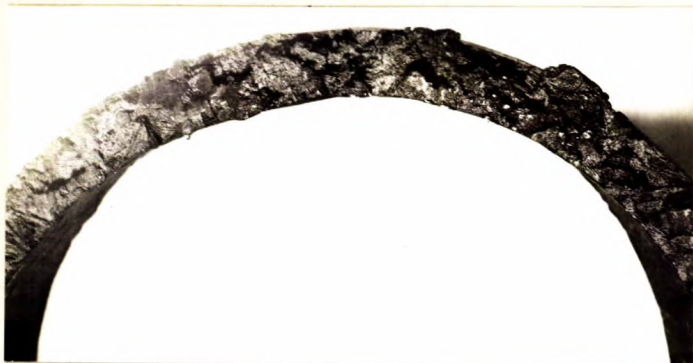
Figure 1.

Both castings appeared to be free from surface imperfections. However, it will be noted, in Figure 2, that the wall thickness of the scum valve spigot is greater on one side than on the other. Both fractures were coarse grained. The fractures were covered with an oxide film which made it impossible to tell the condition at the time of failure.

NO. 1 BOILER SAFETY VALVE SPIGOT.

The irregular wall thickness and the unsoundness of the metal in the scum valve spigot casting are due to serious moulding defects and might account for the failure of this casting. The slight porosity and the high lead content observed in the No. 1 Boiler safety valve spigot are only minor defects, however, and under normal operating conditions this casting should have proved satisfactory.

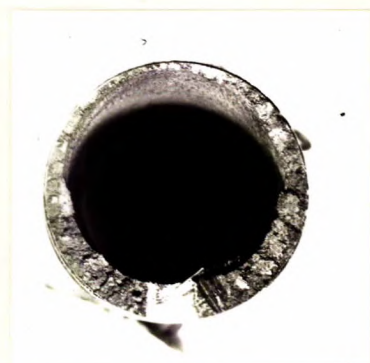
Figure 2.

NO. 1 BOILER SCUM VALVE SPIGOT.

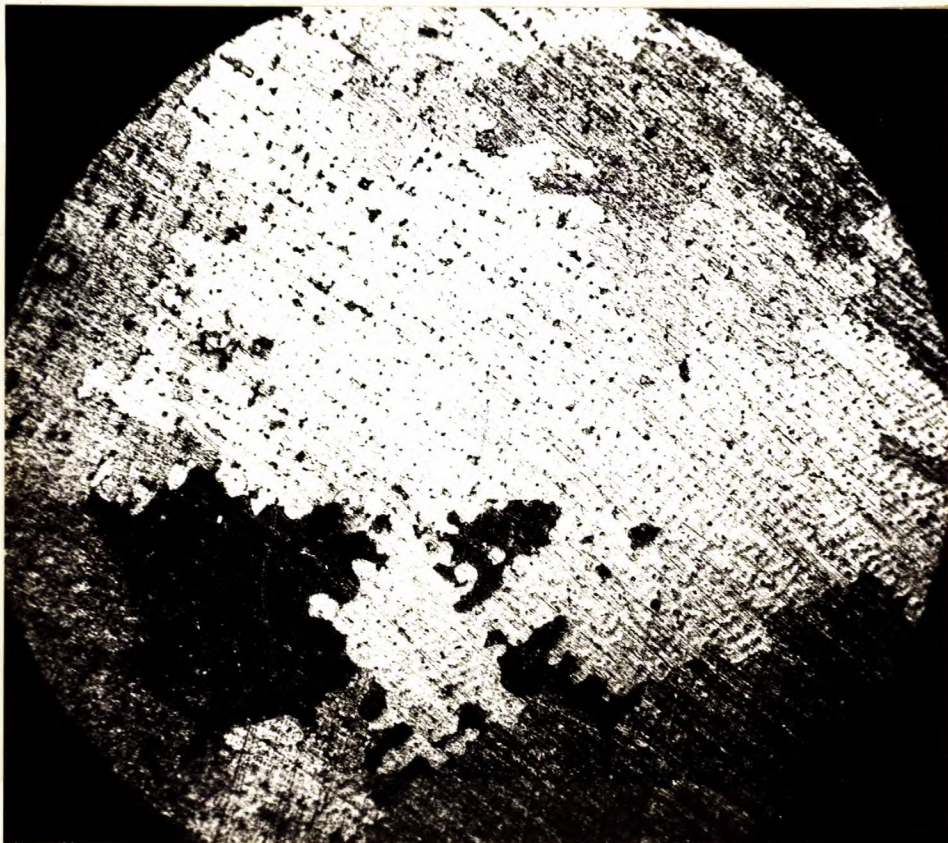
Figure 3.

Both specimens had a coarse-grained structure characteristic of cast bronze. Although slight porosity was observed in it, the No. 1 Boiler safety valve spigot was, on the whole, composed of fairly sound metal. The scum valve spigot, however, was quite porous. The respective structures of these materials are illustrated in Figures 3 and 4.

SHOWING A POROUS SECTION AND COARSE-
GRAINED STRUCTURE OF NO. 1 BOILER
SAFETY VALVE SPIGOT.

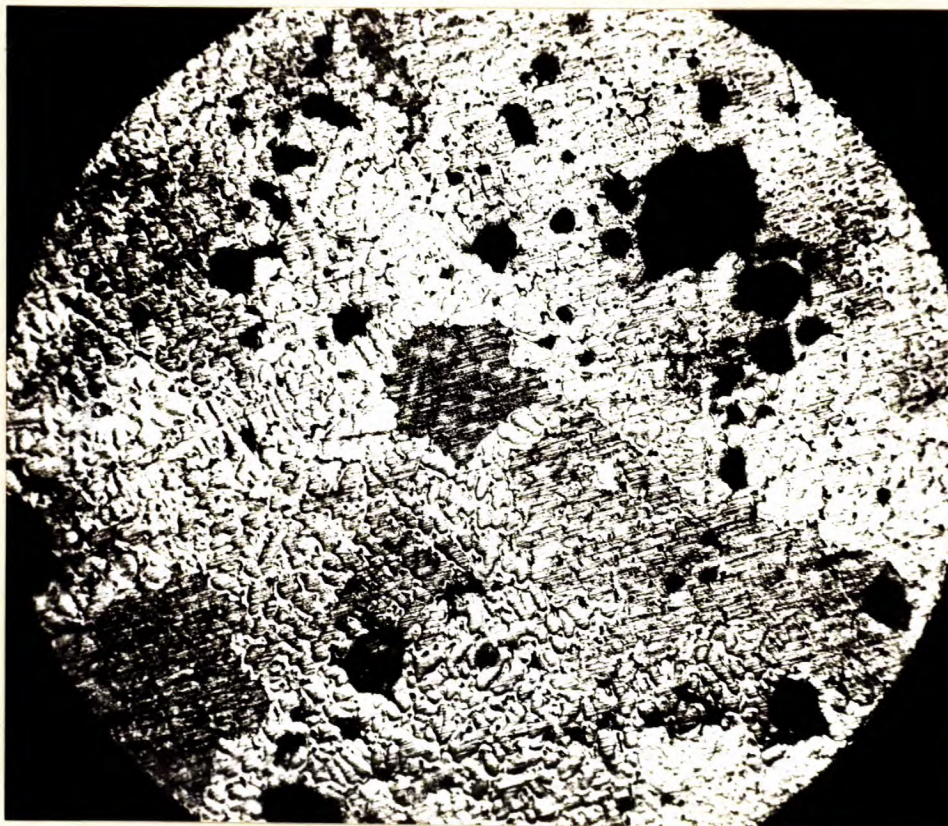
Figure 4.

SHOWING POROUS SECTION AND COARSE-
GRAINED DENDRITIC STRUCTURE OF
SCUM VALVE SPIGOT.

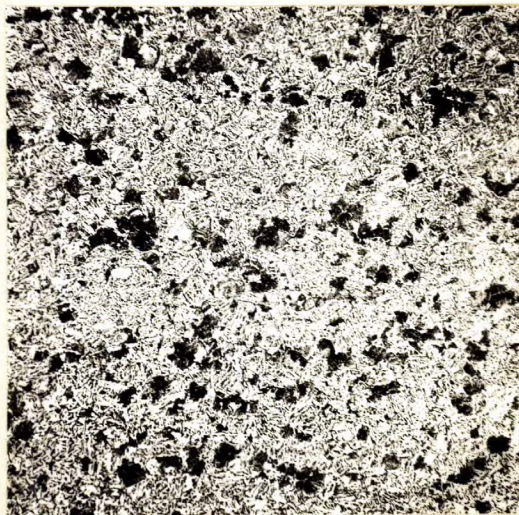
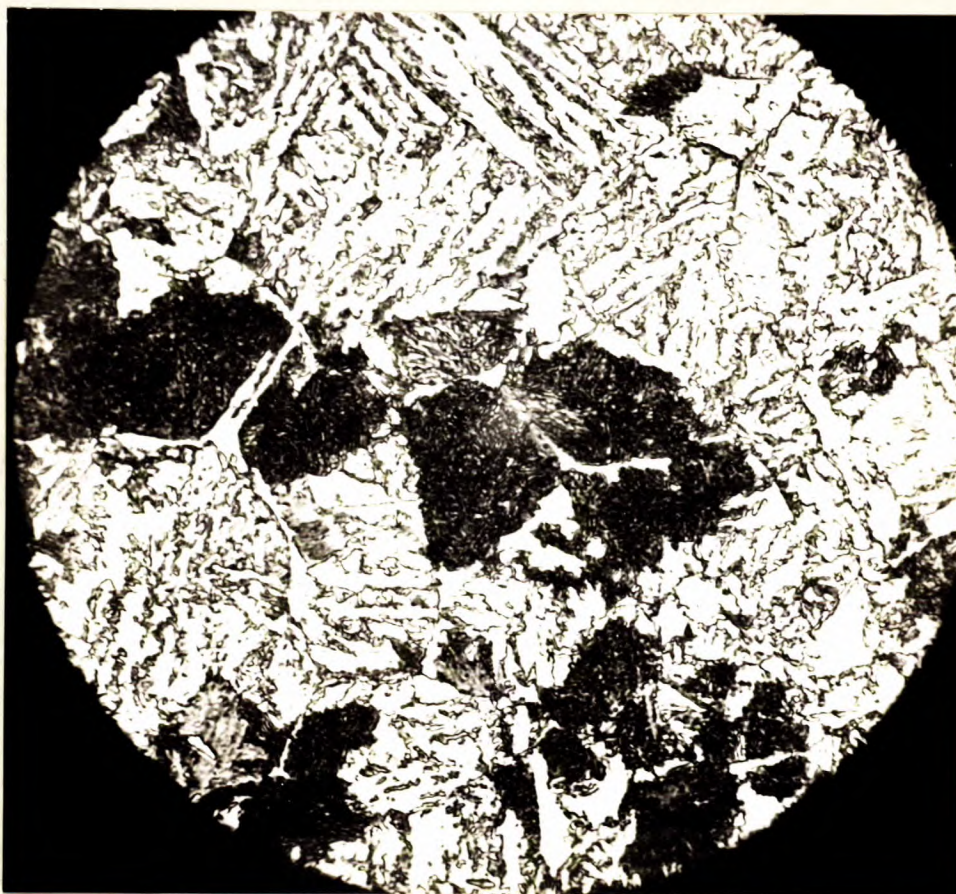
Specimens of the studs in the "as received" and "heat treated" conditions were polished, etched in 2 per cent nital, and examined microscopically. The structure of the steel in the "as received" condition is shown in Figures 5 and 6 and consists of large areas of free ferrite and fine pearlite, together with dark etching areas of sorbitic pearlite. The nital-etched structure of the steel after heat treating is

STEEL NO. 7, "AS RECEIVED".

The microscopic examination showed a large amount of free ferrite to be present, which would indicate that the quenching rate was too low. This was confirmed by experimental heat-treatments, carried out on several of the studs, which showed that with proper heat treatment, free ferrite could be eliminated and high impact values obtained by a quench in water from 1525° F. and a draw at 1100° F. The steel was quenched in oil from the draw, as SAE 3130 steel is subject to temper brittleness. The tempered material had a Brinell hardness of 269. SAE 3130 steel of this hardness should have the following mechanical properties:

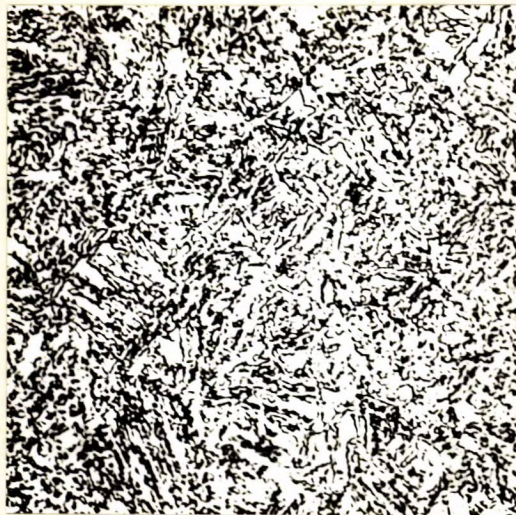
shown in Figure 7. The structure consists of tempered martensite.

STEEL NO. 3, "HEAT-TREATED".

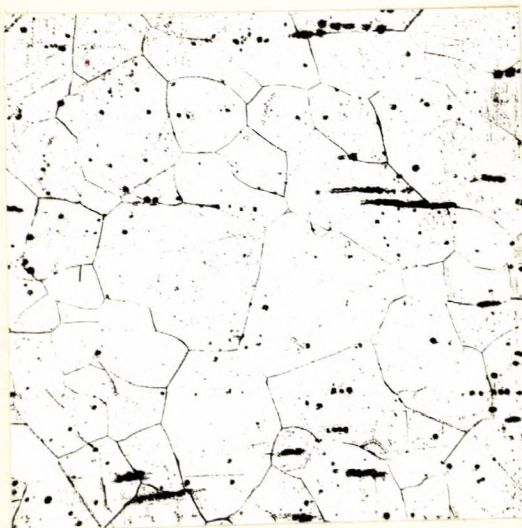
Figure 8.

The nital-etched structure of Steel 8 (Figure 8) consists essentially of fairly large grains of ferrite and long stringers of sulphide inclusions.

UNALLOYED, LOW-CARBON STEEL STUD NO. 8.

The steel studs were found to have a composition similar to that of an SAE 3130 steel, a medium-carbon, low-alloy nickel-chromium steel. Steel No. 8 is one exception, as it was found to be an unalloyed low-carbon steel. Steels Nos. 1 to 7 were all heat-treated to approximately the same hardness. Apart from the low impact values, mechanical properties are considered generally satisfactory.
