ORE DRESSING AND METALLURGICAL LABORATORIES.

Investigation No. 1677.

Examination of Broken Bolts from Snowmobile Track.

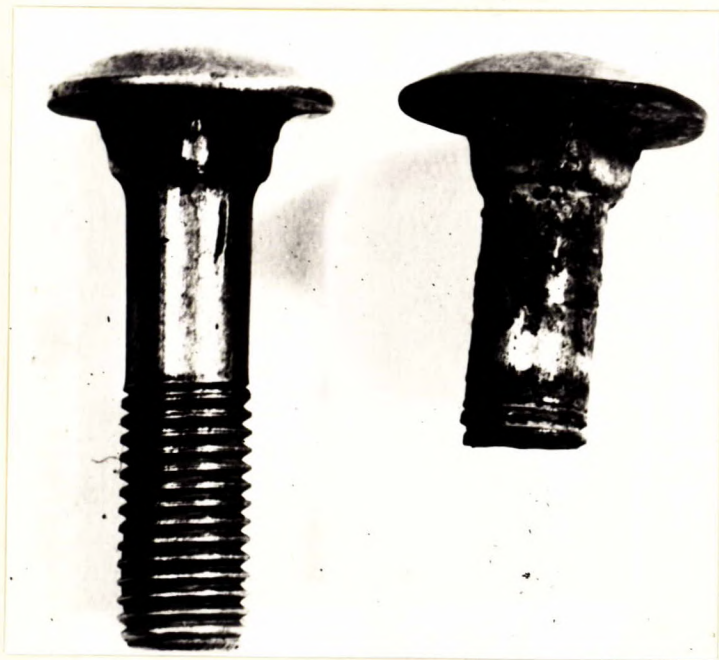
Figure 1.

The bolts are of the rolled-thread type. The point of failure was located at the second thread in all specimens, and fractures are of the duplex type typical of fatigue failures. (See Figures 1 and 2).

BROKEN AND UNBROKEN BOLTS.

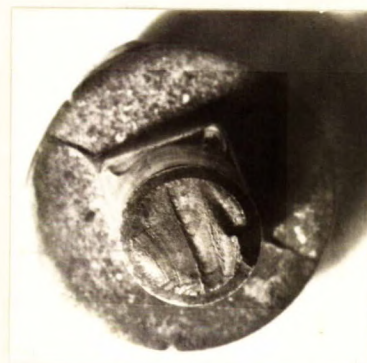
Figure 2.

FATIGUE-TYPE FRACTURE.

The bolts have a chemical composition which meets S.A.E. 1035 specifications, and are suitably heat-treated to the specified hardness (200-260 Brinell). The fractures at the points of failure show that breaking is caused by fatigue as the result of relatively high alternating stresses. This is further substantiated by the fact that the bolts had withstood 800 miles of service and then started to fail in considerable numbers. These bolts, being of the rolled-thread type and free from decarburization, have a fatigue limit which approaches the optimum for their present hardness. No metallurgical

defects were discovered. Consequently, it is concluded that the bolts did not have the strength required to resist the alternating service stresses.

1. A bolt of higher hardness could be expected to have a higher fatigue life, consequently bolts with a hardness of from 300 to 350 Brinell should be tried on the vehicle. If these bolts fail more rapidly in fatigue, a softer bolt than used at present would likely give better service.
2. The possibilities of surface treatments should be investigated.
3. A laboratory fatigue test should be developed that will give a measurement of the fatigue life of the bolts.
4. Conditions of assembly in the field should be investigated, to eliminate as much of the alternating stresses as possible. This may be accomplished by increasing bolt tension but may also involve design changes.

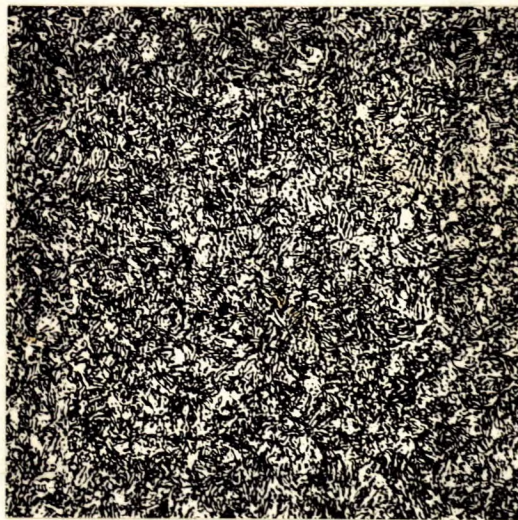
Figure 3.

Microscopic examination of bolts sectioned longitudinally revealed a homogeneous sorbitic structure (see Figure 3, a photomicrograph at X250 magnification). Careful examination of all surfaces failed to show any decarburization.

MICROSTRUCTURE OF BOLT.
