July 14th, 1944.

ORE DRESSING AND METALLURGICAL LABORATORIES.

Investigation No. 1678.

Examination of Armoured Snowmobile Sprockets.

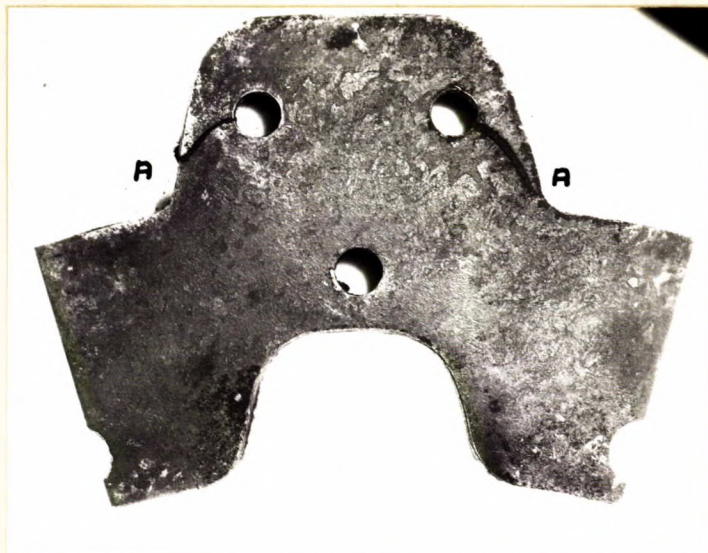
Figure 1.

One tooth was chosen at random from each sprocket and magnafluxed. In all three, quench cracks of varying severity were observed. Some cracks ran from the wearing surface to the rivet holes (at A in Figure 1), while others ran along the wearing faces (see B in Figure 2) and along the root of the tooth (at C in Figures 2, 3 and 4). The cracks were most severe in Sprocket C.

SPROCKET C.

The absence of ferrite in the hardened zone indicates that quenching conditions were satisfactory. Quenching cracks, which would prove serious in service, might be avoided by pre-heating prior to flame hardening.

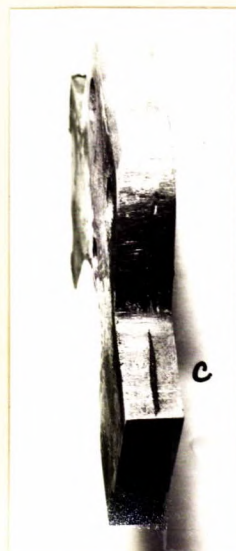
Figure 3.

SPROCKET C.

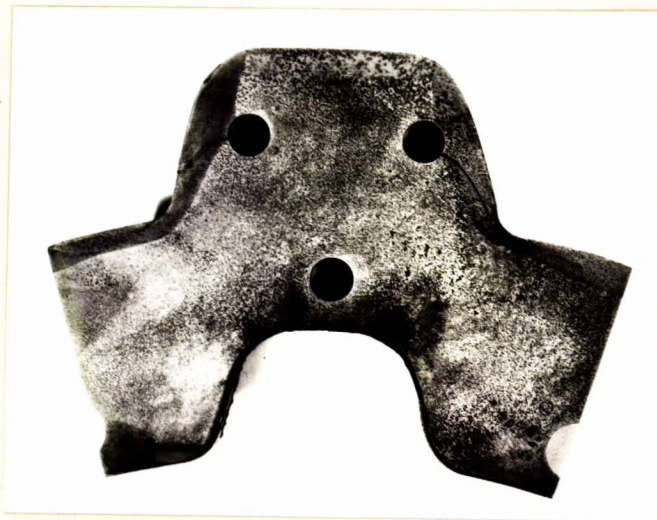
Figure 5.

A 5 per cent nital etch was used to bring out the hardened zone. On only one of the three teeth was the flame-hardening satisfactory as to depth of hardened zone (see Figure 5).

SPROCKET C.

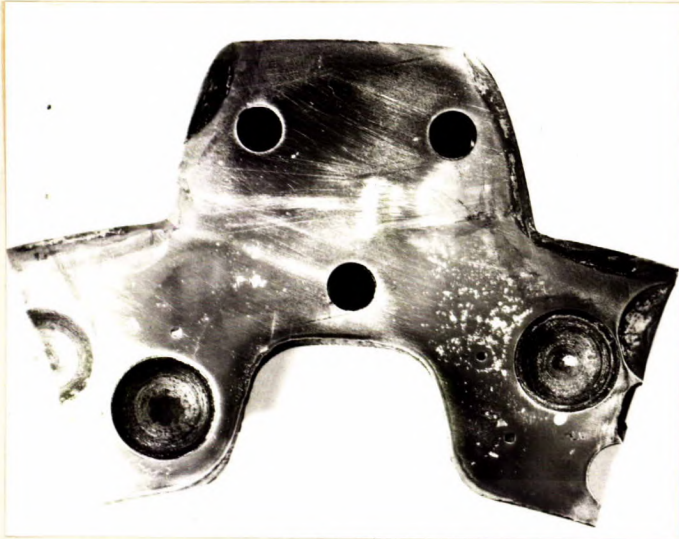
Figure 6.

On a tooth taken from each of the other two sprockets, the hardened zone was discontinuous and too shallow (see Figures 6 and 7).

SPROCKET B.

The excessive wear is due to the shallow and discontinuous flame-hardened zones. This, in turn, is due to lack of control in the flame hardening process. It is strongly recommended that the process be investigated with a view to improving the control.

A thorough study of the flame-hardening process is recommended, with a view to improving the control on the operation.

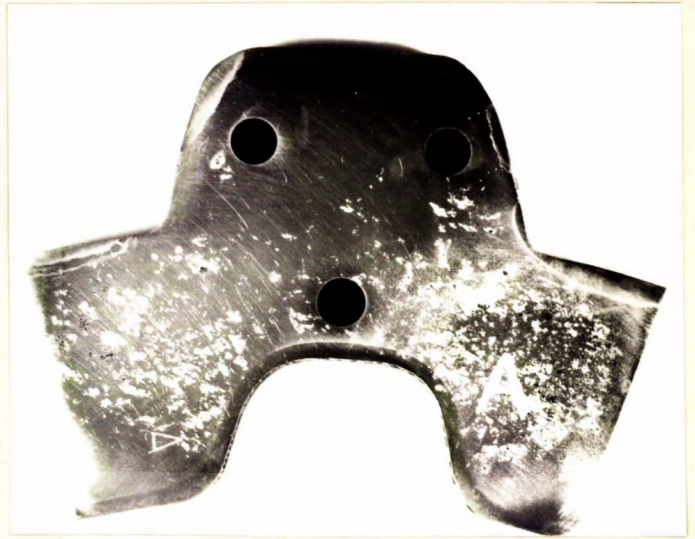
Figure 7.

SPROCKET A.

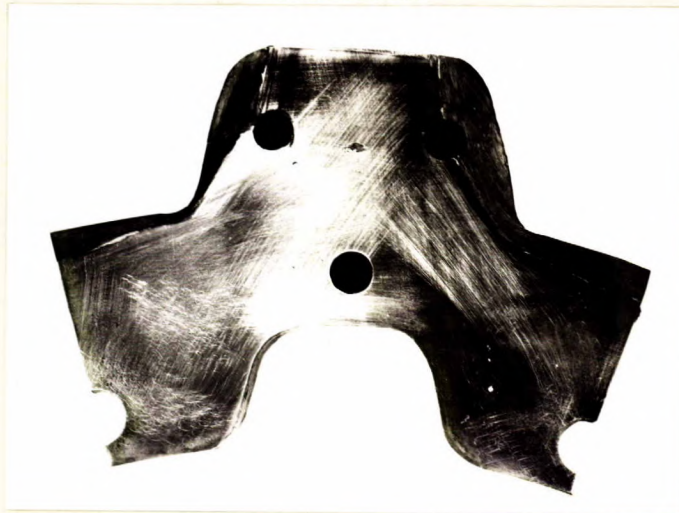
Figure 8.

Another tooth was cut from Sprocket C and examined. This proved satisfactory on only one side (Figure 8).

SECOND TOOTH FROM SPROCKET C.

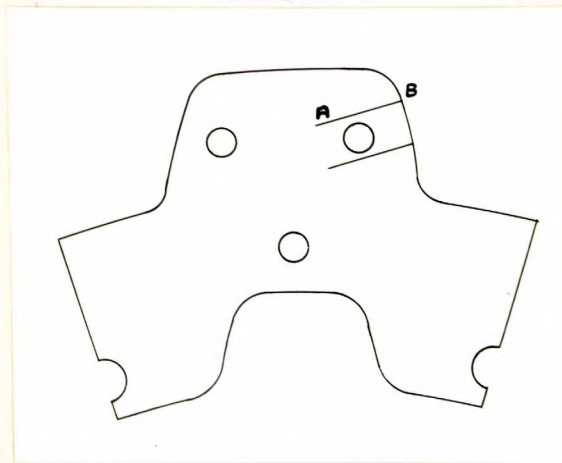
Figure 9.

Hardness surveys were made with the Vickers hardness tester, along line AB as shown in Figure 9; they corroborated the evidence obtained from the macro-examination. The results, converted to the Rockwell "C" scale, are shown in Table I.

the hardened zone is too shallow in A and B, while it is too deep in C.

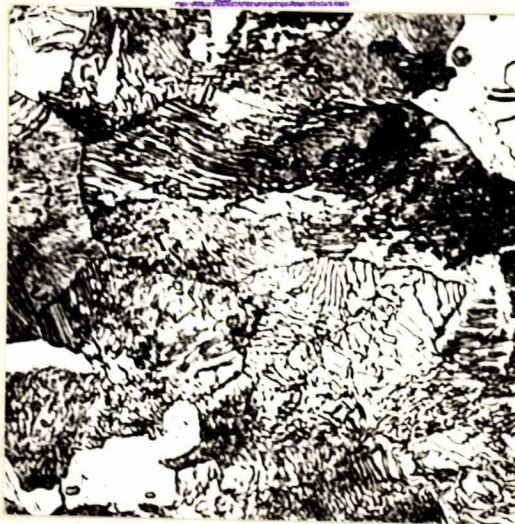
Figure 10.

Microscopic examination showed the interior of the sprocket to consist of pearlite and pro-eutectoid ferrite (see Figure 10), while the hardened zone varied from martensite at the surface (Figure 11) to sorbite and troostite near the transition zone.

INTERIOR OF SPROCKET.

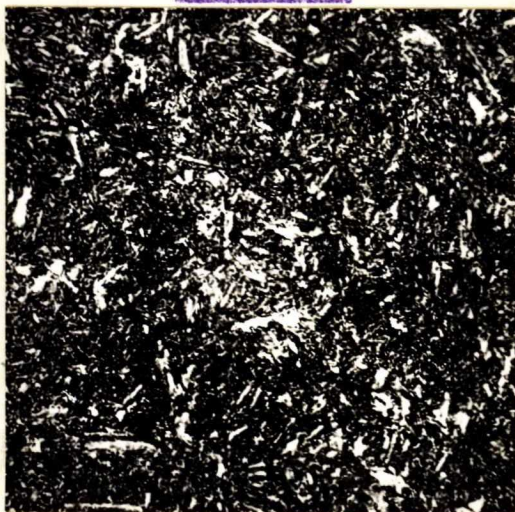
Figure 11.

HARDENED ZONE NEAR SURFACE.
