July 17th, 1944.

ORE DRESSING AND METALLURGICAL LABORATORIES.

Investigation No. 1679.

Examination of Welds of German Scout Car.

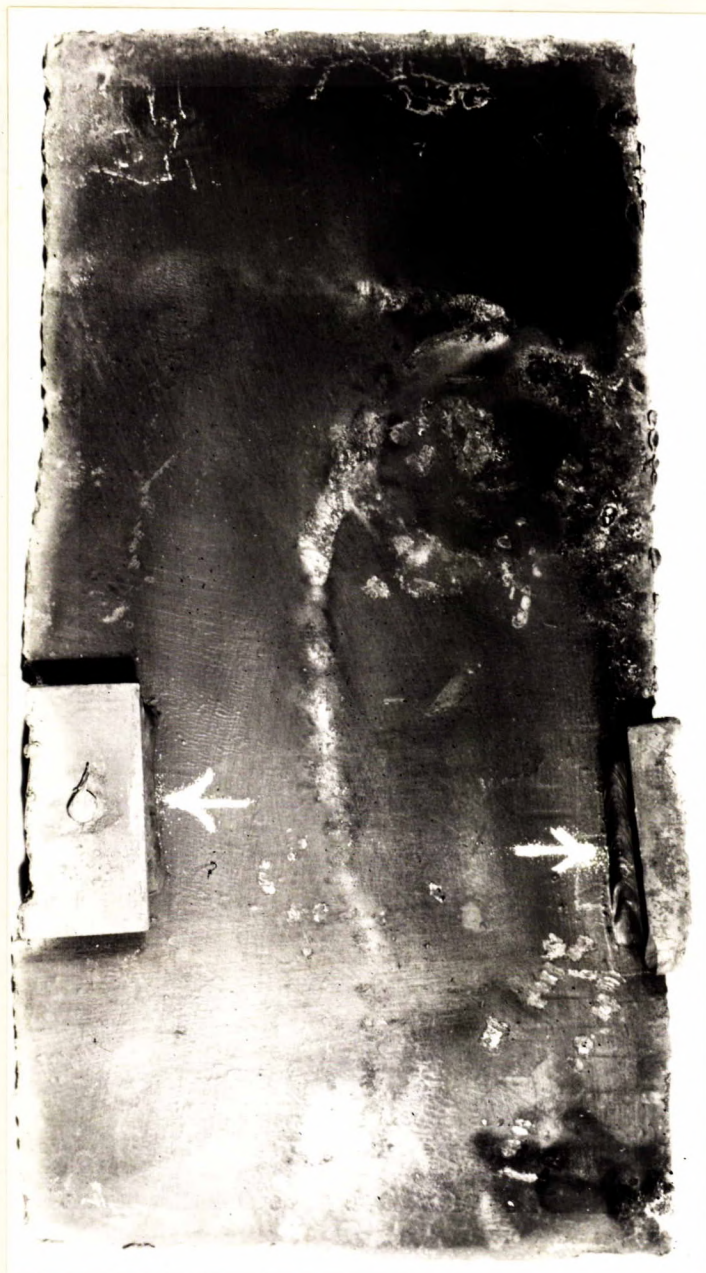
Figure 1.

The fillet welds joining the tapping block to the bulletproof plate are of poor quality. Undercutting is extensive and severe. This indicates the use of inexperienced or indifferent welders and low inspection standards. The use of short fillet welds, rather than welding of the entire periphery of the tapping block, is interesting and may indicate an enforced economy of weld metal. On the other hand, the possibility exists that these welds may be sufficiently strong to secure a particular attachment.

FLAME-CUT BULLETPROOF PLATE  
SAMPLE, 'AS RECEIVED'.

Arrows point to fillet welds joining tapping  
blocks to armour plate. Note proximity of  
flame-cut edge to welds examined.

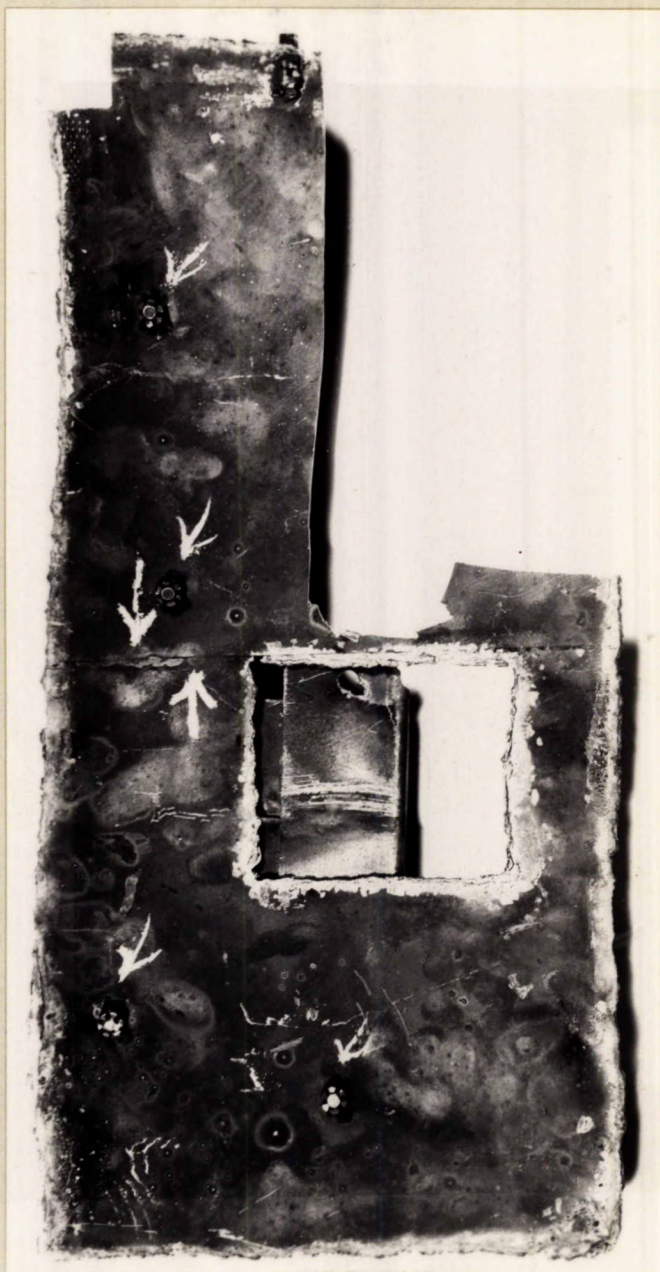
Figure 2.

A visual examination of the samples indicated that all welds were made in a single pass. In the case of the butt weld in the thinner plate, a back-up bar was used but the bottom of the weld showed extensive lack of penetration and poor fusion. In many places fusion had been secured only in the upper 20 per cent of the sheet thickness. The tack welds joining the nuts to the back of this plate are obviously designed to facilitate assembly, in that the nuts themselves

FLAME-CUT THIN PLATE  
SAMPLE, 'AS RECEIVED'.

Arrows point to butt weld in centre.  
Note lack of penetration. Arrows  
also point to nuts tack-welded to  
plate.

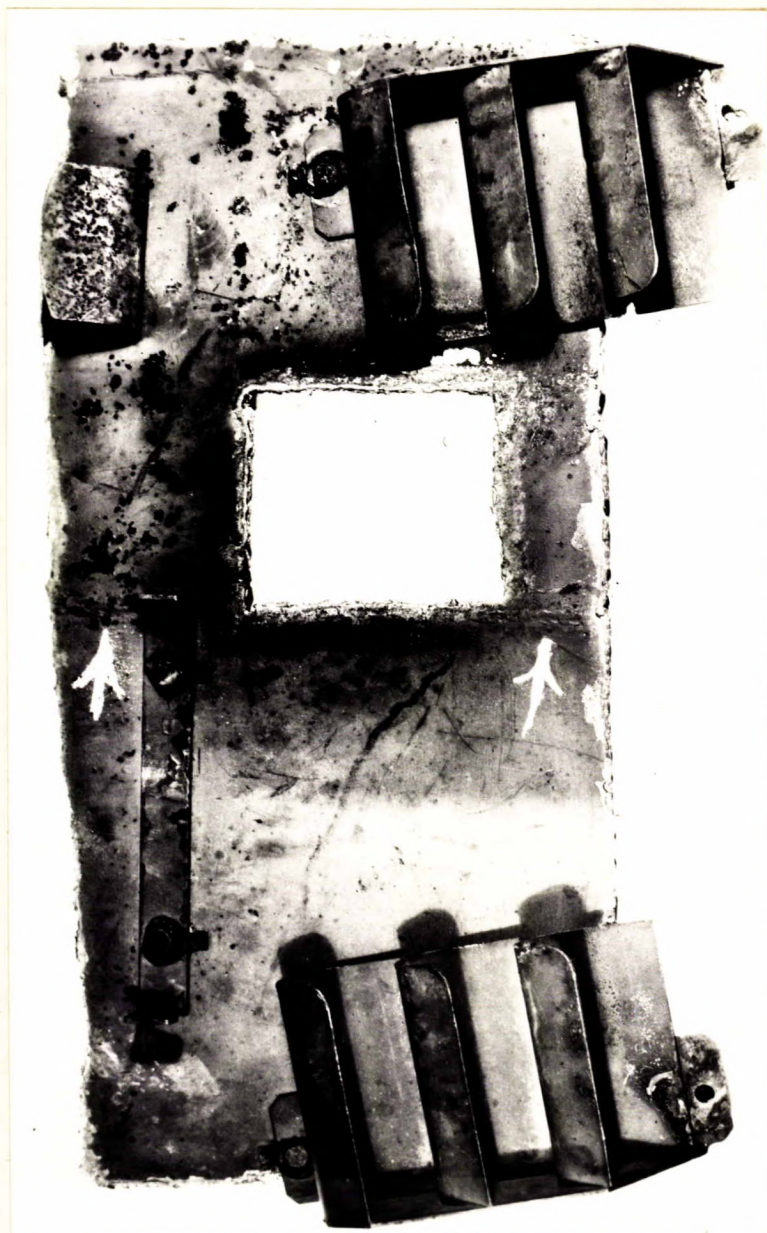
Figure 3.

OPPOSITE SIDE OF THIN PLATE  
SHOWN IN FIGURE 2.

Arrows point to butt weld in centre.

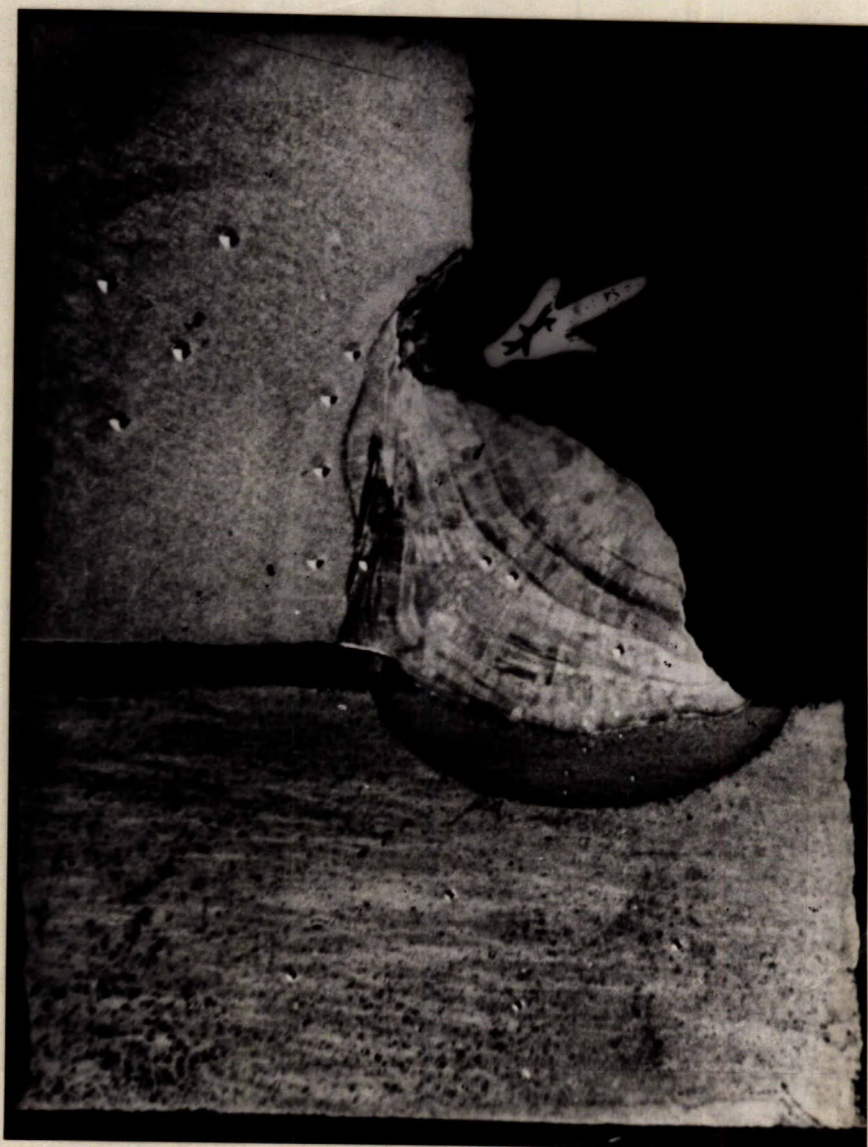
Figure 4.

The macro and micro examinations of the fillet welds on the bulletproof plate indicated the use of a low-carbon austenitic electrode. It will be noted, from Figure 4, that penetration of the weld metal into the armour plate is low, and this may be a characteristic of the electrode used, or it may be due to welding speed. A low penetration characteristic is useful in avoiding the dangers of dilution of the weld metal by armour plate material. The structures of the heat-affected zones and the normal materials show nothing unusual. A very definite possibility exists that these structures may be considerably modified by the heat of the flame-cutting process used to secure the samples.

MACRO SECTION OF FILLET WELD JOIN-  
ING TAPPING BLOCK TO ARMOUR PLATE.

Arrow points to severe undercut partly  
filled with slag. Note low penetration  
and narrow heat-affected zone.

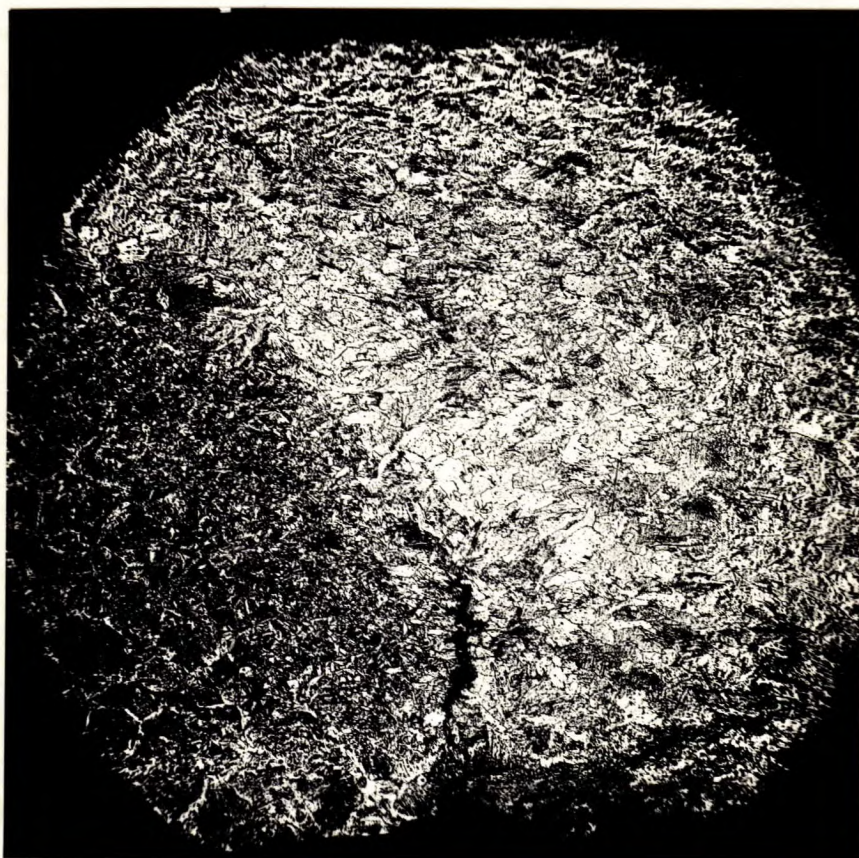
Figure 5.

The macro and micro examinations of the weld in the thinner plate indicated the use of a low-carbon ferritic electrode. A crack was found in the root of the weld which probably originated in adjacent areas of lack of penetration and/or poor fusion.

MACRO SECTION OF BUTT WELD IN THIN PLATE.

Note crack at root of weld, probably origin-  
ating in adjacent areas of lack of pene-  
tration and/or poor fusion. Low-carbon  
welded metal.

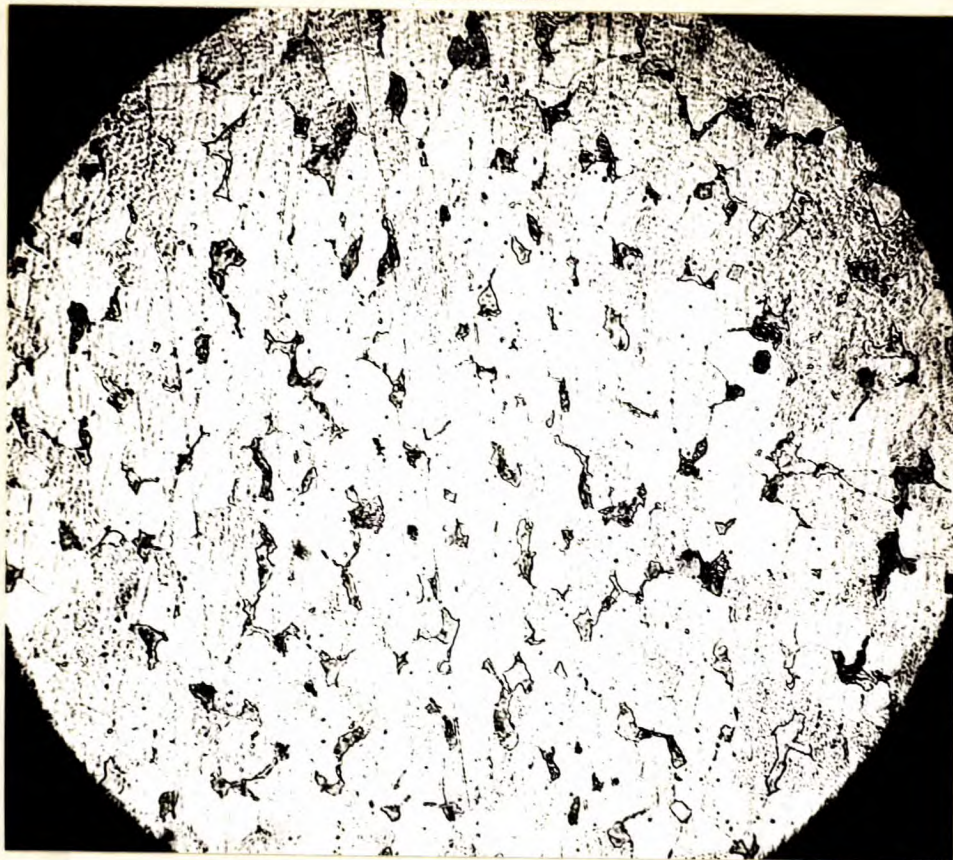
Figure 6.

NORMAL STRUCTURE OF TAPPING BLOCK MATERIAL.

Pearlite in a matrix of ferrite.

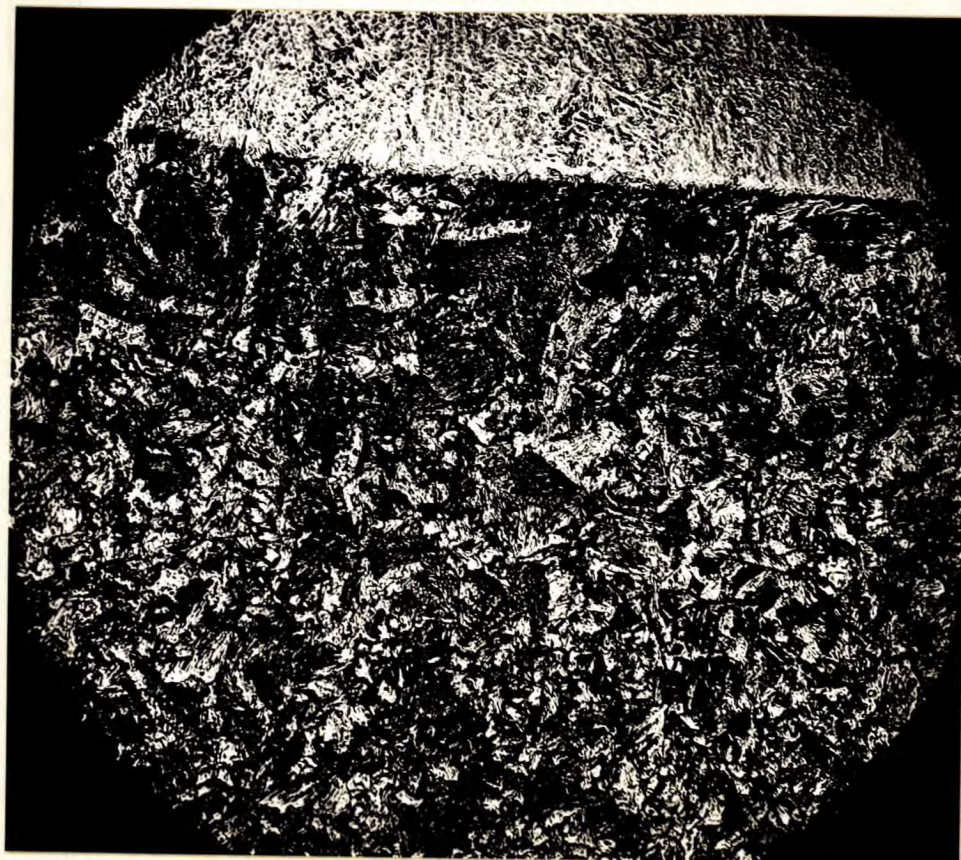
Figure 7.

HEAT-AFFECTED ZONE (LOW-CARBON MARTENSITE)  
AND FUSION LINE OF TAPPING BLOCK MATERIAL.

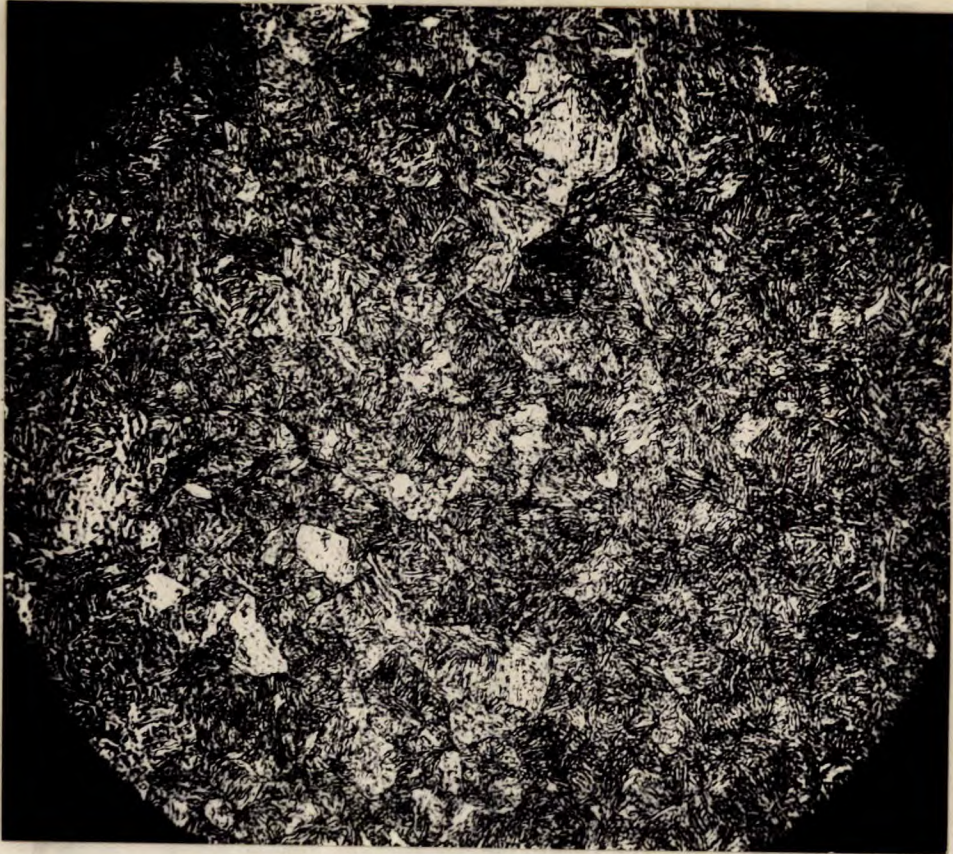
X500, etched in 1 per cent HCl and  
4 per cent picric acid in alcohol.  
NORMAL STRUCTURE OF BULLETPROOF PLATE.  
Tempered martensite.

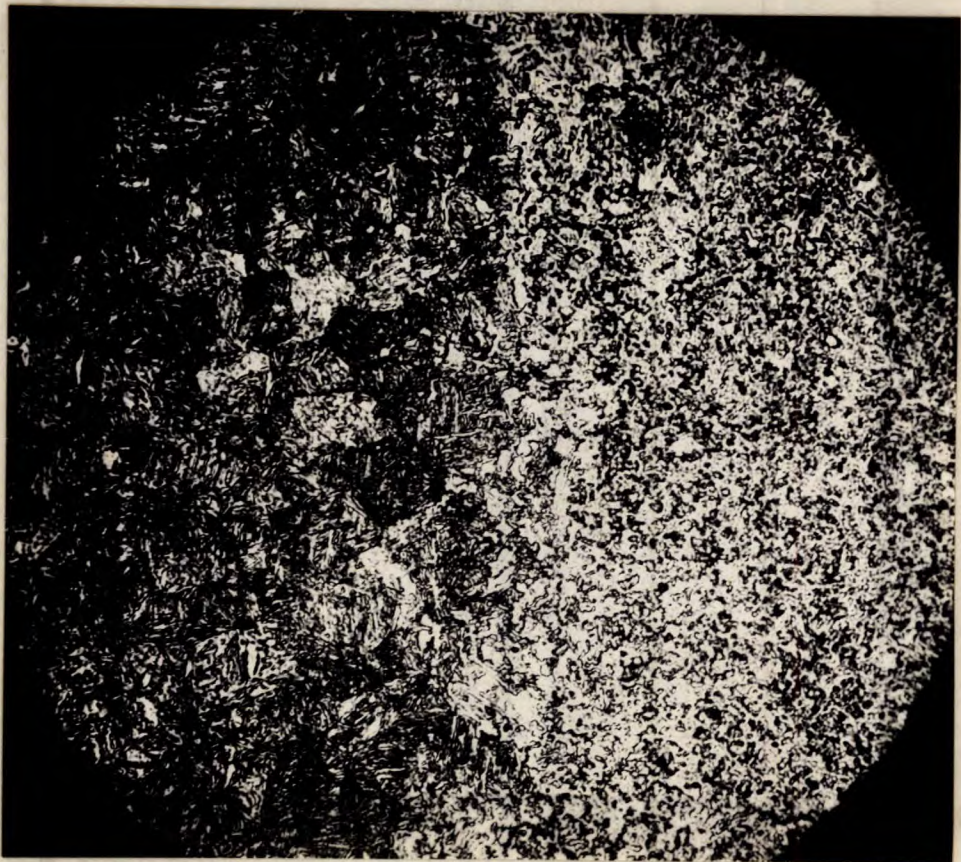
Figure 9.

X500, etched in 1 per cent HCl and  
4 per cent picric acid in alcohol.  
TRANSITION ZONE OF BULLETPROOF PLATE.  
Note spheroidizing effect on carbides.

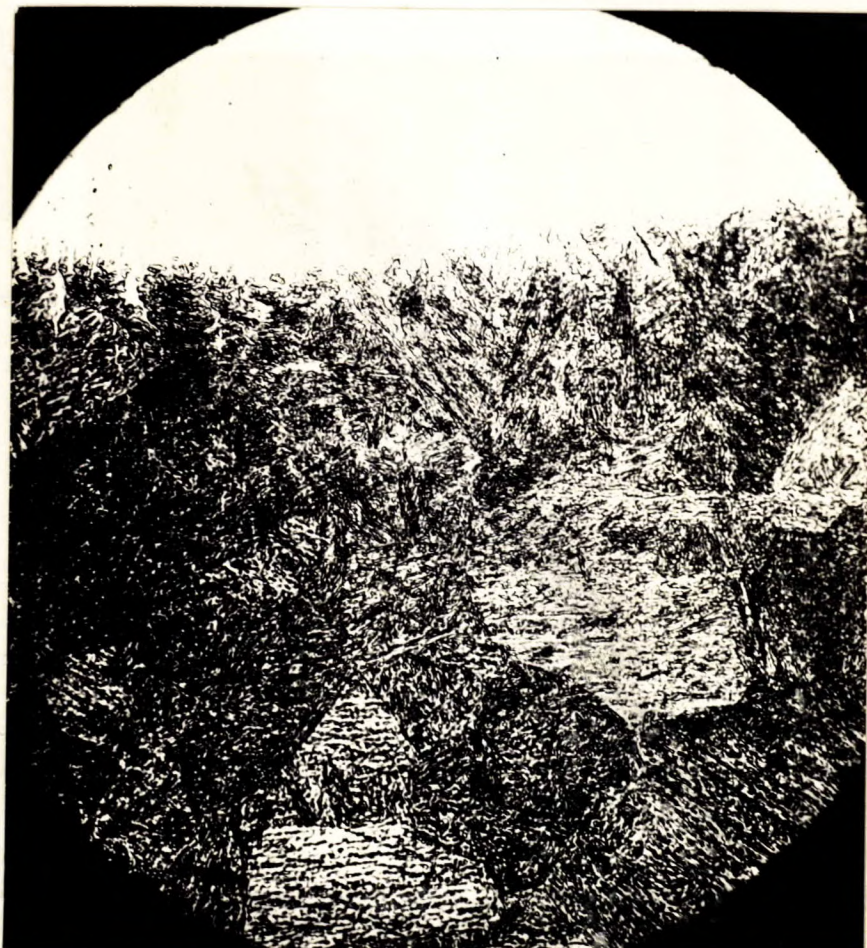
Figure 10.

STRUCTURE OF HEAT-AFFECTED ZONE (COARSE,  
TEMPERED MARTENSITE) AND FUSION LINE  
OF BULLETPROOF PLATE.

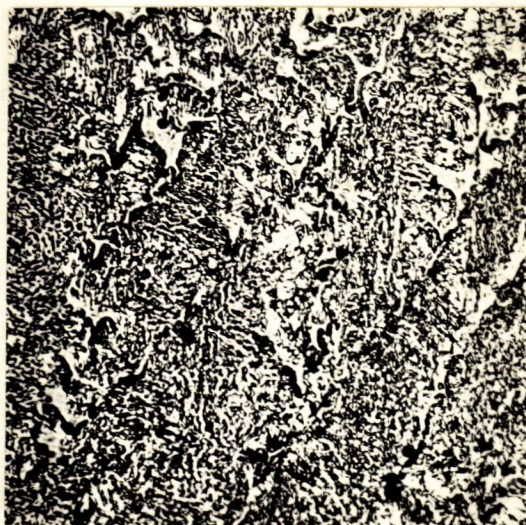
Figure 11.

composition, as shown by the analysis, undoubtedly is affected by dilution by the metals being welded. The microscopic examination and hardness tests reveal that the deposited weld metal is partially austenitic and is very close to the border line separating the ferritic and austenitic conditions. The carbon content is higher than is usual but this may be the result of pickup from the armour plate. The very low molybdenum content might be expected to cause root cracking difficulties, although no root cracks were observed in the welds examined.

STRUCTURE OF WELD METAL.

Hyper-eutectic cementite in a matrix of austenite.
