ORE DRESSING AND METALLURGICAL LABORATORIES.

Investigation No. 1683.

Investigation to Determine the Cause of
Cracks in Manganese Steel Castings.

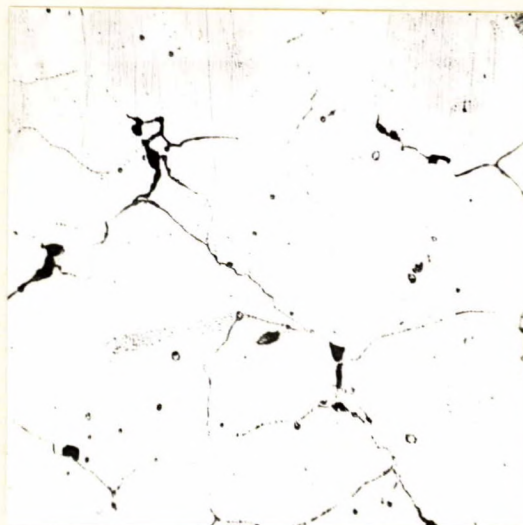
Figure 1.

Figure 1 is a photomicrograph, at X100 magnification, of the structure of Sample No. 40. It consists of austenite with carbide grain boundaries.

MICROSTRUCTURE OF SAMPLE NO. 40.

Austenite with carbide
grain boundaries.

The expansion of the crack in Sample No. 40 after it was cut indicates that the failure was caused by internal stresses. The cause of these stresses could not be determined from the specimens submitted. This is not surprising, as trouble of this nature is more likely to be caused by the moulding and pouring practice than by the use of off-standard metal.

Chemical analysis and microstructure examination do not give any indication of the cause of cracking. Moulding conditions should be investigated. Mould hardness, hot strength and collapsibility of sand have some effect on cracking. Experimenting with foundry procedure will probably result in the elimination of this defect.
