ORE DRESSING AND METALLURGICAL LABORATORIES.

Investigation No. 1690.

Examination of Corroded Cap from High Alloy
Steel Retort Used in Magnesium Production.

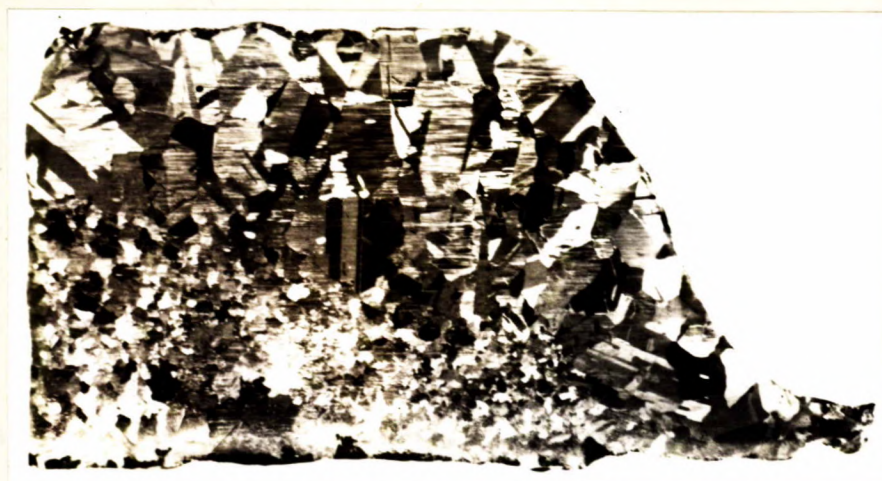
Figure 1.

3. Macro sections were machined from two areas. Figure 1 shows a section of the retort barrel and the almost complete corrosion of the weld. Figure 2 shows another section of the retort barrel, weld and cap material. In this case approximately one-half of the weld depth has corroded away. In both cases the large grains show the extent of decarburization.

MACRO SECTION OF RETORT AND WELD.

Note large grain size resulting from decarburization.

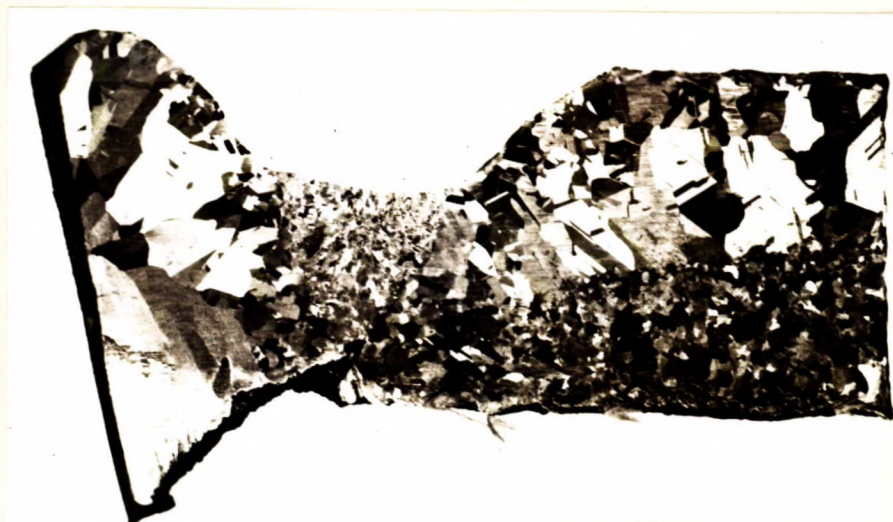
Figure 2.

The macro and micro examinations reveal no evidence of possible causes of corrosion. It is interesting to note (see Figure 2) that the recommended joint design (a U joint) has not been used but, rather, a simple V joint with an included angle of 50 degrees and a zero root gap. This type of joint is too narrow and difficulties might be encountered in slag removal. The microscopic examination reveals no evidence of preferential oxidation along grain boundaries that

3. The weld joint was a simple V with a 50 degree included angle and zero root gap, and not the recommended U joint.

MACRO SECTION OF RETORT, WELD AND CAP MATERIAL.

Note the large grain size resulting from decarburization.
Note also weld outline revealing a V type of joint with zero root gap.

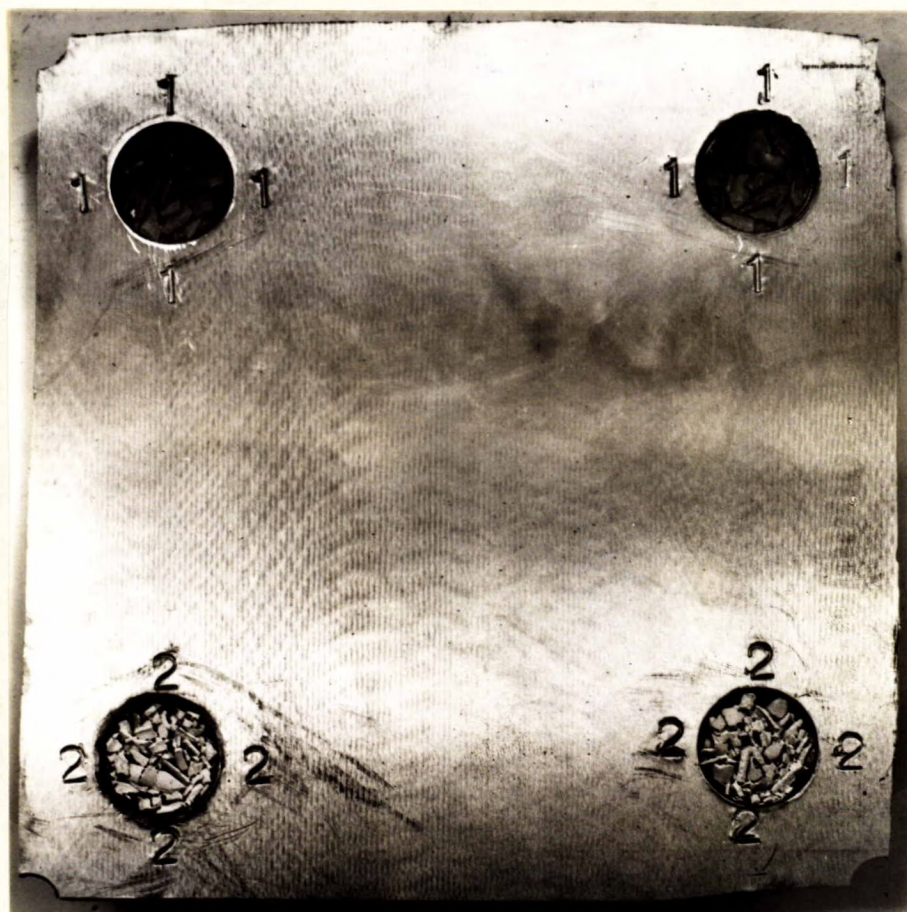
Figure 3.

HIGH TEMPERATURE CORROSION TEST PLATE.

Section of Retort Cap, Ground Smooth.

The holes are 1 inch in diameter and $\frac{1}{4}$ inch deep.
Holes numbered 1 contain 1 gram of Arcos flux;
those numbered 2 contain 1 gram of Arcaloy flux.

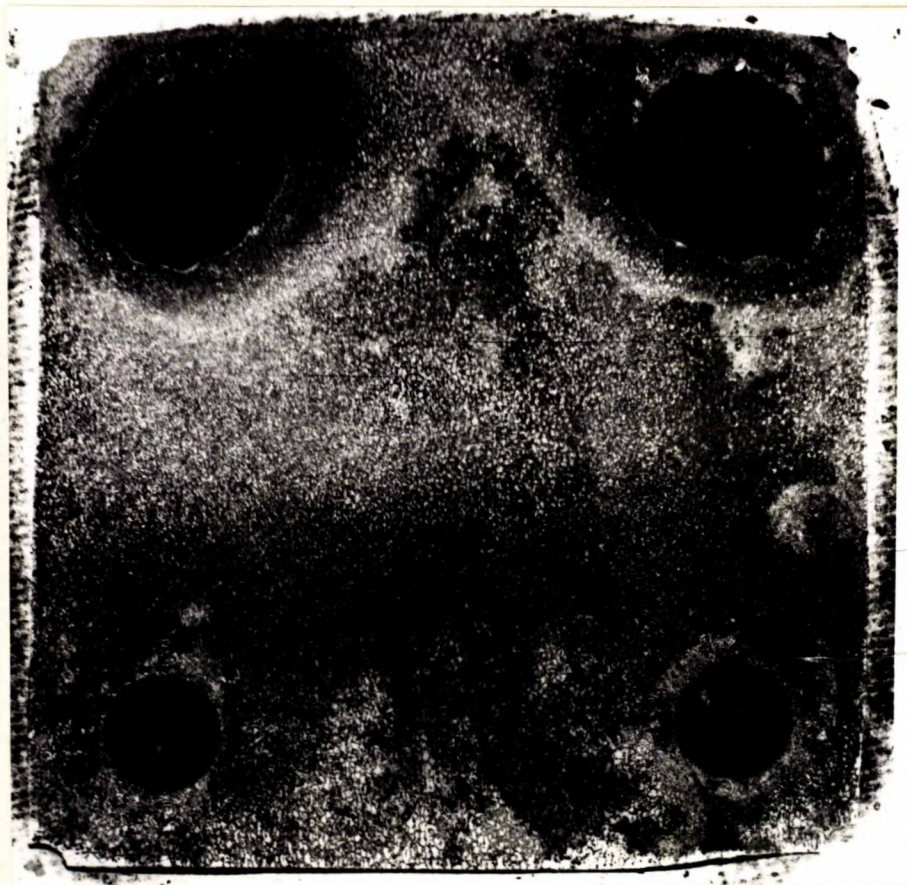
Figure 4.

The results of the corrosion tests at high temperature are significant and in agreement with others[•] investigating this problem. It is apparent that the test conditions duplicate fairly closely the operating conditions of the magnesium retorts. It would appear that at 2150° F. both fluxes have a liquid phase, differing only in amount. The Arcos electrode flux has by far the greater amount of this liquid phase at temperature, and this has extremely high wetting power and fluidity as evidenced by the climbing from the drilled hole and spreading over a wide surface. The photograph (Figure 4) taken while the test plate was about 2000° F. shows the extremely heavy ring of corrosion product around the holes containing the Arcos flux. It is noteworthy that the holes containing the Arcaloy flux have no such severe attack. It has been shown that the corrosive damage caused by the liquid phase is out of all proportion to the amount in action. The mechanism is, apparently, that the liquid phase acts as a solvent on the protective oxide coating, thereby continuously exposing fresh surfaces.

HIGH TEMPERATURE CORROSION TEST PLATE
AT TEMPERATURE OVER 2000° F.

Holes number 1 are at top; holes numbered 2 are at bottom.

Note heavy ring of corrosion product around holes containing Arcos flux. Note also wide ring around each top hole, revealing extent of spread of liquid phase. Bottom holes (Arcaloy flux) show slight evidence of a liquid phase also.

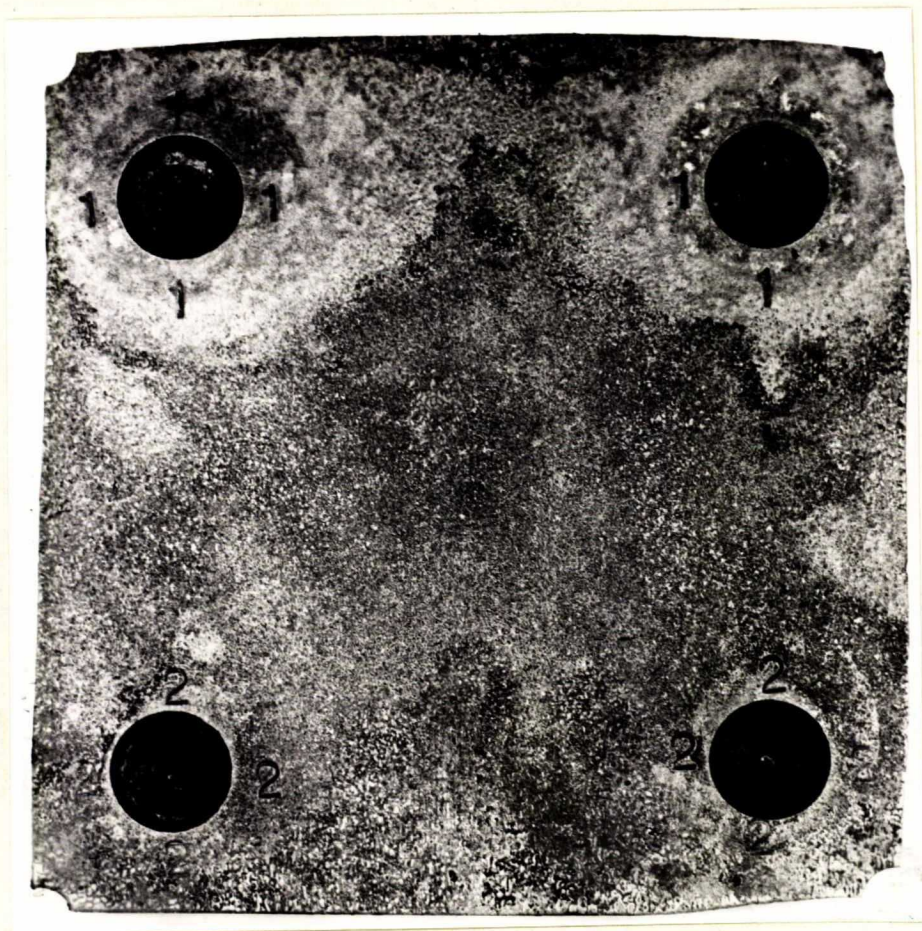
Figure 5.

4. The corrosive action of the Arcos flux is far greater than that of the Arcaloy flux. This is due to the high fluorine and silicate contents of the former. It would appear that the weld corrosion has been due to welding flux trapped in the weld.

HIGH TEMPERATURE CORROSION
TEST PLATE WHEN COLD.

Plate Wire-Brushed When Cold.

Note severe surface pitting around top
holes. Note also heavy scaling of
top holes.

Welding of retorts should be done with an electrode with a rutile-type coating which is low in fluorine and silicate contents.
