August 2nd, 1944.

ORE DRESSING AND METALLURGICAL LABORATORIES.

Investigation No. 1693.

Examination of Stainless Steel Exhaust Stub
from Canadian-built Mosquito Aircraft.

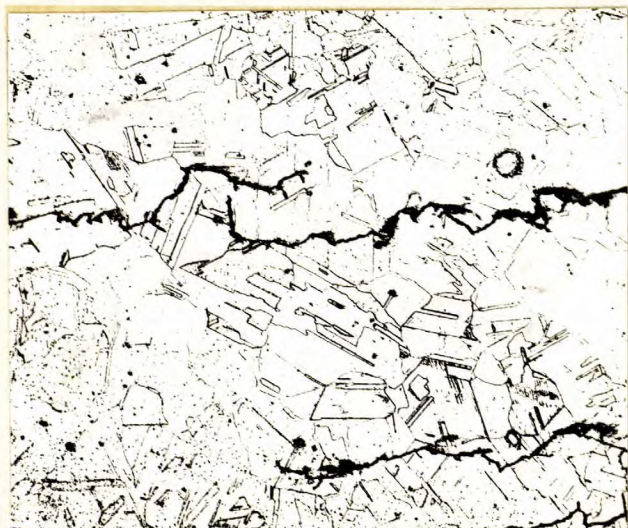
Figure 1.

Figure 1 shows typical transcrystalline cracks running parallel to the failure.

SHOWING TRANSCRYSTALLINE
CRACKS PARALLEL TO FAILURE.

The transcrystalline failure definitely indicates that the failure was due to either of two causes: (1) stress-corrosion cracking, or (2) simple fatigue. The fact that the steel failed a very short time after being installed would also lend support to the claim that failure had occurred due to fatigue or stress-corrosion, rather than "burning", as the failure can occur in fatigue or stress-corrosion after only a very few cycles, provided the stress is high enough.

1. It is suggested that 18-8 stainless steel, preferably stabilized with columbium or titanium, be tried. After welding, the manifold should be given a stress-relieving anneal of 1350° F. for 1 hour, followed by a furnace cool.
2. If the above be unsatisfactory, the stainless 18-8 should be replaced by Inconel.
3. Other stainless steels, such as the 25 Cr/20 Ni (Type 310), which has superior mechanical properties at elevated temperatures to the 18-8 but is inferior to Inconel, might be tried where the latter is not available.

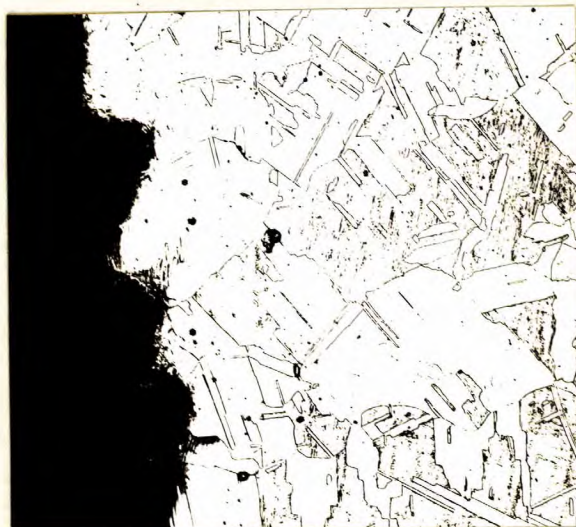
Figure 2.

Figure 2 shows the microstructure at the failure. Note complete lack of evidence of "burning" or corrosion.

MICROSTRUCTURE AT
FAILURE. (AUSTENITE).

Visual and microscopic examinations of the exhaust stub at the point of failure did not reveal any evidence of "burning". Microscopic examination also failed to show any intergranular corrosion.

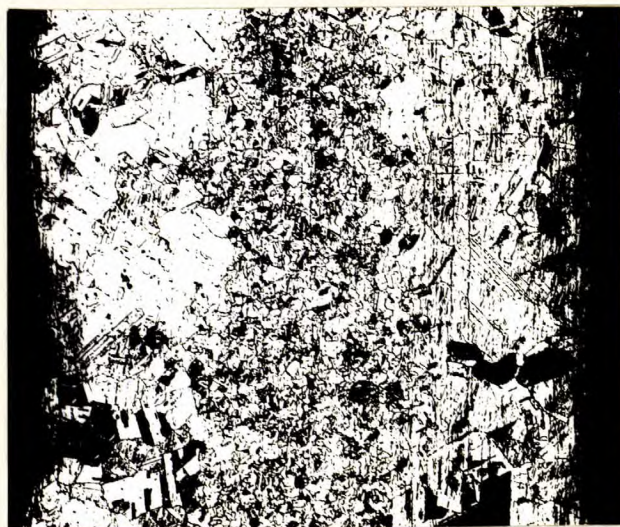
Figure 3.

Figure 3 is a photomicrograph, taken at a magnification of 50 diameters, showing the structure of the cross-section of the stainless steel sheet used to make the manifold. Note the coarse grains at either surface. These large grains may be due to either of two causes: (1) decarburization incurred during the rolling operation, or (2) lower-temperature recrystallization of the outer skin because of greater work-hardening in this area during the rolling operation.

CROSS-SECTION SHOWING
LARGE GRAINS AT SURFACE.

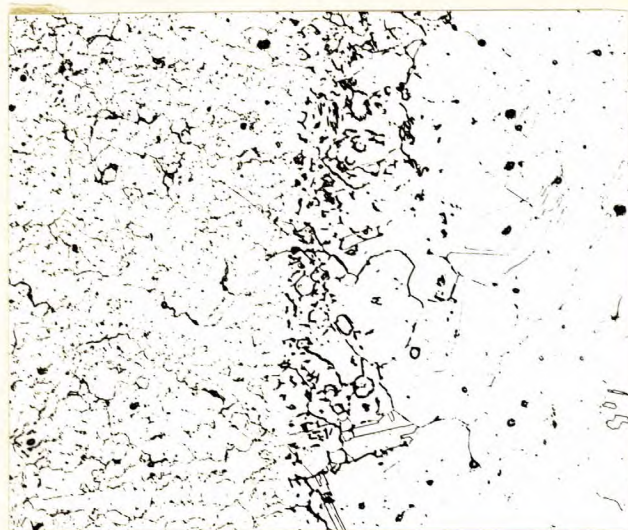
Figure 4.

Figure 4 shows the junction of the weld and parent

metal. Note the precipitation of carbides, marked by dark etching areas.

SHOWING JUNCTION OF WELD
(LEFT) AND PARENT METAL.

Micro-examination of the weld shows the presence of precipitated carbides, which may be considered normal for 18-8 steel which has not been stabilized with columbium, titanium, or other stabilizing elements. Since the failure occurred at right angles to the welds, it is reasonable to assume that the welding was not responsible for the failure.

The tendency for stress-corrosion cracking in this part may be overcome by the following stress-relieving anneal after welding: Heat for 1 hour at 1350° F. and furnace cool. In order to prevent the precipitation of carbides, which might result in intergranular corrosion, the steel should contain stabilizing elements, such as columbium or titanium.
