R E P O R T
of the
ORE DRESSING AND METALLURGICAL LABORATORIES.

Investigation No. 1694.

Examination of Manganese Steel Track Shoe.

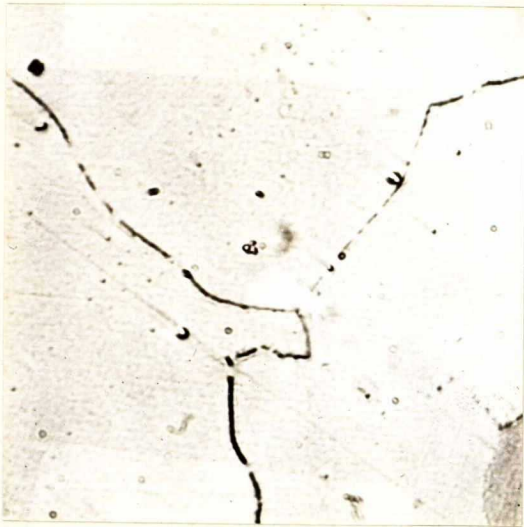
The steel was examined under the microscope for free carbides. Fine carbides were observed on many of the grain boundaries, as shown in Figure 1. The carbide-free grain boundaries obtained on quenching a piece of the steel from 1900° F. are shown in Figure 2. Figure 3 shows the detail of the carbide grain boundaries.

Carbides on the grain boundaries are detrimental, as they embrittle the steel. The amount of carbides in the sample submitted may not be too serious, but the presence of a condition which needs correction is indicated. These carbides undoubtedly occur as a result of improper quenching, as carbides present as a result of heating to too low a

2. The carbides on the grain boundaries are undoubtedly caused by improper quenching.

X1000, nital etch.

As Received.

CARBIDES ON
GRAIN BOUNDARIES.

Consideration should be given to improvement of quenching practice.

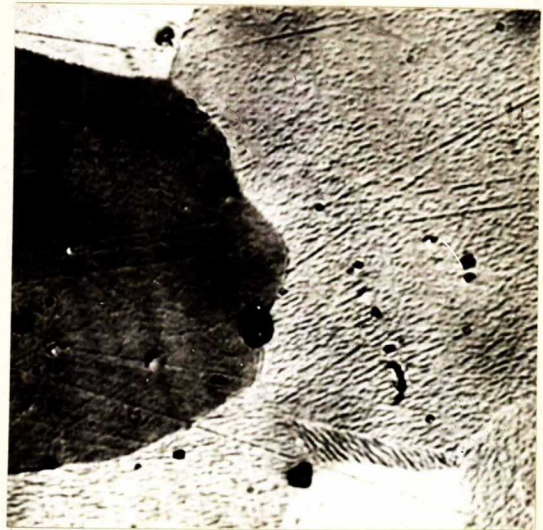
Figure 2.

X1000, nital etch.

After Water Quenching from 1900° F.

CARBIDE-FREE
GRAIN BOUNDARIES.

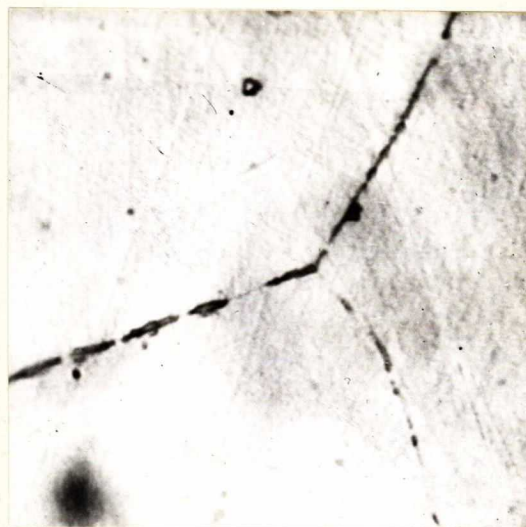
Figure 3.

X2000, nital etch.

As Received.

DETAIL OF GRAIN
BOUNDARY CARBIDES.
