August 5th, 1944.

Investigation No. 1695.

Metallurgical Examination of C.D.P. Track Shoe and  
Pin Which Had Been Field-Tested in England.

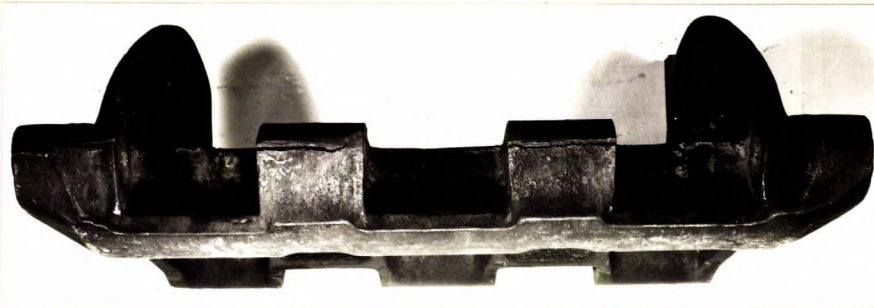
Figure 2.  
TRACK SHOE A.  
Note cracks in  
eye-hole walls.

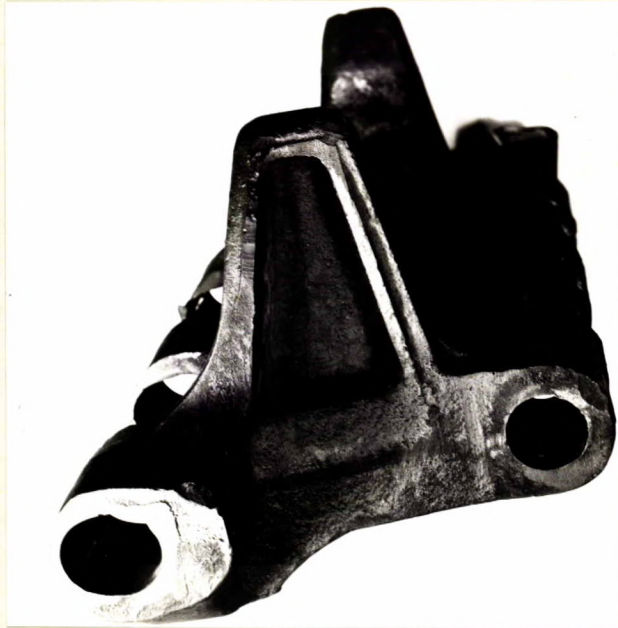
Figure 4.

END VIEW OF TRACK SHOE A.

Note elliptical shape of  
eye-hole, due to wear.

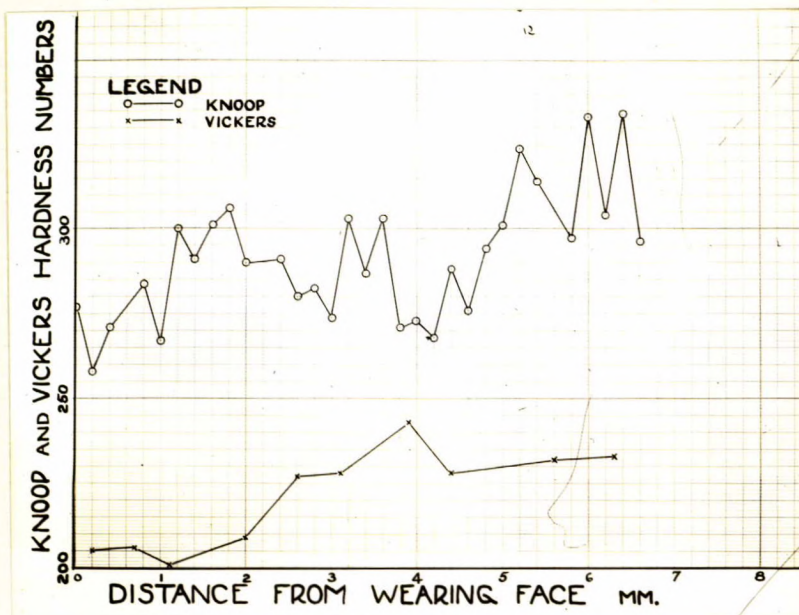
Figure 8.

The transverse section from the eye-hole wall was also subjected to hardness surveys with both Vickers and Tukon hardness testers, using 10-kilogram and  $\frac{1}{2}$ -kilogram loads respectively. The wall was not work-hardened (indeed, it appeared softer near the worn surface, as may be seen in Figure 8), although slip bands showed up in the micro-examination.

Quartz has a hardness of 7 in Moh's scale of hardness. This, according to O'Neill's "Hardness of Metals and its Measurement", page 138, is equivalent to 685 Brinell or 885 Vickers, or 64 on the Rockwell 'C' scale. As can be seen from Figure 8, the eye-hole wall had a Vickers pyramid number of about 225. The pin was about 45 Rockwell 'C'. The fineness and great hardness of the quartz give it excellent abrasive qualities. The presence of moisture, due to either climatic or surface conditions, is essential, however, as the tests on both the American and African deserts prove.

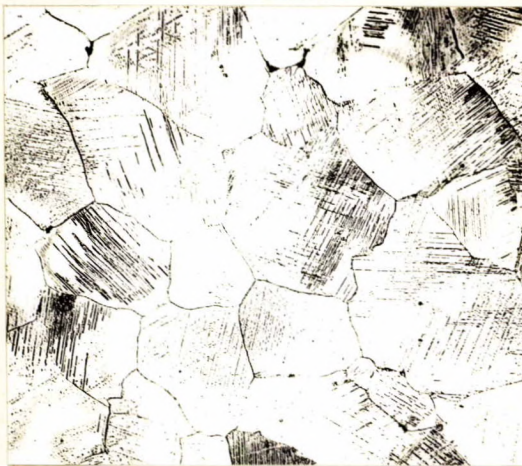
Figure 9.

STRUCTURE OF EYE-HOLE WALL.

A.S.T.M. Grain Size, 5.

Note strain lines.

either dimension was observed. The presence of slip bands, as outlined by decomposition products (see Figure 9), indicates that work-hardening had commenced but had not reached a sufficiently advanced stage to produce a measurable increase in hardness.

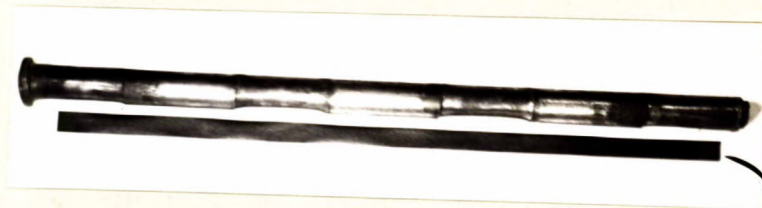
Figure 10.

TRACK PIN AS RECEIVED.

Note worn contours of pin.

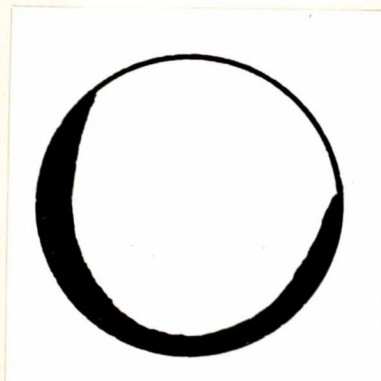
Figure 11.

Transverse sections were cut from one worn and one unworn portion of the pin. Figure 11 gives a comparison of the two sections. The shaded area represents approximately the amount of metal worn from the smaller section.

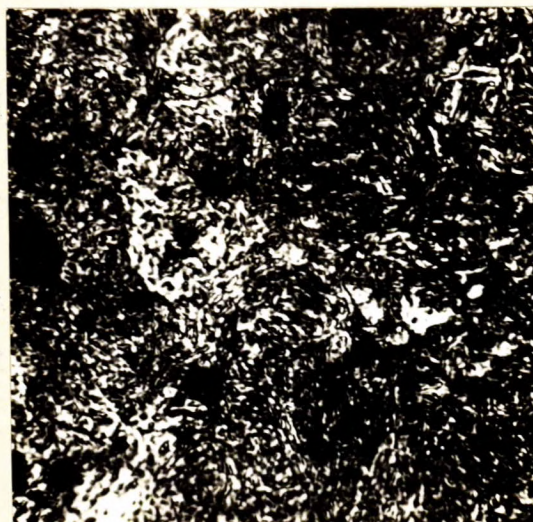
A photomicrograph of one transverse section etched in 2 per cent nital was then made. It is shown in Figure 13. The structure is entirely drawn martensite. The structure shown is typical, there being no banding of the steel.

TRANSVERSE SECTION OF PIN.

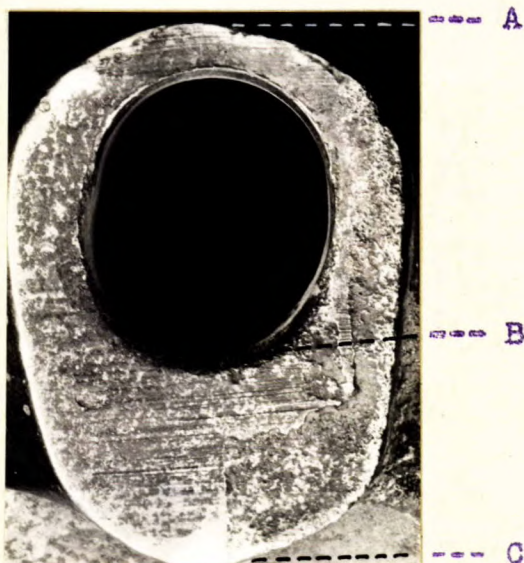
Figure 14.

The metallurgical examination indicated that the shoe had been subjected to abrasion only, since there was no appreciable work-hardening in the eye-hole wall. Also, any stretching of the eye-hole wall by the pounding of the track pin would result in an increase in length between A and B and between A and C (as shown in Figure 14), and no change in
