O T T A W A August 10th, 1944.

ORE DRESSING AND METALLURGICAL LABORATORIES.

Investigation No. 1699.

Investigation of Generator Base Failures.

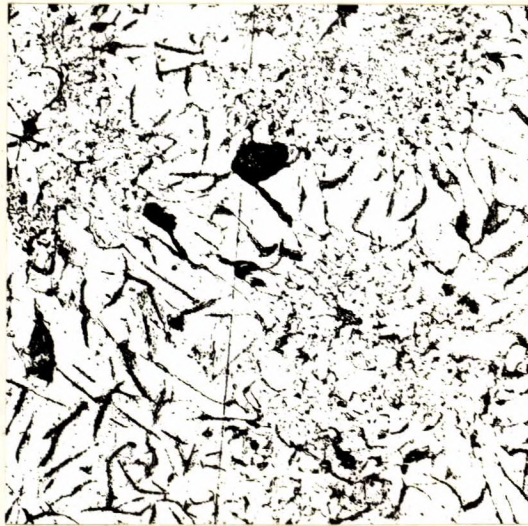
Figure 1.

Figure 1 is a photomicrograph of the unetched structure.

The low hardness and tensile strength indicate that this is an A.S.T.M. Spec. A48-36, Class 20 grey iron. The sizes and arrangement of the graphite particles are typical of this grade of iron.

X100, unetched.

MICROSTRUCTURE OF CASTING RECEIVED.

Typical A.S.T.M. Specification A48-36,
Class 20 grey iron,

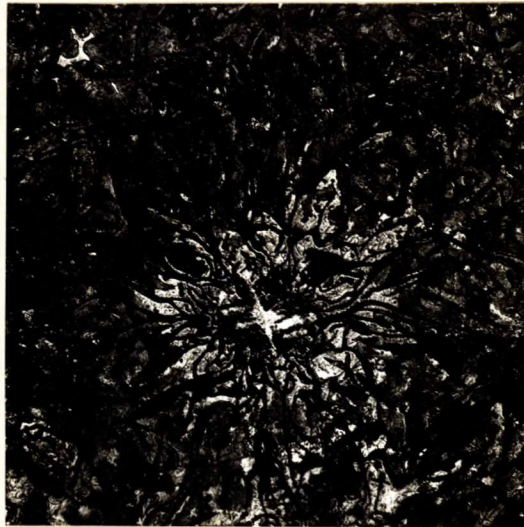
Figure 2.

Figure 2 is a photomicrograph of the structure after etching in hydrochloric and picric acids (Vilella's etch).

X100, etched in picric
and hydrochloric acids.
