ORE DRESSING AND METALLURGICAL LABORATORIES.

Investigation No. 1700.

Examination of a Manganese Steel Traylor Mantle.

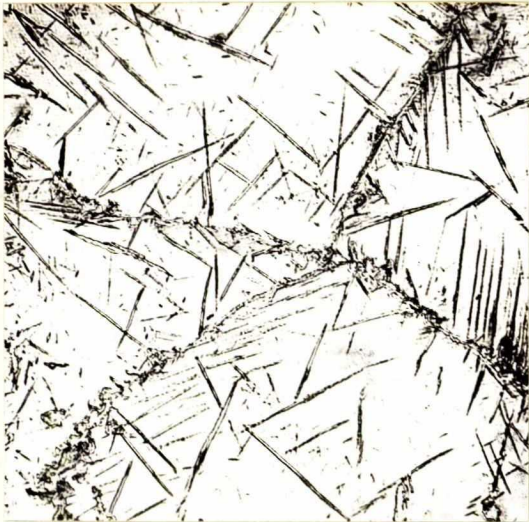
Figure 1.

The structure at the surface of the casting was found to differ from that at the centre. Figure 1, at X200 magnification, is a photomicrograph of the structure at the centre. Figure 2, also at 200 diameters, shows the microstructure $\frac{1}{2}$ inch from the outside, unworked surface. Figure 3, at X1500 magnification, shows the troostitic nature of the dark particles of Figure 2.

The absence of massive carbides indicates that the steel has been heat-treated, and that the soaking time and temperature have been sufficient to afford complete solution. The structure at the centre is typical of lower reheating than that at the surface. This indicates that external heat has been applied since heat-treating. The comparable structures obtained by reheating the properly quenched steel support this view.

X200, nital etch.
MICROSTRUCTURE AT CENTRE.

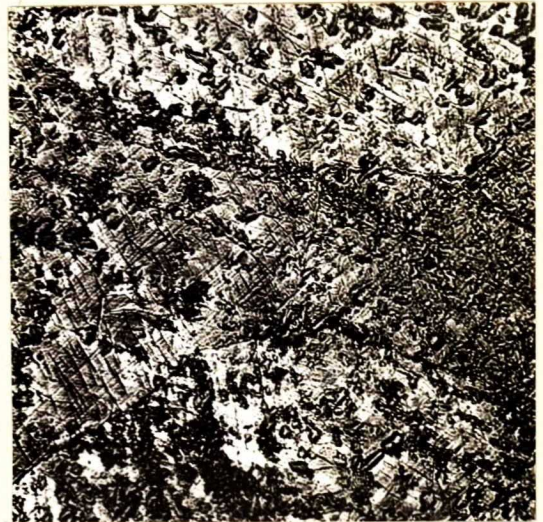
Figure 2.

X200, nital etch.
MICROSTRUCTURE $\frac{1}{4}$ INCH
FROM SURFACE.

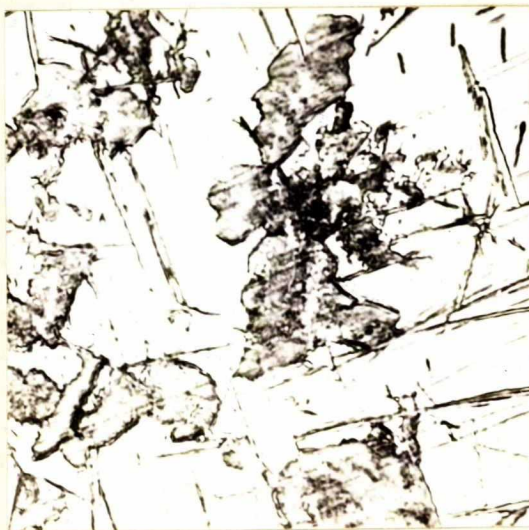
Figure 3.

X1500, nital etch.
MICROSTRUCTURE $\frac{1}{4}$ INCH
FROM SURFACE.

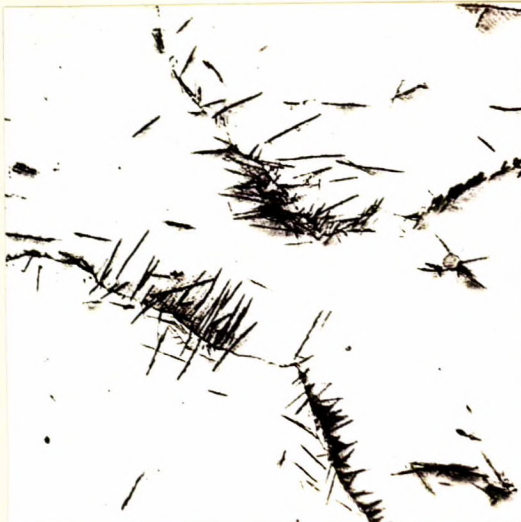
Figure 4.

In an attempt to obtain comparable microstructures, a section of the mantle was heated for four hours at 1900° F. and water-quenched. One sample was reheated to 850° F. for one hour, and another to 1150° for one hour. The resultant microstructures are shown respectively in Figures 4 and 5.

MICROSTRUCTURE AFTER REHEATING
TO 850° F. FOR ONE HOUR.

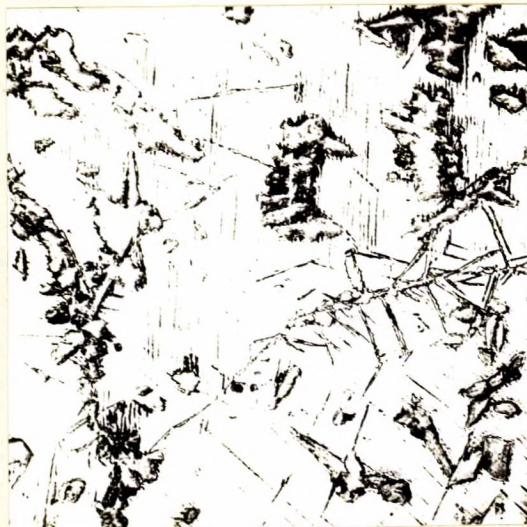
Figure 5.

MICROSTRUCTURE AFTER REHEATING TO
1150° F. FOR ONE HOUR.
