August 24th, 1944.

ORE DRESSING AND METALLURGICAL LABORATORIES.

Investigation No. 1703.

Metallurgical Examination of Three Spring Leaves.

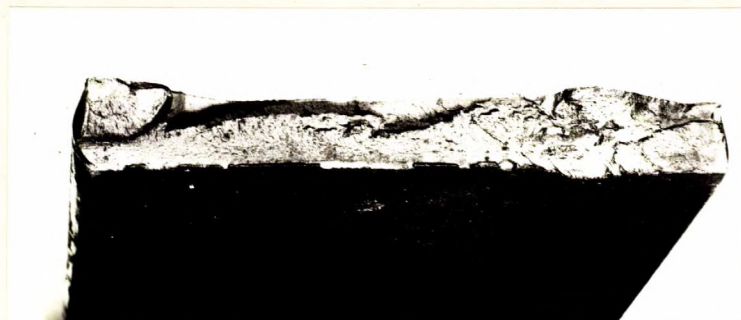
Figure 1.

SHOWING FRACTURE OF SPRING LEAF "A".  
(Approximately full size).

Since the fractures shown in Figures 1 and 2 are

typical of fatigue fractures, it is reasonably safe to assume that the spring leaves failed in fatigue as a result of surface decarburization.

Surface decarburization in spring steels should be entirely avoided by heat treating in a properly controlled atmosphere, in order to prevent a reduction in the endurance value of the steels. Some consideration should be given to raising the maximum hardness allowed to 48 Rockwell 'C'. Endurance limit of the properly heat-treated springs could be further increased, if this should prove necessary, by a shotblasting operation.

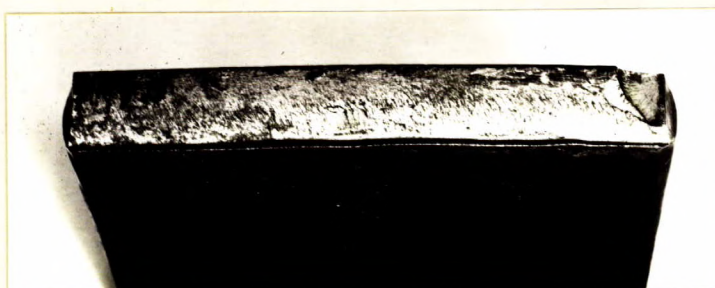
Figure 2.

SHOWING FRACTURE OF SPRING LEAF "B".  
(Approximately full size).

The hardness tests show that Leaves A and C have the specified hardness, but that Leaf B is harder than that called for by the specifications. Incidentally, experience with track pins indicates that this steel is still fairly tough at 48 Rockwell 'C'. Consideration, then, might well be given to increasing the maximum hardness allowed to this figure as the harder material has higher fatigue strength.

Micro-examinations reveal that the steels are dirty but not excessively so. The heat treatment has been correct except in Leaf B, which should have been drawn at a slightly higher temperature for a longer period of time.

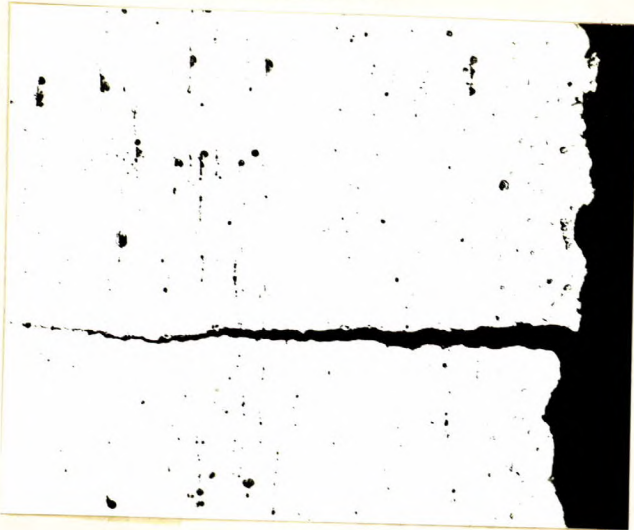
Figure 3.

Figure 3 (unetched) is a typical crack found in Leaf A. These cracks are very numerous and extend inward from both flat surfaces of Leaf A. No such cracks were found in Leaves B and C.

X100, unetched.  
SHOWING TYPICAL CRACK

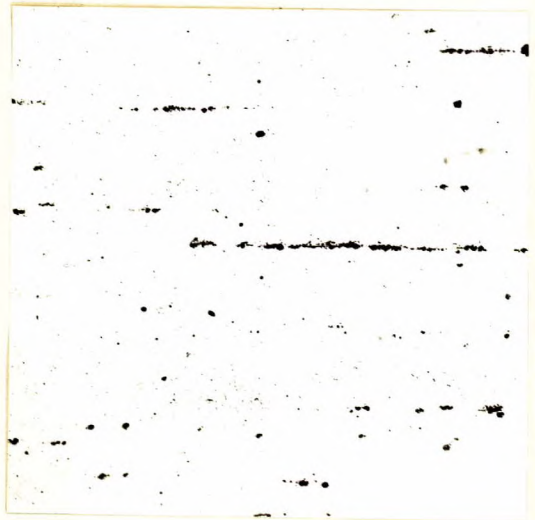
Figure 4.

The inclusions shown in Figure 4 are typical of all

three leaves.

X100, unetched.  
SHOWING INCLUSIONS.

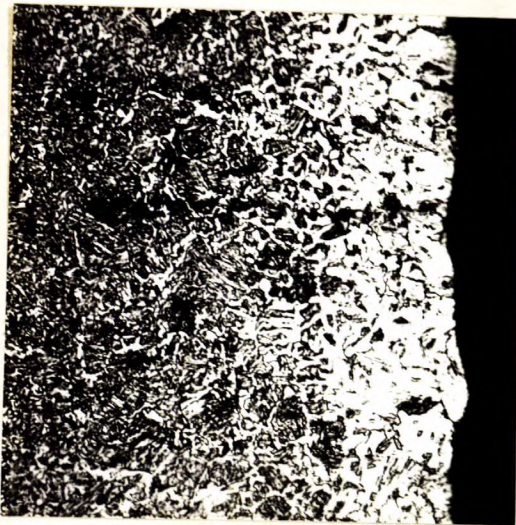
Figure 5.

Figures 5, 7 and 9 show the extent of the decarburization occurring in Leaves A, B and C, respectively.

All three leaves reveal considerable decarburization, which is very detrimental to the endurance value of the springs. The A.S.M. Metals Handbook has the following to say regarding decarburization:

X250, nital etch.  
SHOWING DECARBURIZATION.

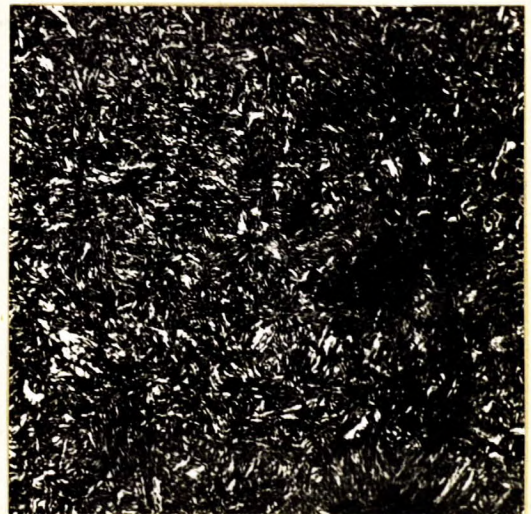
Figure 6.

The microstructures of all three leaves are normal for that of SAE 9255 steel quenched and drawn, that is, tempered martensite.

X500, nital etch.  
SHOWING MICROSTRUCTURE.

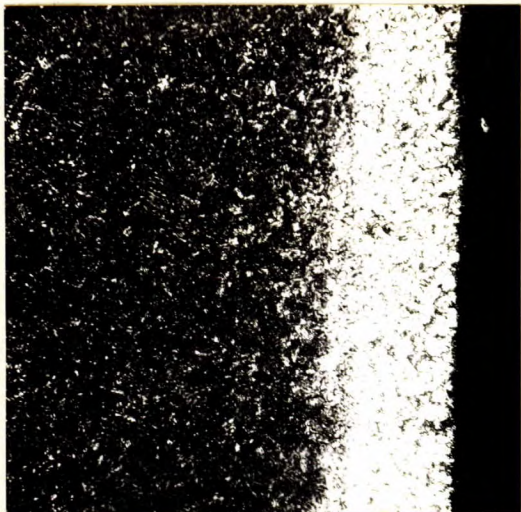
Figure 7.

X250, nital etch.  
SHOWING DECARBURIZATION.

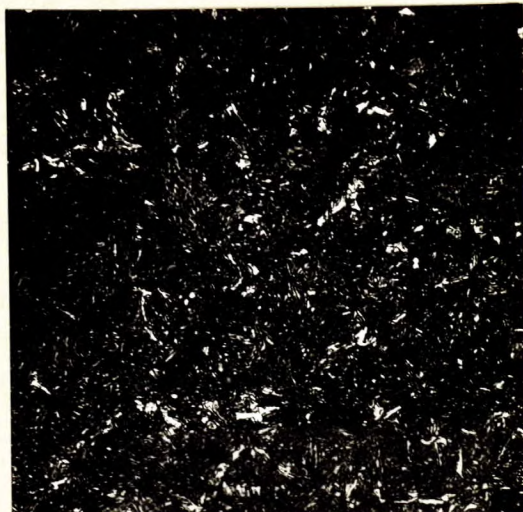
Figure 8.

X500, nital etch.  
SHOWING MICROSTRUCTURE.

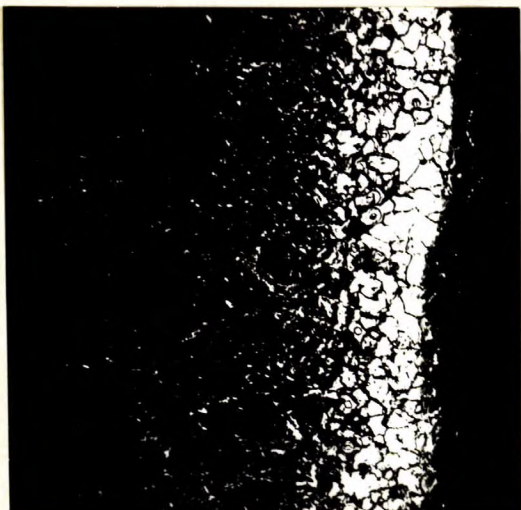
Figure 9.

X250, nital etch.  
SHOWING DECARBURIZATION.

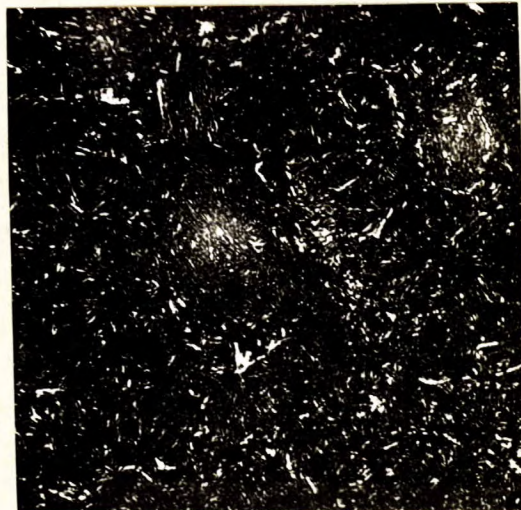
Figure 10.

X500, nital etch.  
SHOWING MICROSTRUCTURE.
