ORE DRESSING AND METALLURGICAL LABORATORIES.

Investigation No. 1705.

Examination of T.50 Steel Tubing.

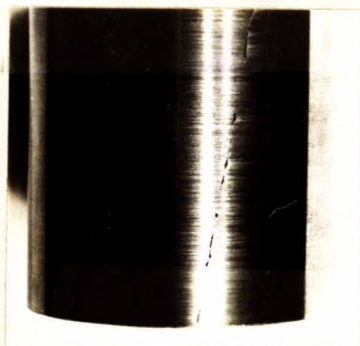
Figure 1.

SHOWING DEFECT IN  
TUBING AS RECEIVED.

The results of this investigation would indicate that the surface defect in the tube was caused by faulty tube manufacture and did not originate in the raw material. If the defect cannot be removed prior to assembly, these tubes and any tubes with similar defects should be rejected.

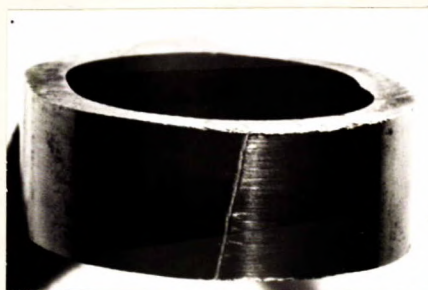
Figure 2.

The tubing was found to meet the requirements of the flattening test. However, when the tubing was flattened to slightly less than the specified diameter it cracked along the line of the defect (see Figures 1, 2 and 3).

SHOWING CRACK IN BEND SPECIMEN  
ALONG THE LINE OF DEFECT.

The tubes submitted were found to have a chemical composition within the limits specified for 2-T-50 steel tubing. They also had the specified tensile and bend properties. The bend test, however, showed that there was a tendency towards stress concentration along the line of the defect (see Figure 2). The microstructure indicated that the tubes had received a normalizing-and-draw heat treatment. Although this conforms to the specification, a more homogeneous

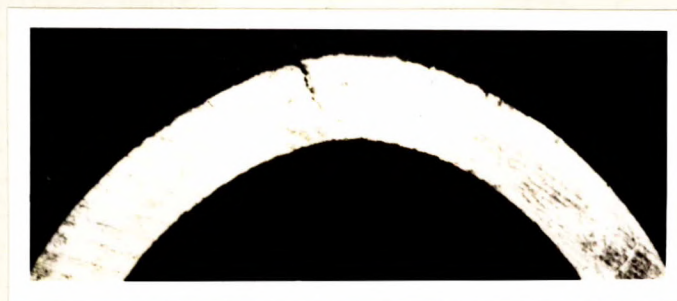
Figure 3.

SHOWING CRACK ON END OF  
OVERSTRESSED BEND SPECIMEN.

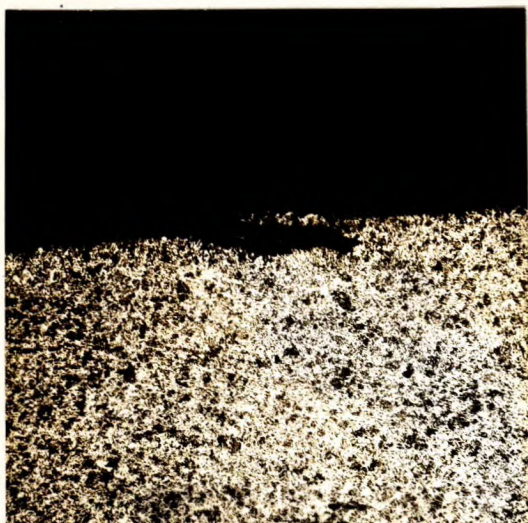
was then etched in a solution of 2 per cent nitric acid in alcohol and re-examined. The nital-etched structure of the steel, shown in Figures 4 and 5 (photomicrographs at X100 and X1000 magnification respectively), consists of fine pearlite, the iron-iron carbide constituent, and ferrite (shown as light material in the photomicrographs), the iron content. No decarburization was noted along the surface of the tubing. The defect in the tube can be observed in Figure 4.

X100, etched in  
2 per cent nital.

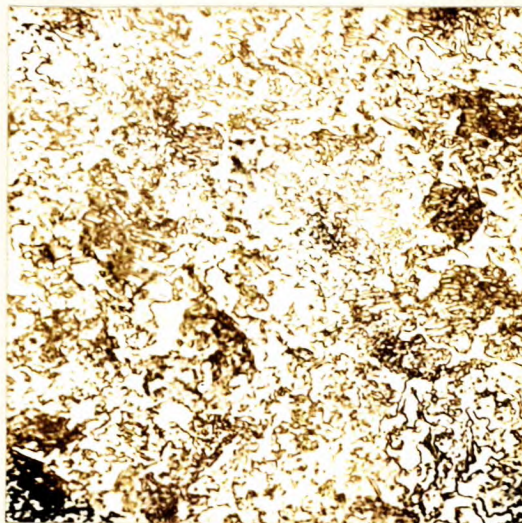
Figure 5.

X1000, etched in  
2 per cent nital.
