September 14th, 1944.

Investigation No. 1710.

Examination of a C.D.P. Track Shoe and Pin from an
Experimental Lot Which Had Failed in Test.

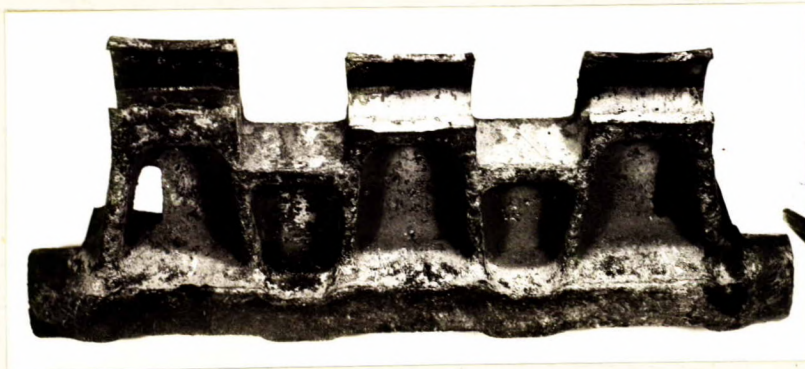
Figure 1.

The hinges on the three-hinge side of the shoe had all fractured (see Figure 1).

VIEW OF FRACTURES.

An examination of the fractures indicated the occurrence of a cold shut in one hinge.

The smooth surface of the fracture in one hinge indicated a cold shut. This and the very serious shrink in one other hinge are undoubtedly serious defects. Both defects indicate poor foundry practice. However, this should not be taken as an indictment of the producer, as it is understood the shoes in question were from a small experimental lot and that no other shoes have been made at this plant. There would, as yet, have been no opportunity of eliminating foundry troubles inevitably encountered in the commencement of production of a fairly complicated casting.

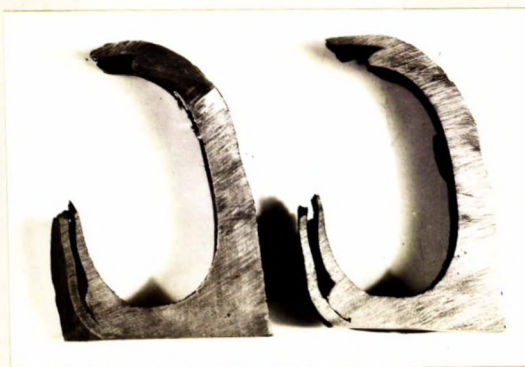
Figure 2.

Two of the hinges had pieces missing. One hinge had a serious shrink in the wall (see Figure 2).

TWO SECTIONS FROM SAME HINGE.

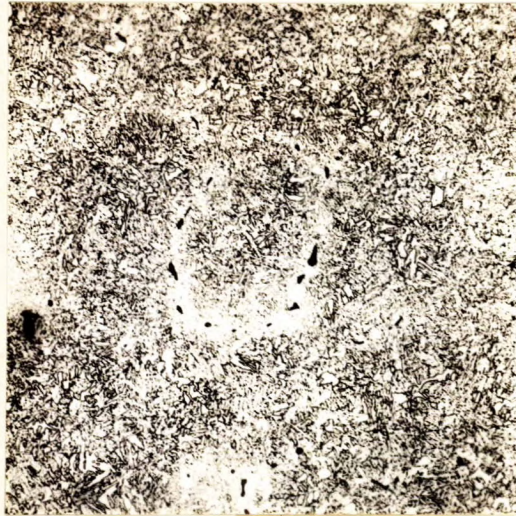
Figure 5.

The microstructure was tempered martensite with the inclusions segregated around the grain boundaries (see Figure 5).

TEMPERED MARTENSITE.

Note inclusions in grain boundaries.

The eutectic inclusions present at the grain boundaries point to a high solubility of sulphides. The solubility of the sulphides is influenced by the oxide content of the steel, and thus a low oxide content is indicated. Either greater additions of aluminium, which would result in the formation of aluminium sulphides of lower solubility, or smaller additions, which would lower the solubility of the iron- and manganese-sulphides, might result in a more proper dispersion of non-metallics.

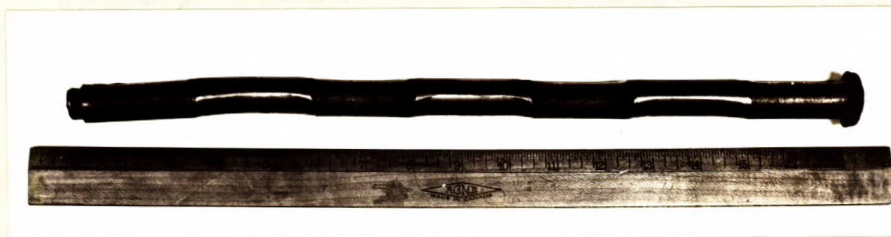
Figure 6.

The track pin was deeply worn and also slightly bent (see Figure 6).

PIN AS RECEIVED.

The pin had the specified composition but the hardness, particularly at the surface, was low. Low core hardness indicates low draw temperature, while the lower surface hardness is due to partial decarburization. This low hardness is responsible for the excessive wear.

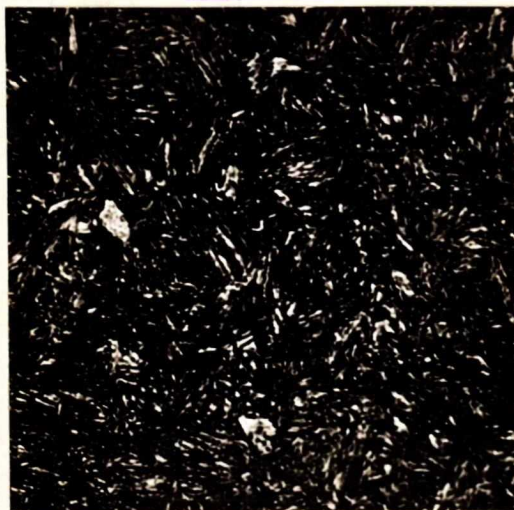
Figure 7.

The structure was tempered martensite (see Figure 7).

MICROSTRUCTURE OF PIN.
