ORE DRESSING AND METALLURGICAL LABORATORIES.

Investigation No. 1711.

Examination of Fractured Piat Bomb.

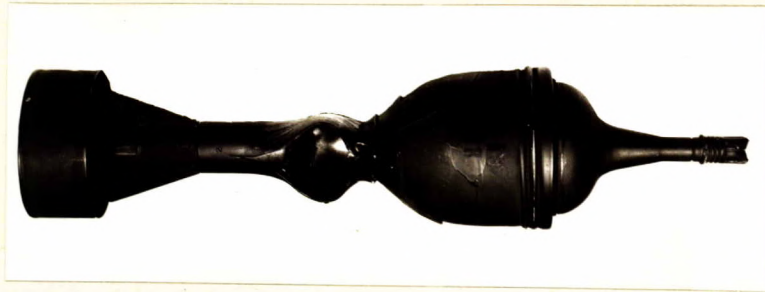
Figure 1.

Figure 1 is a photograph showing the Piat bomb in the "as received" condition. The inner and outer tubings were disassembled and given a visual examination. The outer and inner tubes, together with the failed portions of these tubes, are illustrated in Figures 2 and 3. The tubes were found to have the following dimensions:*

FRACTURED PIAT BOMB.
(Approximately $\frac{1}{5}$ actual size).

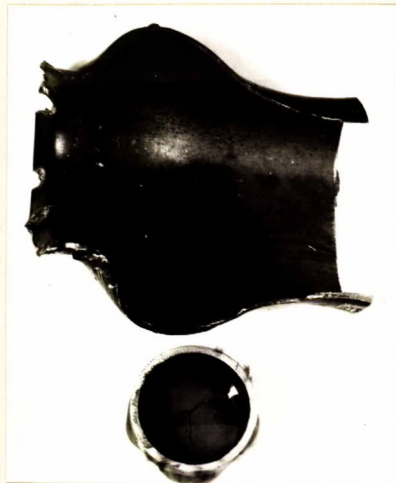
Figure 2.

OUTER TUBE.
(Approximately $\frac{1}{5}$ actual size).

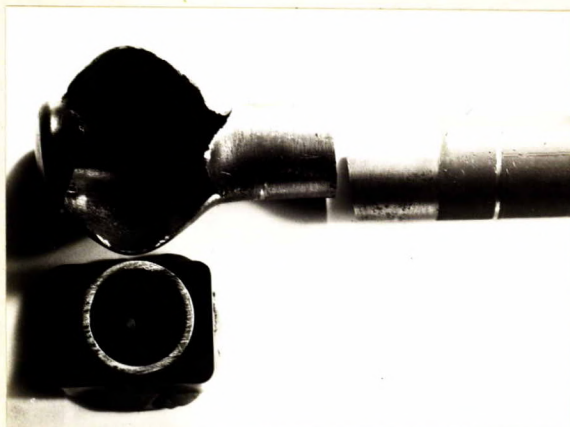
Figure 3.

INNER TUBE.
(Approximately $\frac{1}{5}$ actual size).

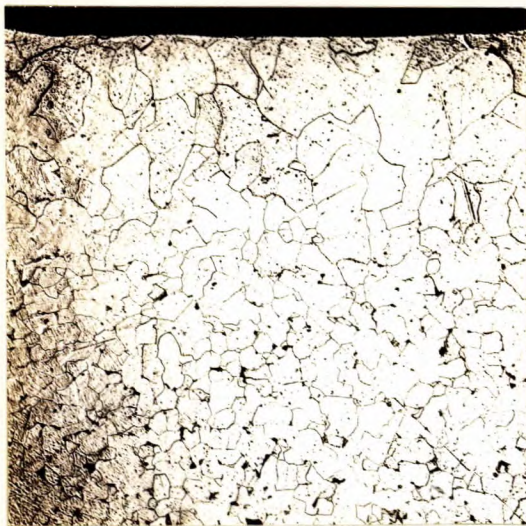
Figure 4.

well as grain growth at the surface (see Figure 4).

X100, etched in
2 per cent nital.

INNER TUBING.

The large grains at the outer surface of the inner tube are most probably due to the effect of cold work. There is also evidence of slight decarburization. Since the failure of the

tube was brought about by an explosive force, it is not thought that the latter defect would contribute to the cause of failure. The structure of tubes indicate that they both received a normalizing heat treatment and, apart from the slight decarburization of the inner tube, noted above, the heat treatment appeared to be quite satisfactory.

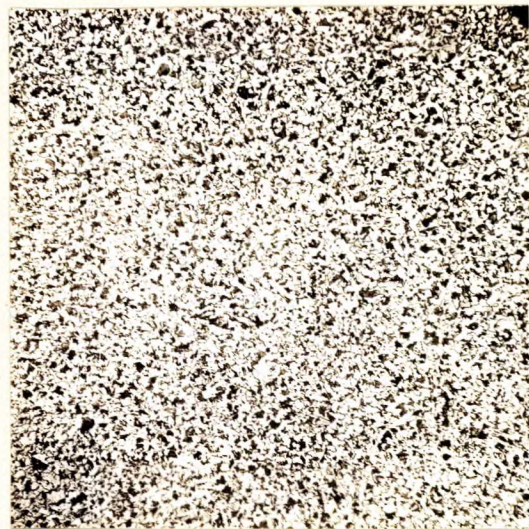
Figure 5.

X100, etched in
2 per cent nital.

OUTER TUBING.
