O T T A W A September 21st, 1944.

R E P O R T

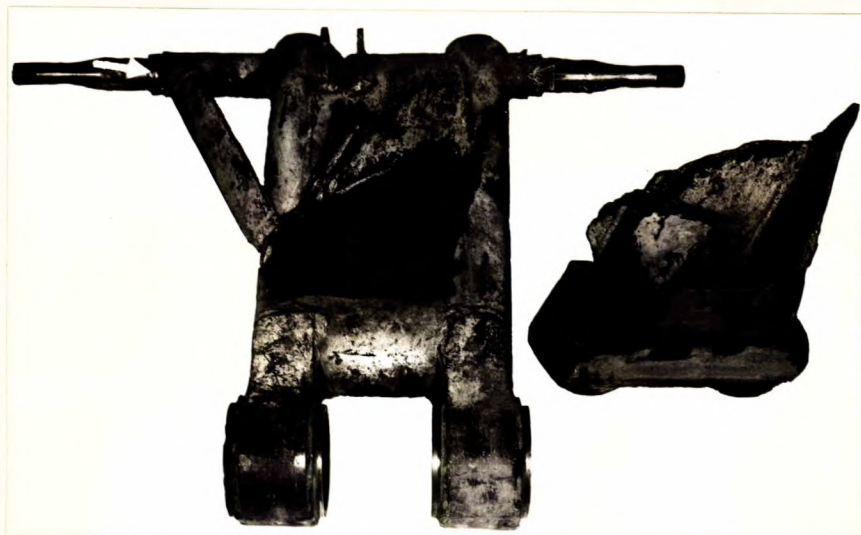
PHOTOGRAPH OF SAMPLE A, SHOWING THE SPRING SEAT ASSEMBLY COMPLETELY TORN AWAY FROM BODY.

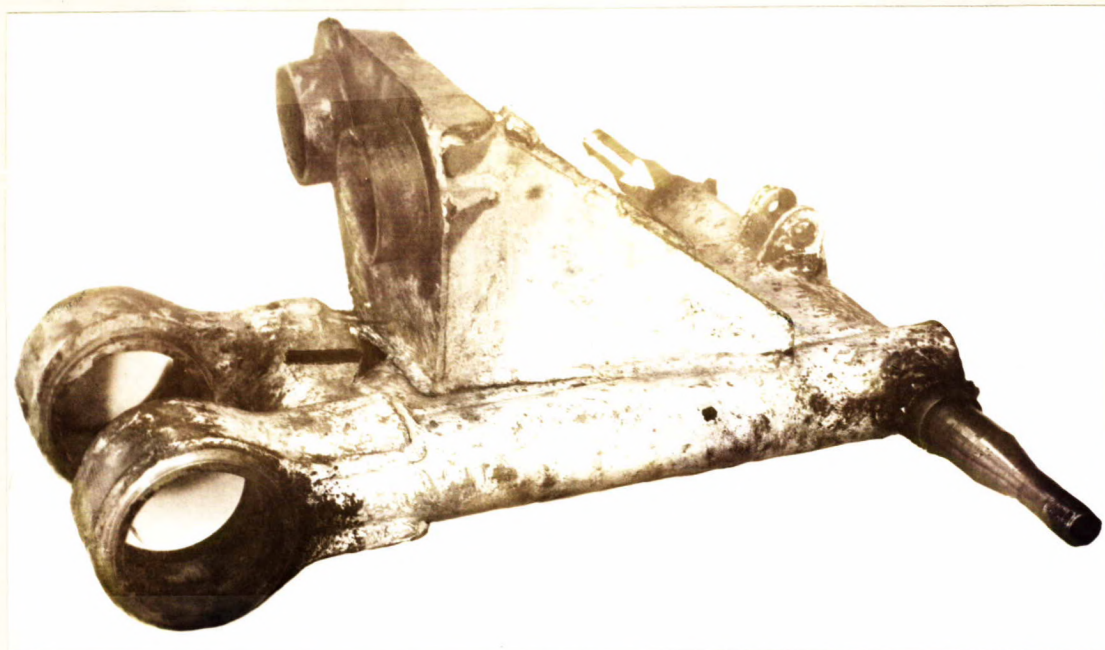
PHOTOGRAPH OF SAMPLE B.

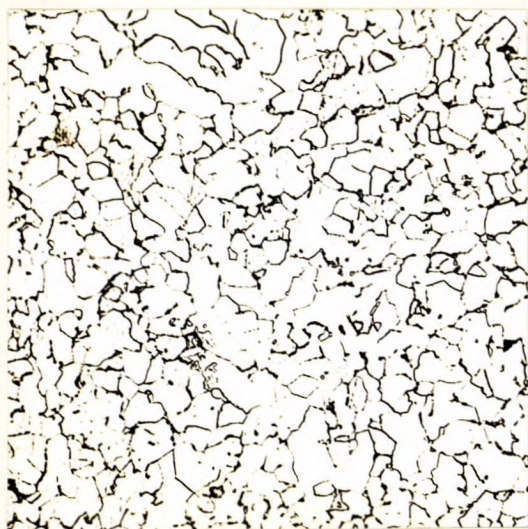
X250, nital etch.
REINFORCING PLATE
(PART NO. B 38422).

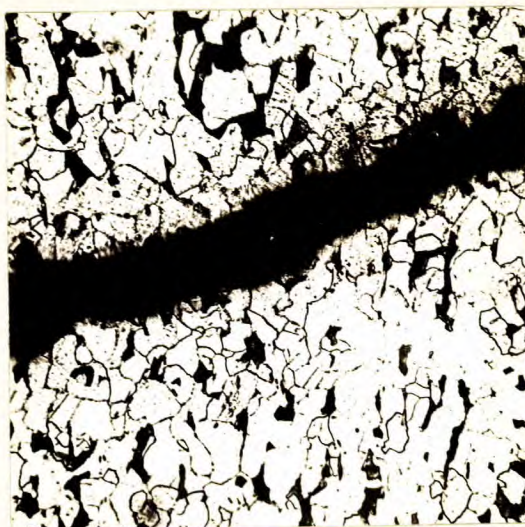
X250, nital etch.
FRACTURE IN PINION SUPPORT
TUBING (PART NO. B 38417).

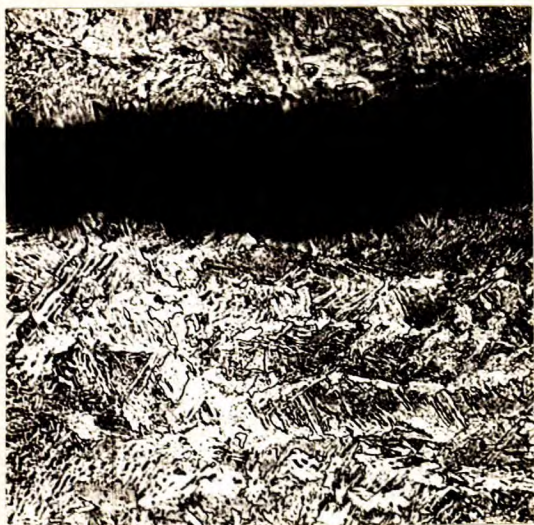
X250, nital etch.
FRACTURE IN PINION SUPPORT
TUBING, THROUGH WELD METAL.
Note absence of distortion
at edge of fracture.

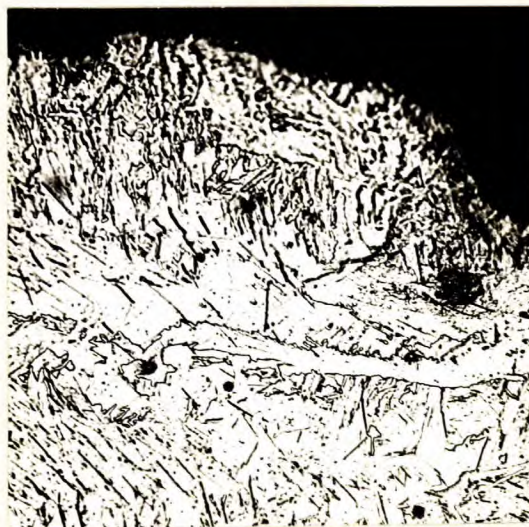
X250, nital etch.
EDGE OF FRACTURE IN REINFORCING
PLATE, RUNNING THROUGH WELD METAL.
Note absence of distortion.

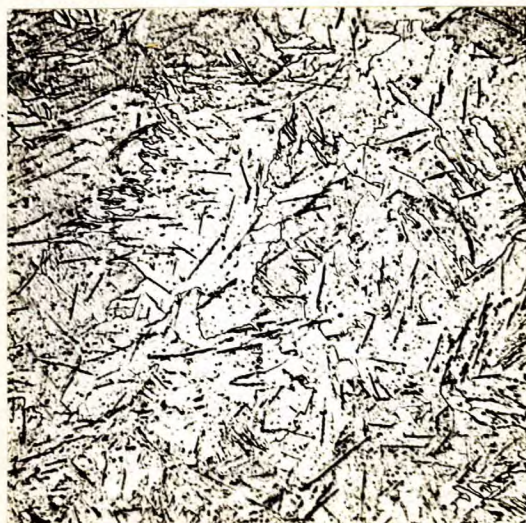
X250, nital etch.
WELD METAL DEPOSITED AT JUNCTION OF
REINFORCING PLATE AND SPRING SEAT PLATE.
Note nitride needles.
