September 25th, 1944.

ORE DRESSING AND METALLURGICAL LABORATORIES.

Investigation No. 1713.

Metallurgical Examination of a Steel Casting from
Sorel Steel Foundries Limited, Sorel, Quebec.

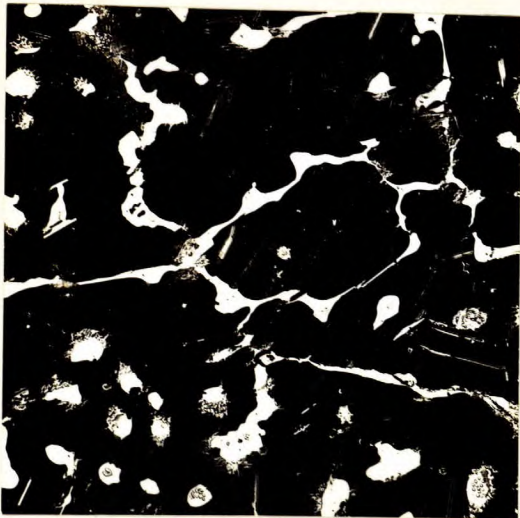
Figure 1.

Sections were cut from the sample submitted and prepared for microscopic examination. Figures 1 and 2 are photomicrographs, at X100 magnification, of the casting in the "as received" condition, taken respectively at the centre and near the edge of the specimen.

The chemical analysis and microscopic examination show that the casting is a manganese steel but has substantial additions of nickel, chromium and molybdenum. The presence of the latter elements has resulted in the formation of a eutectic of carbides and austenite which cannot be eliminated by heat treatment. This opinion is corroborated by the photomicrographs, Figures 3 and 4, which show the presence of the eutectic after the casting had been heated at 1900° F. for one hour and quenched

AUSTENITE (BLACK) AND
EUTECTIC (WHITE).

Taken at centre of
casting.

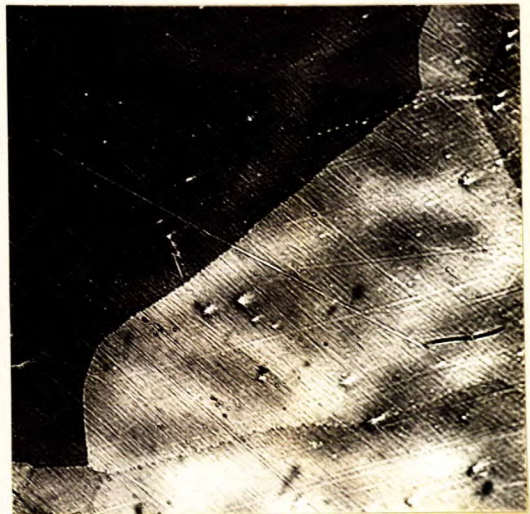
Figure 2.

The lack of the eutectic at the surface of the casting is most likely due to decarburization.

AS RECEIVED.

ALL AUSTENITE; DECAR-
BURIZED ZONE.

Taken at edge of
casting.

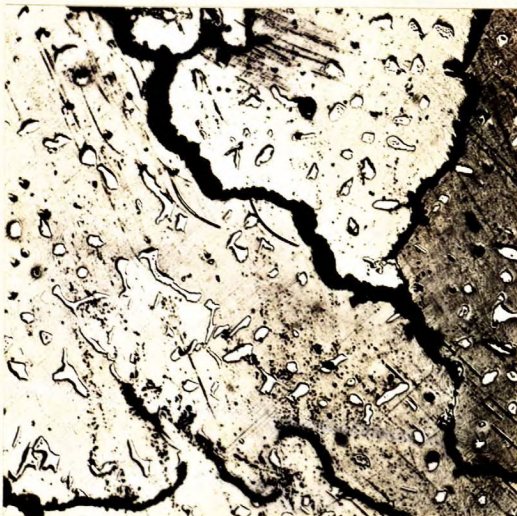
Figure 3.

Figures 3 and 4, at magnifications of X50 and X400 respectively, show the microstructure of the casting after heating at 1900° F. for one hour and quenching in water.

in water. Large cracks were also found scattered throughout the metal. The presence of this eutectic would render the metal extremely brittle and would account for the lack of ductility.

AUSTENITE AND EUTECTIC.

Note, also, large
cracks.

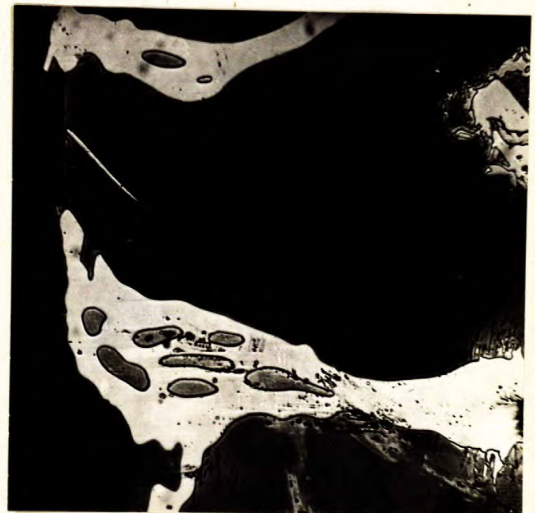
Figure 4.

EUTECTIC
(CARBIDES + AUSTENITE).

Heated at 1900° F. for One Hour;
Quenched in H₂O.
