O T T A W A September 26th, 1944.

ORE DRESSING AND METALLURGICAL LABORATORIES.

Investigation No. 1714.

Metallurgical Examination of Failed T-16
Universal Carrier Track Links.

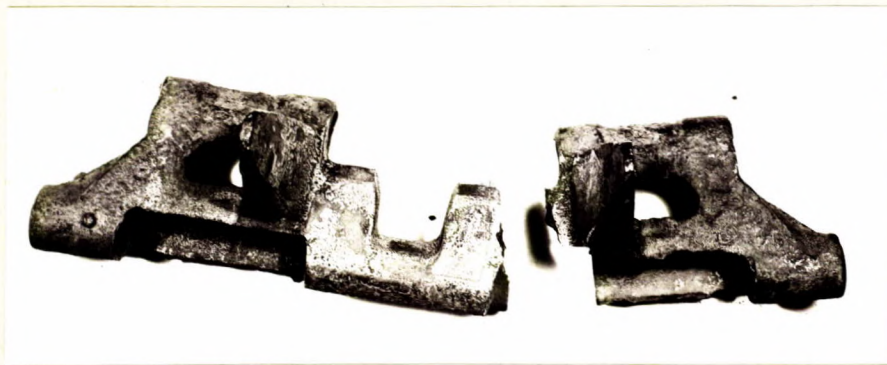
Figure 1.

- No. 1. - #3 link on left track in blue section.
At 958 miles the link broke across the barrel
(see Figure 1).
- No. 2. - #25 link on right track, blue section.
At 1,434 miles the link broke across the
barrel (also Figure 1).
- No. 3. - #13 link on left track, unpainted section.
At 1,247 miles, top broke off guiding lug
(see Figure 2).
- No. 4. - #145 link in red section. Failure as
shown in Figure 2.
- No. 5. - Link painted yellow. Failure as in
Figure 2.

TRACK LINKS NOS. 1 AND 2 FAILED IN THIS MANNER.

The presence of eutectic-type inclusions outlining the grain boundaries of Links Nos. 1 and 2 causes considerable loss of ductility and impact strength and explains early failure

3. Microscopic examination has shown eutectic-type inclusions outlining the grain boundaries in the metal adjacent to the points of failure in Links Nos. 1 and 2. This arrangement of non-metallic inclusions invariably lowers the ductility and impact strength, and is the most likely cause of failure in these links.

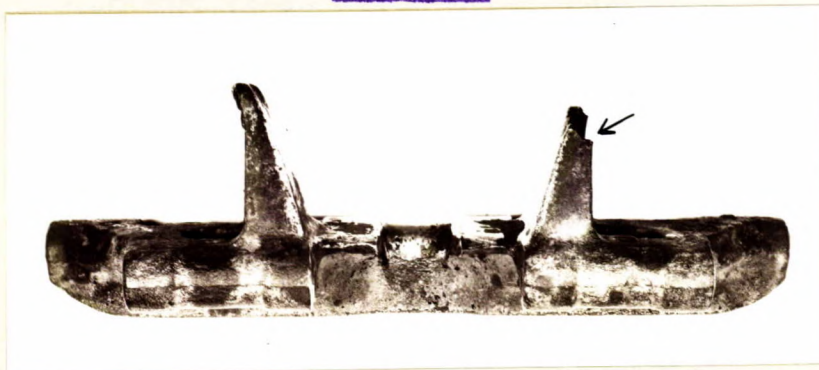
Figure 2.

TRACK LINKS NOS. 3, 4 AND 5 FAILED IN THIS MANNER.

Arrow indicates failure on guiding lug.

The hardness (336-375 Vickers) is definitely higher than usually observed in satisfactory cast steel links.* The resultant lowering of impact strength would contribute to failure, particularly in the guiding lugs.

2. The hardness of the links is definitely higher than normally found in satisfactory cast steel links and is considered a contributory cause of failure, particularly in the guiding lugs.

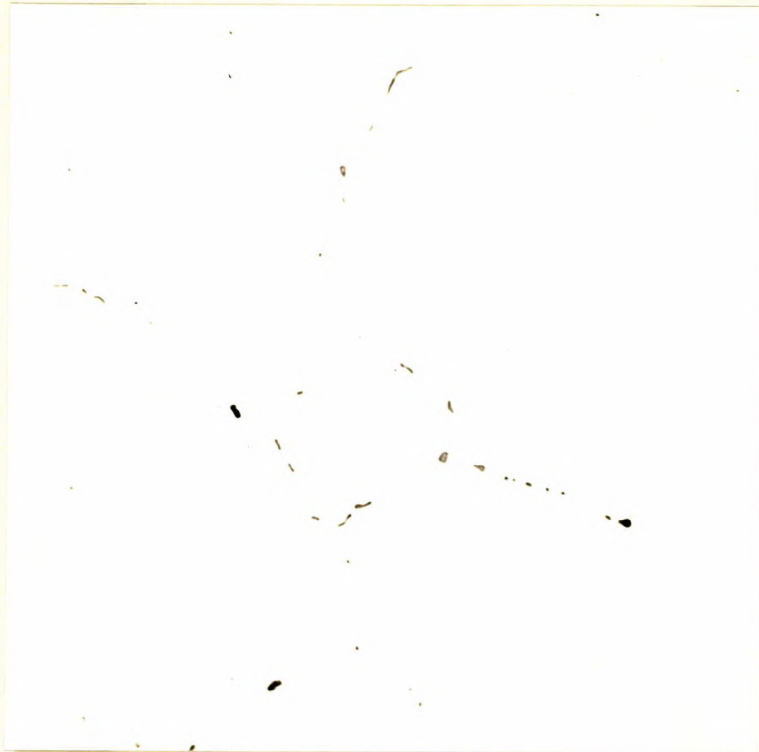
Figure 3.

Microscopic examination of Links Nos. 1 and 2 at the points of failure disclosed a drawn martensitic microstructure, some areas of which contained numerous eutectic-type duplex inclusions outlining the grain boundaries. Photomicrographs of these areas, in the unetched and etched condition, are shown in Figures 3 and 4. The microstructure of the metal adjacent to the breaks in the guiding lugs of Links 3, 4 and 5 was uniformly drawn martensite. A typical example of this is shown in Figure 5.

X500, unetched.

EUTECTIC-TYPE INCLUSIONS, PROBABLY DUPLEXED
SILICATES AND ALUMINIUM SULPHIDE.

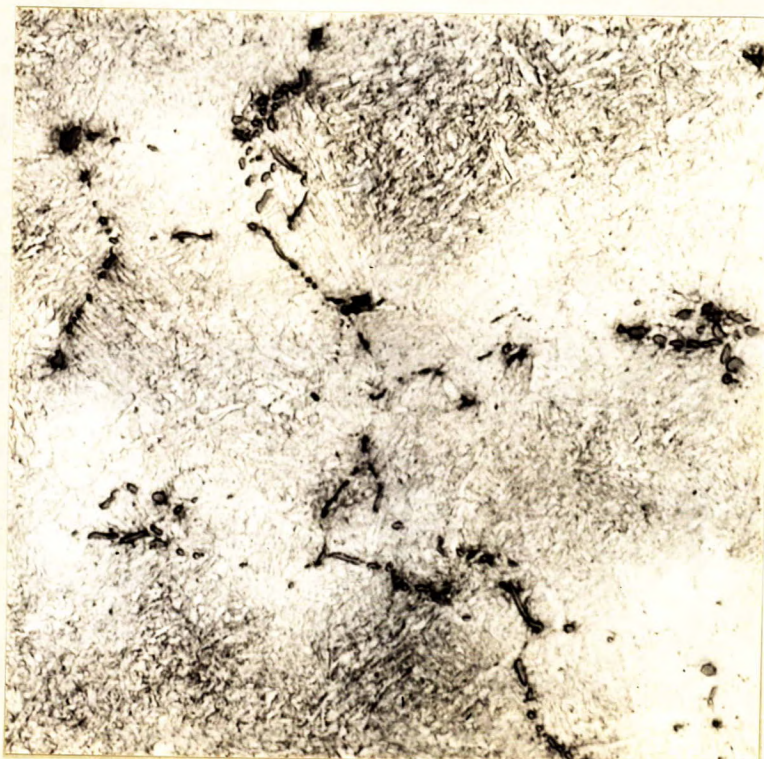
Figure 4.

X500, etched in 2 per cent nital.

DRAWN MARTENSITE CONTAINING EUTECTIC-
TYPE, NON-METALLIC INCLUSIONS.

at these points. This unfavourable arrangement of the non-metallic inclusions has originated from improper killing of the steel in the melting process.

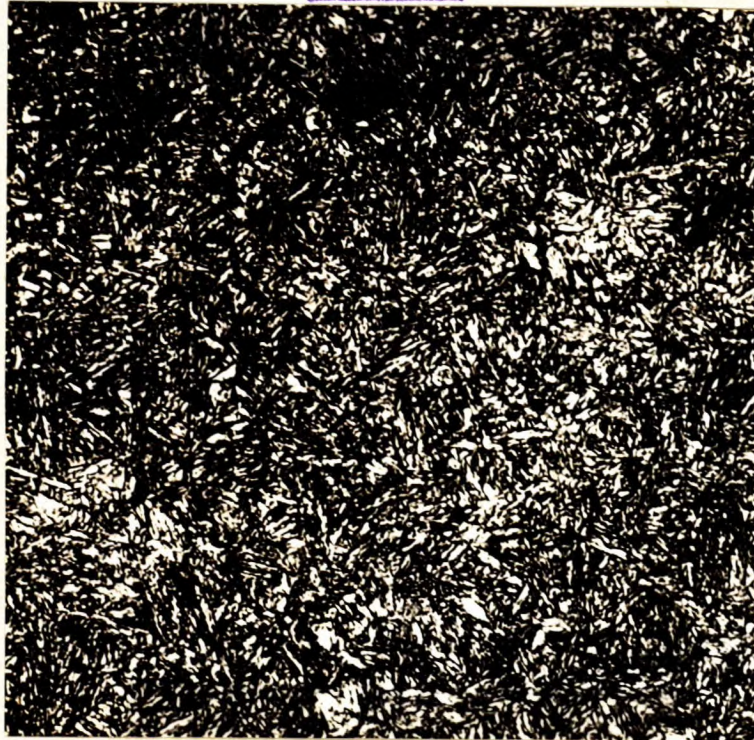
Figure 5.

X500, etched in 2 per cent nital.

DRAWN MARTENSITIC MICROSTRUCTURE.
