ORE DRESSING AND METALLURGICAL LABORATORIES.

Investigation No. 1719.

Metallurgical Examination of Ford  
and Chevrolet Exhaust Valves.

O T T A W A      October 10th, 1944.

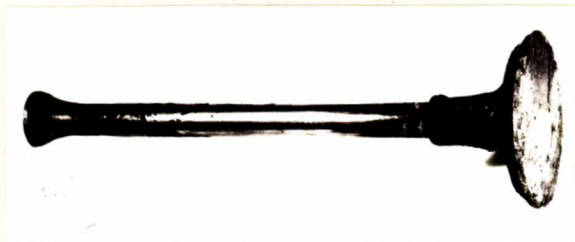
Figure 1.

FORD EXHAUST VALVE.

stantial quantities of lead compound. The barium found in both valve scales comes from the additives in the heavy duty oils. The fact that some nickel, chromium and iron were found in the scale from the Chevrolet valve indicates that corrosion was taking place. These elements were not evident in the scale scraped from the Ford valve.

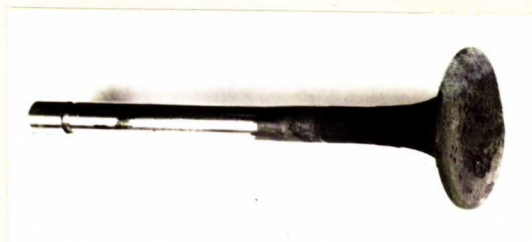
Figure 2.

CHEVROLET EXHAUST VALVE.

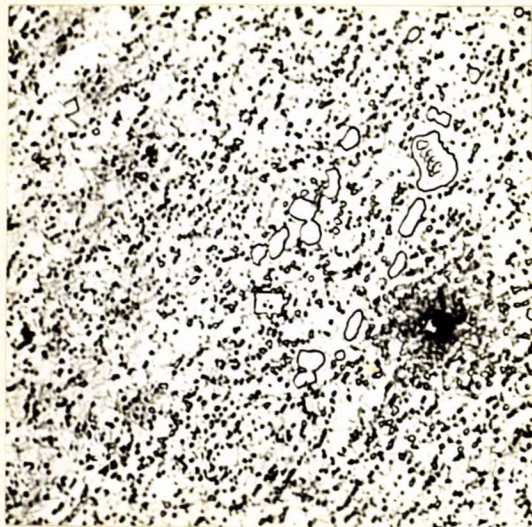
Figure 3.

Sections of the two valve types were polished and etched for microscopic examination. Figures 3 and 4 are photomicrographs at a magnification of X750, showing the microstructures obtained on etching in Vilella's reagent.\* Figure 3, taken from the Ford sample, shows carbides in a background of austenite. Figure 4, taken from the Chevrolet sample, shows the microstructure, which consists of carbides in a ferrite background.

FORD VALVE.

Carbides in a background  
of austenite.

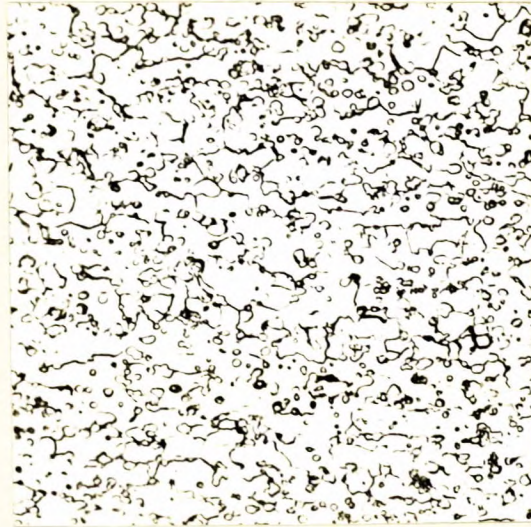
Figure 4.

CHEVROLET VALVE.

Carbides in a background  
of ferrite.
