ORE DRESSING AND METALLURGICAL LABORATORIES.

Investigation No. 1722.

Examination of Fractured Composite
Tail Tubes of a Piat Bomb.

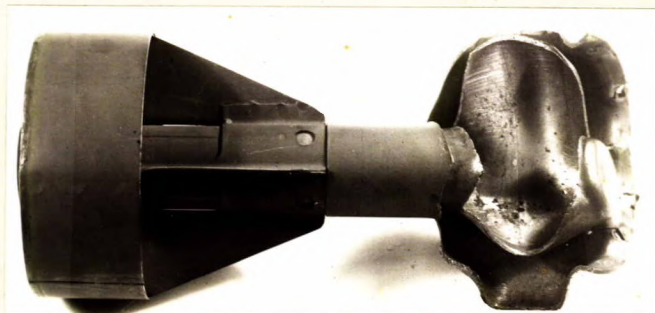
Figure 1.

Figure 1 is a photograph illustrating the nature of the side burst of the composite tail tubes of the Fiat bomb after proof firing.

PHOTOGRAPH SHOWING SIDE BURST OF
FIAT BOMB COMPOSITE TAIL TUBE.

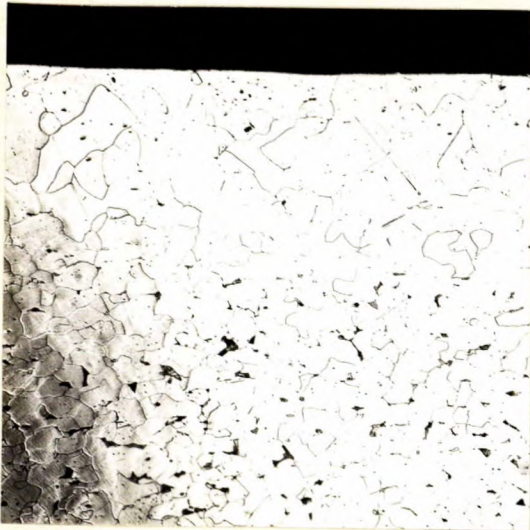
Figure 2.

number of elongated inclusions (chiefly sulphides) were observed in the steel of the outer tube. After an etch in 2 per cent nital, the steels were re-examined. The nital-etched structures of the tubes are shown in Figures 2, 3 and 4. The outer surface of the inner tube (shown in Figure 2) was slightly decarburized, but no decarburization was noted on the inner surface of this tube. The structure is typical of that of a normalized low carbon steel. Figures 3 and 4 are photomicrographs, at X250 and X1000 magnifications respectively, showing the outer tube. It will be noted that while some pearlite is present the carbides are mainly in the spheroidized condition.

INNER TUBE.

tube was also considered to be satisfactory, except for a slight decarburization and grain growth on the outer surface. The microstructure of the outer tube showed that the steel was not completely normalized, the carbides being largely in the spheroidized condition. This would indicate that the steel had not been held long enough at the normalizing temperature to effect complete solubility of these spheroidized carbides. However, failure of the tube is not attributed to this incomplete normalizing, as the pearlite-spheroidized carbide-ferrite material should have approximately the same properties as the pearlite-ferrite, properly normalized material. As for this fairly low carbon steel, the properties would be largely determined by the continuous phase, which is ferrite in both cases. This is confirmed by the mechanical tests, although too much reliance should not be placed on small specimens. It is thought, then, that if the possibility of incorrect design can be eliminated, failure in the present instance can be attributed to mechanical rather than to metallurgical causes.

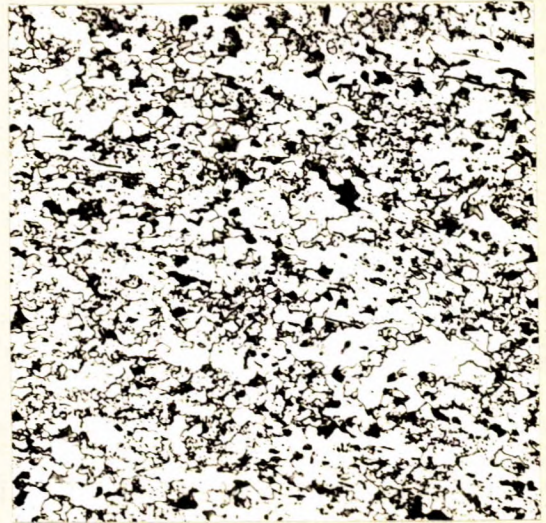
Figure 3.

OUTER TUBE.

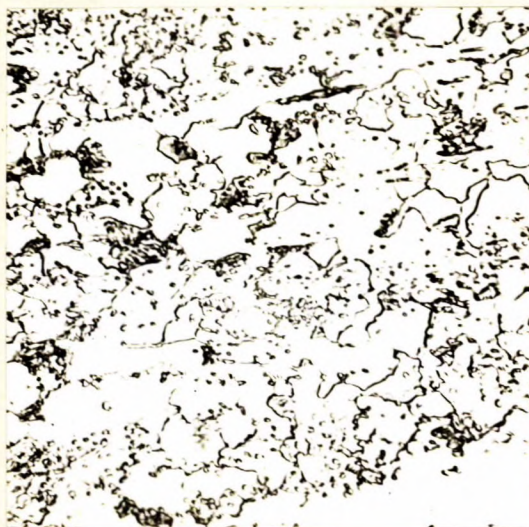
Figure 4.

OUTER TUBE.
