October 19th, 1944.

ORE DRESSING AND METALLURGICAL LABORATORIES.

Investigation No. 1723.

Induction Normalizing of 2-Inch Trench  
Mortar Bomb Tail Units.

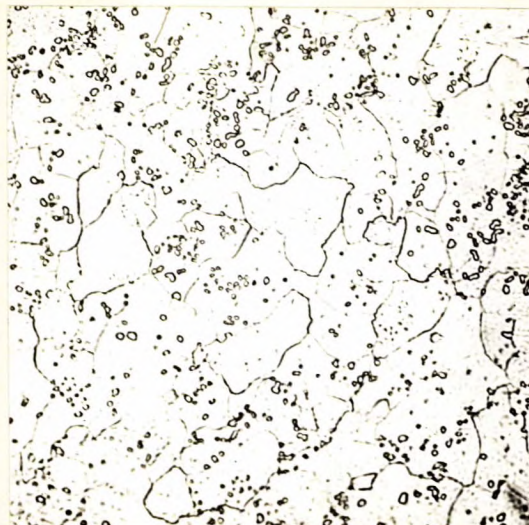
The microstructure "as received" is coarse spheroidite, as shown in Figure 1.

In the "as received" condition the bomb tails were coarsely spheroidized. This type of microstructure makes the austenitizing reaction sluggish.

SHOWING THE MICROSTRUCTURE OF  
THE BOMB TAILS "AS RECEIVED".

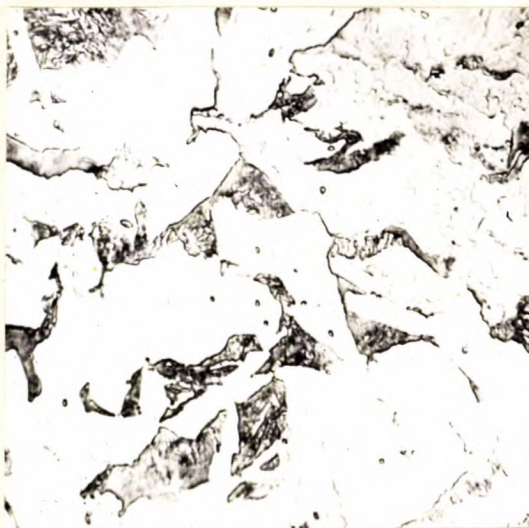
Figure 2.

The microstructure was examined after each of these heat treatments. The constituents were in all cases ferrite and pearlite with a decreasing amount of free carbides as the time at approximately 1800° F. increased. After 290 seconds some residual carbides were still observed (see Figure 2).

The results of the investigation have shown that it is not possible to completely normalize these bomb tails from their coarse spheroidized structure within 5 minutes. The time required to completely dissolve the carbides would thus seem to be too long for economical operation in commercial practice. Moreover, since no provision is made for protective atmosphere

SHOWING THE MICROSTRUCTURE  
DEVELOPED AFTER INDUCTION  
NORMALIZING (290 SECONDS AT  
APPROXIMATELY 1800° F.).

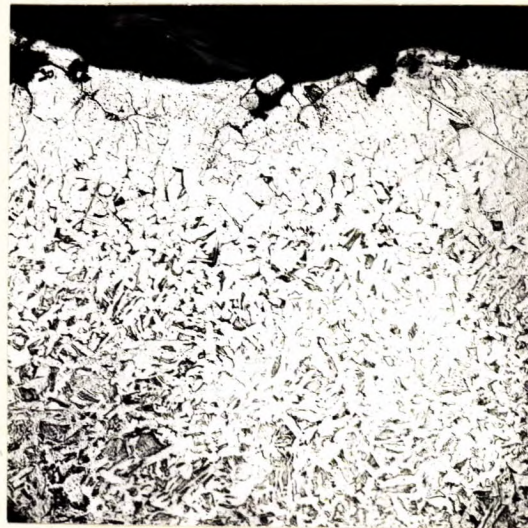
Figure 3.

in the usual induction heat treatment practice, the steel is exposed to oxidation and also decarburization. This condition has been observed in the present case (see Figure 3).

SHOWING DECARBURIZATION  
AFTER INDUCTION NORMALIZING  
(290 SECONDS AT  
APPROXIMATELY 1800° F.).

It is therefore concluded that, from the economical point of view, induction methods are not to be recommended. Moreover, the surface condition of the tails after a treatment of 5 minutes (which is not severe enough) would not seem to be satisfactory.
