Investigation No. 1726.

Examination of Magnesium Alloy Outer Casting for
Tail Wheel Shock Strut of a Mosquito Aircraft.

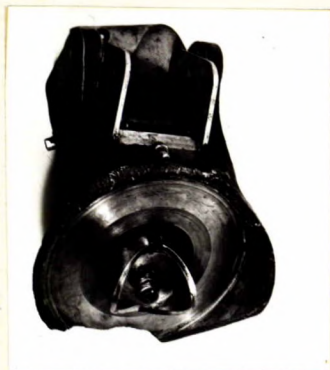
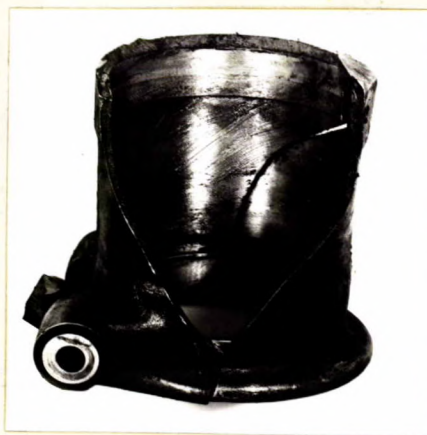
Figure 1.

Figure 1 is a photograph of the casting as received. In Figure 2 (a close-up of the fractured surface), the break is seen to have some typical fatigue characteristics. The nucleus of failure was not noticeable.

CASTING AS RECEIVED.

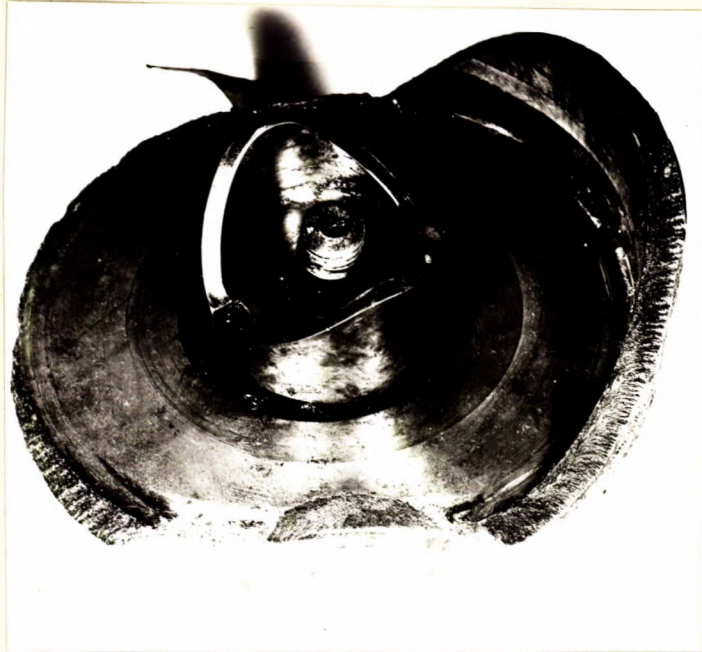
Figure 2.

CLOSE-UP OF PART OF FRACTURE.

In material of this kind, with its comparatively low ductility (about 1.5 per cent elongation in two inches), fatigue, impact and tensile failures might all appear somewhat similar. It would seem, however, from the appearance of the fracture and from the fact that failures occur within a certain range of time rather than at random, that fatigue was the mode of failure.

1. The failure appears to be of the fatigue type.
2. There are indications that this casting has been aged. If this is so, and if design considerations do not necessitate a high proof stress, it would appear desirable to change the practice and use the casting in the solution-heat-treated state, because the fatigue strength would be

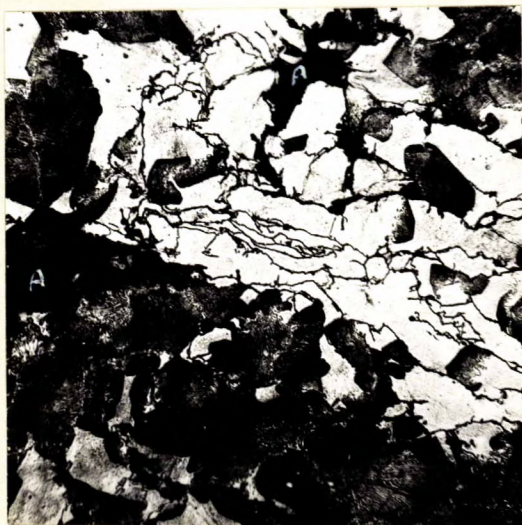
Figure 3.

The casting defect noticed during the mechanical tests was found, when examined microscopically, to consist of cavities with numerous connecting stringers. Figure 3, a photomicrograph of it, shows that there is very little beta precipitation in the defective region, but the normal structure may be seen at the top and bottom of the picture.

PHOTOMICROGRAPH OF DEFECTIVE AREA.

Black voids at A are cavities.
Note connecting stringers.

Macroscopic and microscopic examinations indicate that the defect found in this part is an oxide or dross inclusion. A defect of this type would act as a notch and, if present in a critical area, would contribute to failure, especially failure by fatigue.

3. Defects of a type similar to the one found in this part may have contributed to failure. In view of the number of breakages occurring, however, it would seem most unlikely that, even if no defects of this type were present, this casting would have been absolutely reliable. A change in section thickness or, if skin stresses are responsible for failure, a change in design or material, would seem necessary.
