ORE DRESSING AND METALLURGICAL LABORATORIES.

Investigation No. 1727.

Examination of an S.A. Cam for 4-Inch
Twin Mk. XIX Gun Mounting.

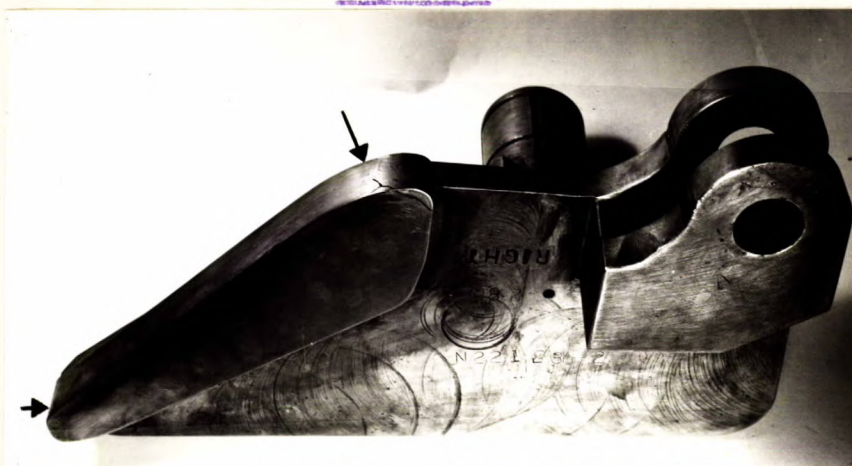
Figure 1.

Figure 1 illustrates the cracks (arrows in picture) on the cam face as it was received. Figure 2 is a close-up view of a crack on the flame-hardened surface.

CAM "AS RECEIVED".

Arrows point to cracks.

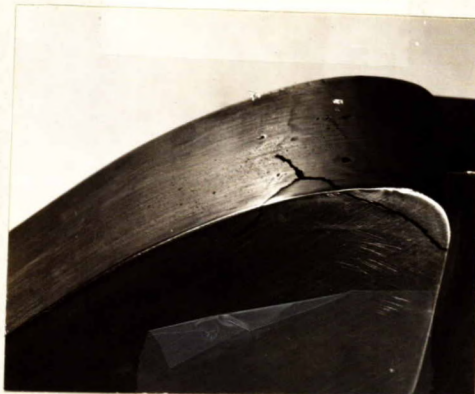
Figure 2.

CLOSE-UP OF A CRACK
ON FLAME-HARDENED SURFACE.

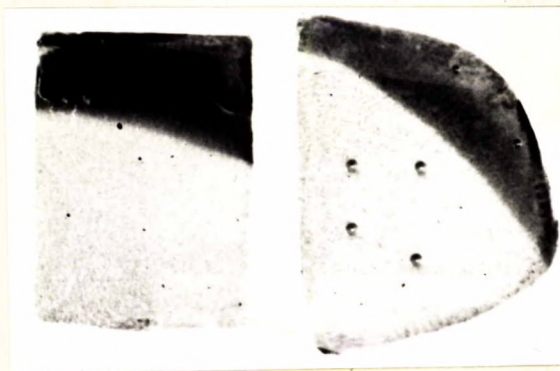
Figure 4.

Figure 4 illustrates the variation in depth of the hardened zone. It varies from 0.12 to 0.30 inch.

DEPTH OF HARDENED ZONE.

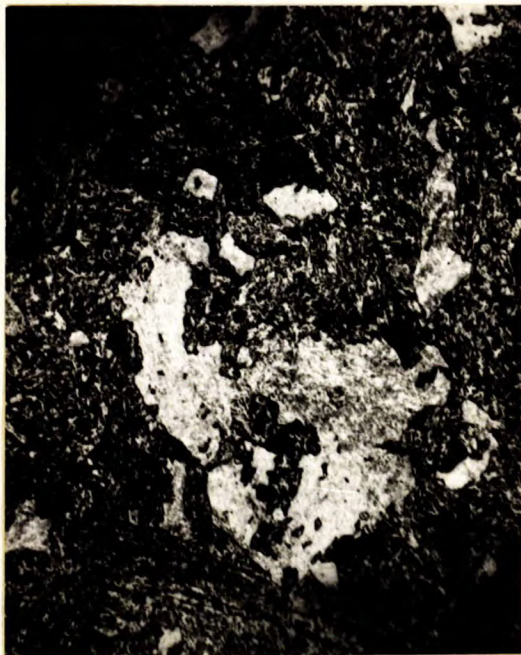
Figure 5.

X250, nital etch.

SORBITE AND FERRITE STRUCTURE
OF THE UNHARDENED CAM.

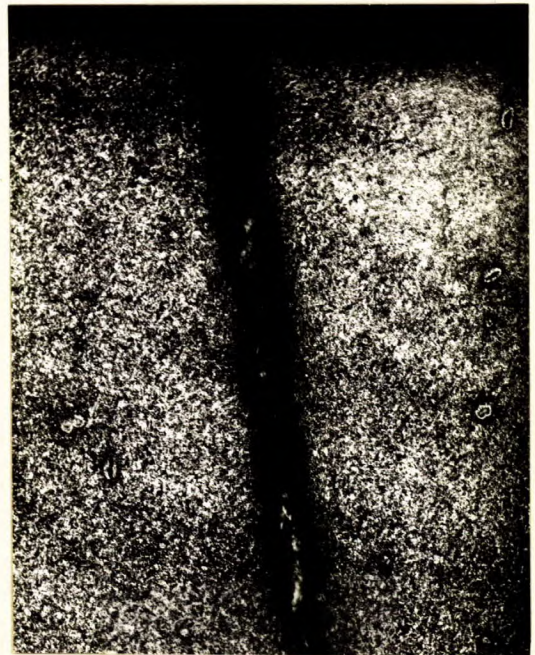
Figure 6.

X150, nital etch.

Note crack and
martensitic structure.

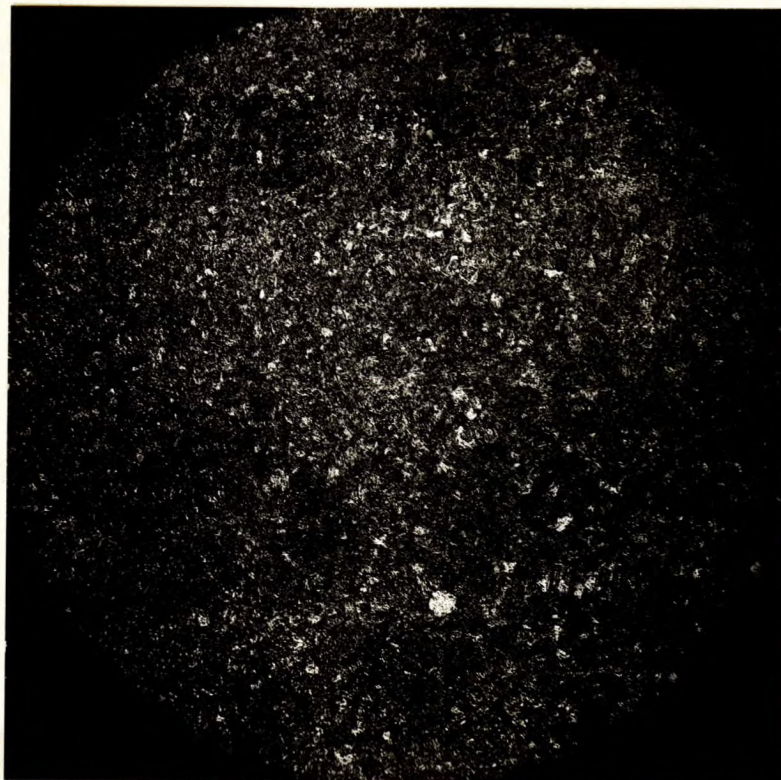
Figure 7.

X100, Vilella's etch.

Note the very fine grain size.

Cracking in a flame-hardening operation is usually caused by heating the work to a high temperature prior to quenching and/or subjecting the heated zone to too severe a quench. Figures 7 and 8 indicate that the grain-coarsening has taken place at the surface. This is caused by overheating, and can be corrected by:

- (1) Raising the flame torch slightly higher.
- (2) Reducing the length of the heating cycle somewhat.
- (3) Reducing the orifice diameter of the burners.

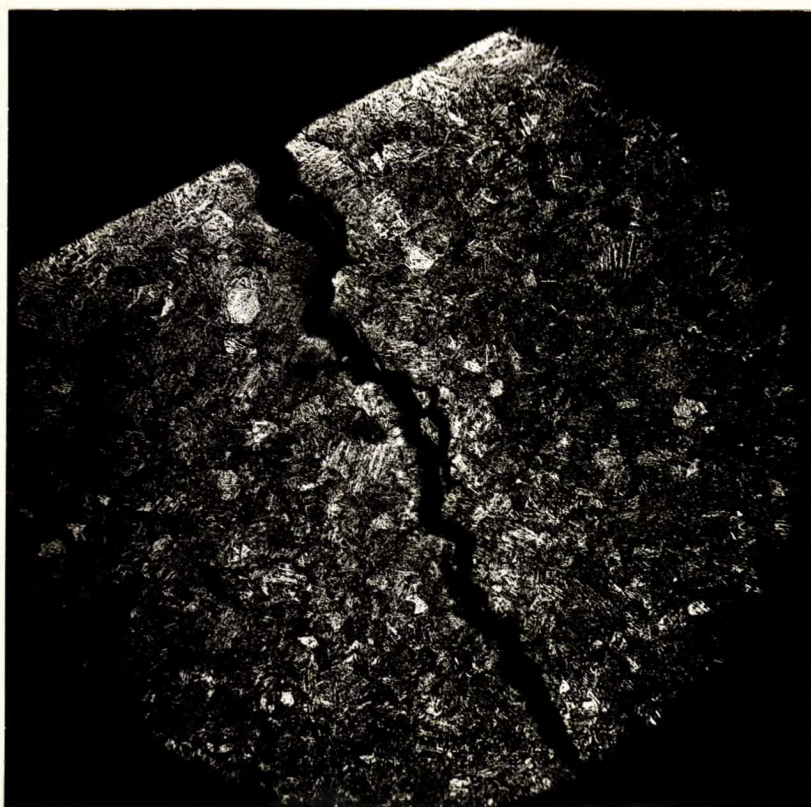
Figure 8.

X100, Vilella's etch.

Note coarser grain size at the surface.
