O T T A W A November 1st, 1944.

R E P O R T
of the
ORE DRESSING AND METALLURGICAL LABORATORIES.

Investigation No. 1728.

Examination of 20-mm. Cartridge Cases.

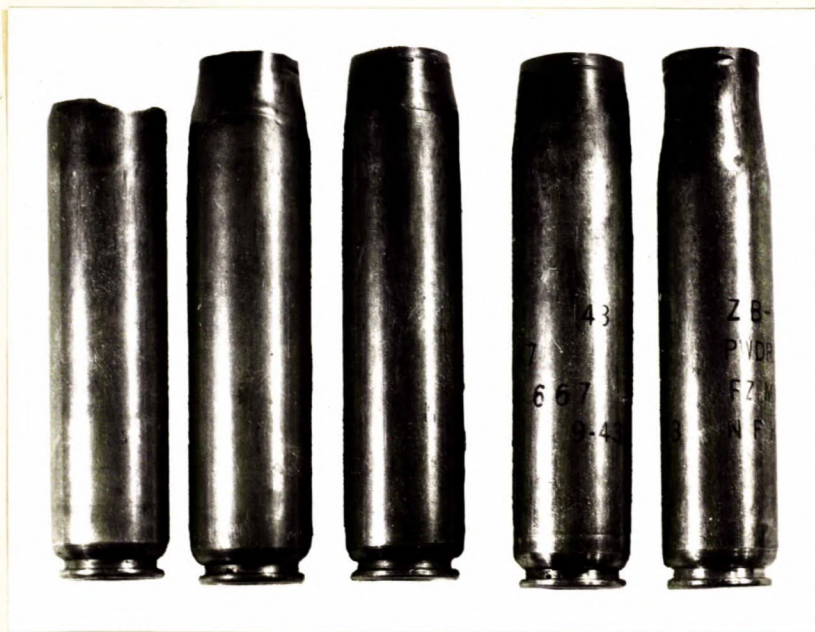
Figure 1.

CASES AS RECEIVED.

No. 1: Case which burst.

Nos. 2 and 3: Cases from same lot as 1. Note crease at neck of each.

No. 4: Case which fired successfully.

No. 5: Unfired case.

By comparing Cases Nos. 4 and 5 (Figure 1), it may be noticed that the neck of the case has expanded on firing.

The outlines of the creases on the necks of Cases Nos. 2 and 3 were found to correspond exactly to the form of the piece detached from Case No. 1. As well, the imprints of the crimping marks on the neck of the detached piece from the No. 1 cartridge case (see Figure 1) were found on Nos. 2 and 3. It was noticed that the rupture in the detached piece, as seen from its imprint in Cases Nos. 2 and 3 (Figure 1), was rather angular and extended farther down the shell in two locations and that these were in line with two of its crimping marks. One of these locations may be seen in Figure 2.

The macro- and micro-examinations show that the markings on the necks of the two cases accompanying the one which ruptured resulted from these cases being fired after the ruptured one and expanding onto the detached piece of it lodged, temporarily, in the front of the chamber. It is evident, then, that only one of the cases submitted ruptured or tended markedly to rupture. From the described and pictured contours of the fracture it would seem that the crimps influenced the stress distribution considerably during failure.

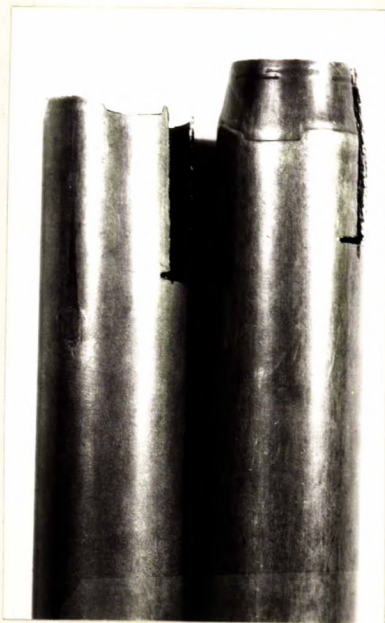
Figure 2.

ANGULAR NATURE OF PART OF FRACTURE.

Samples removed prior to photographing.
Note identical contour of rupture and crease,
as well as imprint of crimp mark on shell
at right above its own crimp.

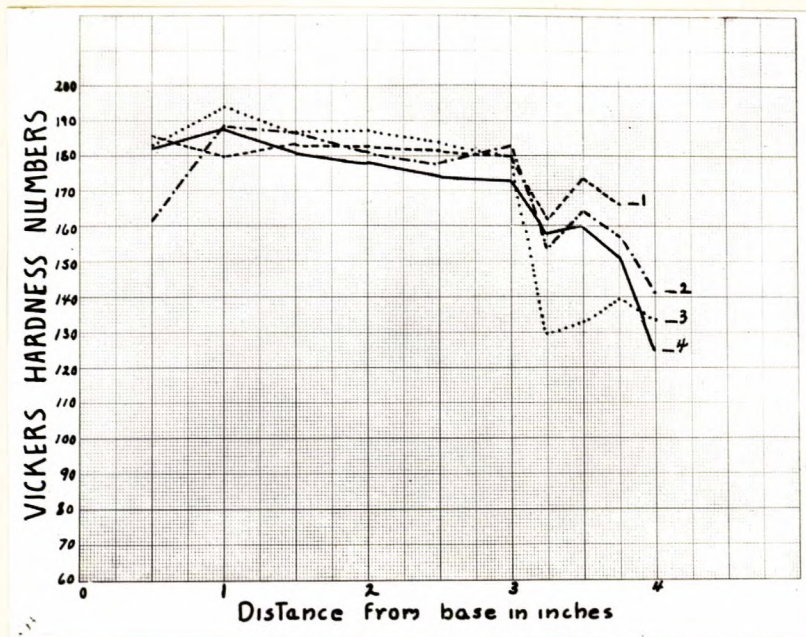
Figure 3.

HARDNESS CURVES FOR FIRED CASES.

- Curve No. 1. - Case which ruptured, with single flash hole.
- " " 2. - Cases, with double flash holes, which fired successfully.
- " " 3. - Cases, with single flash hole, which fired successfully.
- " " 4. - Cases, with creases near shoulder, single flash hole.

The hardness tests and microscopic examination indicate that the material in the cases is quite uniform in the critical area and that there is no apparent metallurgical

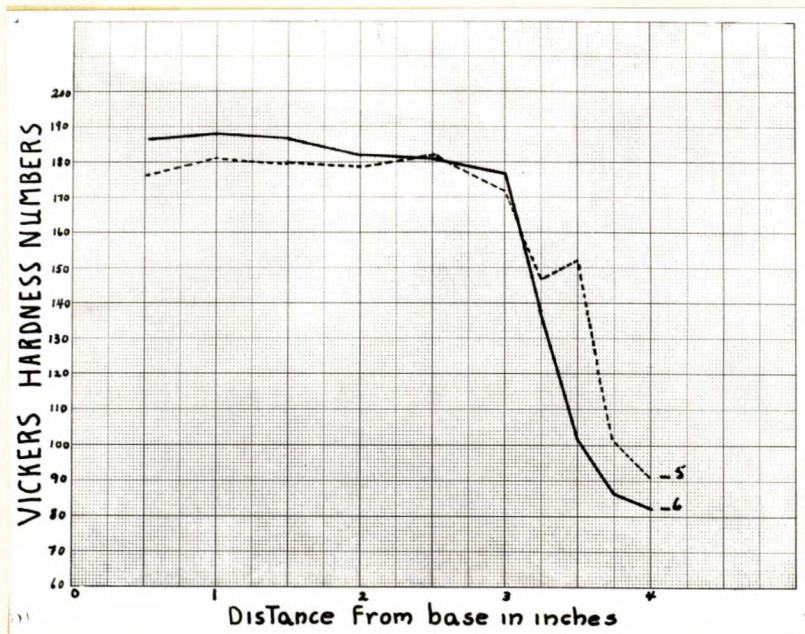
Figure 4.

HARDNESS CURVES FOR UNFIRED CASES.

- Curve No. 5. - Unfired cases with double flash holes.
" " 6. - Unfired cases with single flash holes.

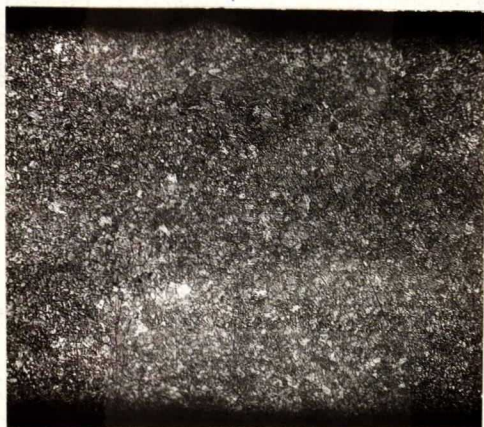
Figure 5.

UNFIRED CASE,
DOUBLE FLASH HOLE.

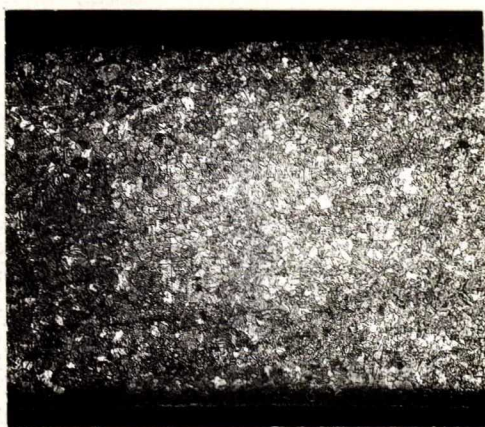
Figure 6.

UNFIRED CASE,
SINGLE FLASH HOLE.

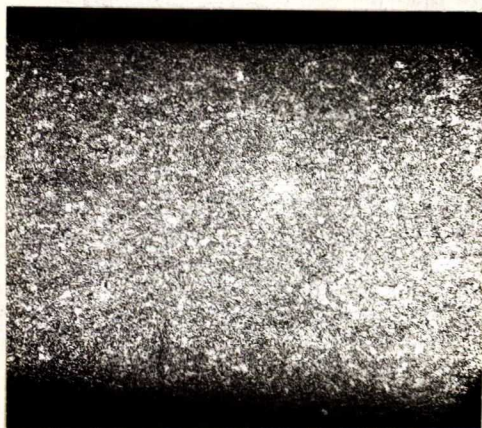
Figure 7.

FIRED CASE,
DOUBLE FLASH HOLE.

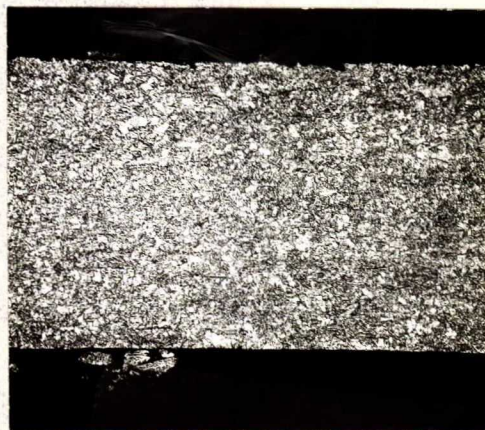
Figure 8.

FIRED CASE,
SINGLE FLASH HOLE.

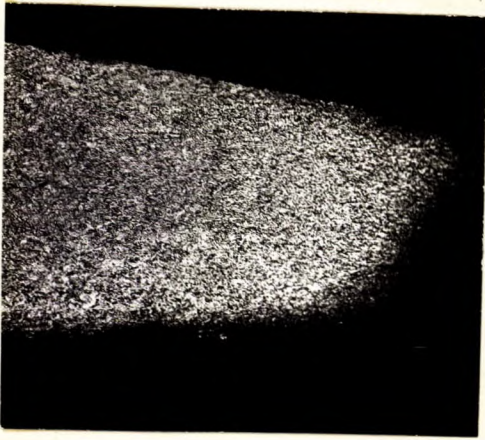
Figure 9.

In Figure 9 it may be noticed that the ruptured case has necked down considerably at the fracture. In Figure 10 the

X75.
FRACTURE IN
RUPTURED CASE.

The appearance of the fracture (Figure 9) shows that the metal failed by tension stressing beyond its ultimate strength. Since the hardness of this ruptured case in the critical area is not significantly different from that of the others, an unusually low tensile strength certainly would not be expected in the cartridge case. Also, the ductile, necked-down nature of the break rules out brittleness of the brass (caused by stress-corrosion cracking, etc.) as a contributor to failure.

The two points, (a) that the break was caused by overstressing in tension and (b) that the crimping played a role in the stress distribution during failure (an indication that the case still held the projectile during the stressing which caused failure), lead to the conclusion that failure was caused by an unusually abrupt and/or severe forward thrust on the projectile and resultant pull on the neck of the case. It would seem that the gun, cartridge or ballistic factor or factors which caused this, such as excessively fast development of breech pressure, too tight crimping, misalignment, etc., were responsible, rather than a metallurgical deficiency in the case, for the rupture.

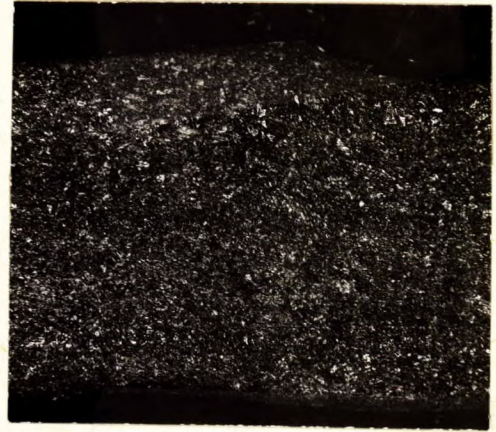
Figure 10.

marking around the neck of a case from the lot in which rupture occurred is seen to be a definite ridge on the outside with a corresponding bulge inside.

X75.
FIRED CASE,
CROSS-SECTION THROUGH CREASE
IN NECK (REFER TO CASES
NOS. 2 AND 3, FIGURE 1).
Outer side of case is at top.
