November 1st, 1944.

ORE DRESSING AND METALLURGICAL LABORATORIES.

Investigation No. 1730.

Examination of a Defective Manganese Steel Jaw Plate.

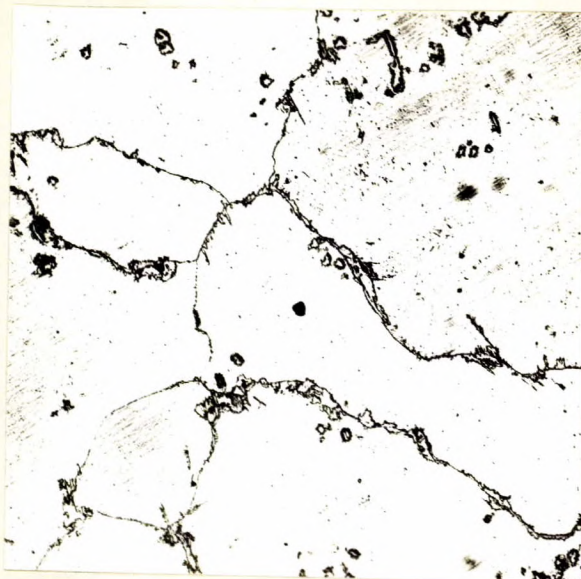
Figure 1.

Figure 1 is a photomicrograph of the structure as received.

casting as received (see Figure 1) are undoubtedly the cause of the failure, and are the result of the high carbon content.

1. The casting failed because of free carbides at the grain boundaries.
2. The carbon content of the steel was above specification for manganese steel. This off-standard analysis was the cause of the free carbides observed.
3. The steel was probably correctly heat-treated.
4. Excessive shrinkage cracks probably contributed to the failure.

MICROSTRUCTURE AS RECEIVED.

Free carbides at grain boundaries  
and throughout the grains.

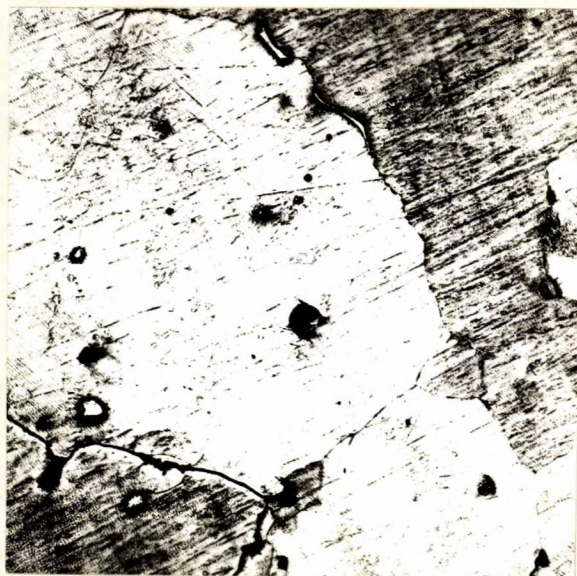
Figure 2.

Figure 2 is a photomicrograph of the structure after a quenching from 1900° F.

The high carbon content of the steel is the real source of the trouble. With such a high carbon content the steel still contains free carbides at the ordinary soaking temperatures even though the carbon-manganese ratio is correct. This is confirmed in the photomicrograph of the specimen quenched from 1900° F. (Figure 2), which shows that the steel still contains carbides at the grain boundaries and throughout the grains. The steel has too high a carbon content to be satisfactory after the normal heat treatment for manganese steel.

The steel also contained an excessive number of shrinkage cracks, and these probably contributed to the failure.

MICROSTRUCTURE AFTER QUENCHING FROM 1900° F.

Free carbides at grain boundaries and throughout  
the grains. Excessive shrinkage cracks.
